# Comparison of nondestructive testing: Infrared thermography, electrical resistivity and capacity methods for assessing a reinforced concrete structure

A series of investigations were carried out on a precast concrete duct in Tarbes, France, which displayed damage patterns. The aim of the study was to rank 55 similar pipe segments in order to determine severity of the damage. The methods used were electrical resistivity measurement, passive infrared thermography and the capacitor method. The first step was to clarify the accuracy of the site measurements of the various techniques in a real situation. All methods allowed water content rate variations and cracks to be distinguished on the surface of concrete. Statistical analysis of the data helped

*Journal of Building Appraisal* (2007) **3**, 77–88. doi:10.1057/palgrave.jba.2950065

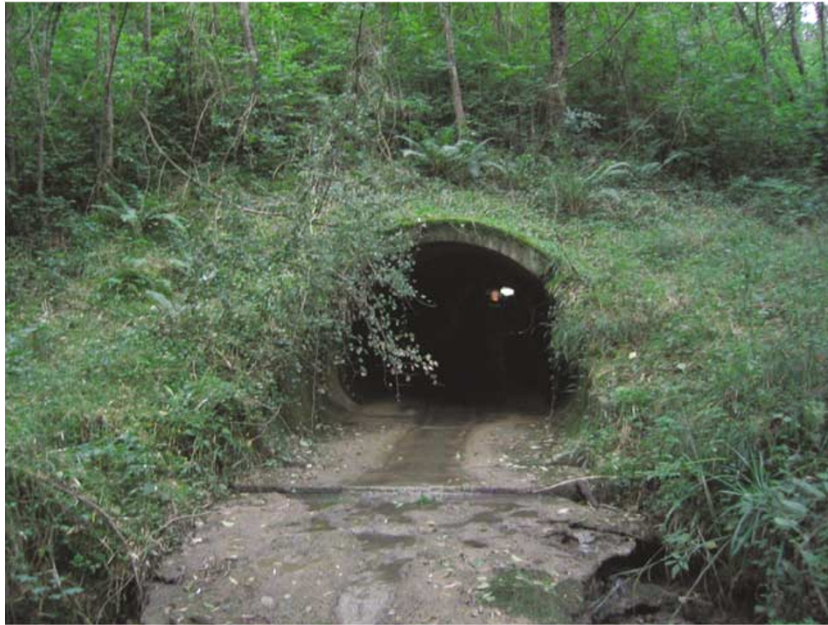
The investigations were carried out on a precast reinforced concrete duct (Figure 1) below the A64 highway near Tarbes in Hautes-Pyrénées, France, which showed visible damage of the surface of the concrete.

**Figure 1:** SW entrance of the duct ( $x=0$  m)

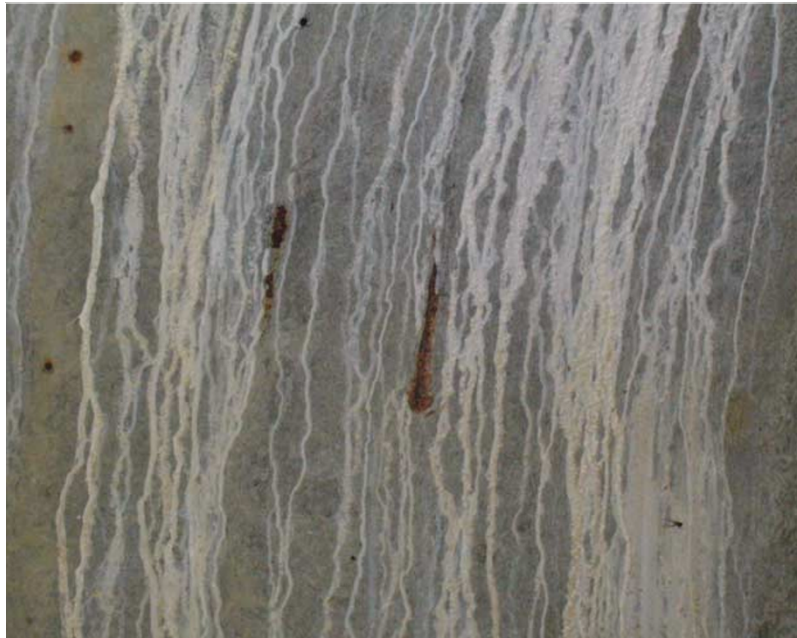
The structure is 165 m long and consists of 55 pipe segments each 3 m long and is oriented NE-SW in the direction of flow. Reference to the location within the pipe is given by the distance from the NE edge of works (0–165 m) or by the number of pipe segments from the NE end (1–55). Each pipe section is roughly ovoid in shape with a height of 1.7 m and a width of 1.8 m and the concrete thickness is about 20 cm. Only the internal surface of the duct could be inspected and showed some damage, such as cracks, which sometimes contained calcite (Figure 2) and which were mainly to the upper part of the duct.

**Figure 2:** Calcite in cracks and visible corroded rebars

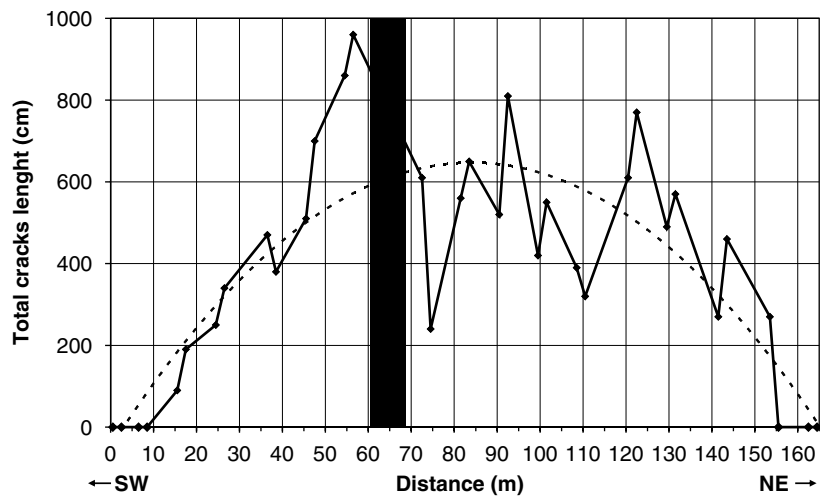
The overall dimensions of the cracks have been evaluated for each 3-m-length segment using the same method that is common in rocks mechanics (Gervais *et al.*, 1993). The cracks appear to be more developed in the middle part of the duct than at its ends (Figure 4).

**Figure 4:** Profile of total cracks length for each segment

although the increase was not symmetrical, being lower at the North-East end. In the same way, it can be seen that the damage pattern exhibits (Figure 4) more cracks between 40 and 130m than at the ends (RGCU — Final report, 2005). On the three graphs (Figures 8–10), the dotted curved line simply comes from a second-order polynomial regression on the experimental data. Its only merit is to highlight the gross trend but it does not provide any explanation.

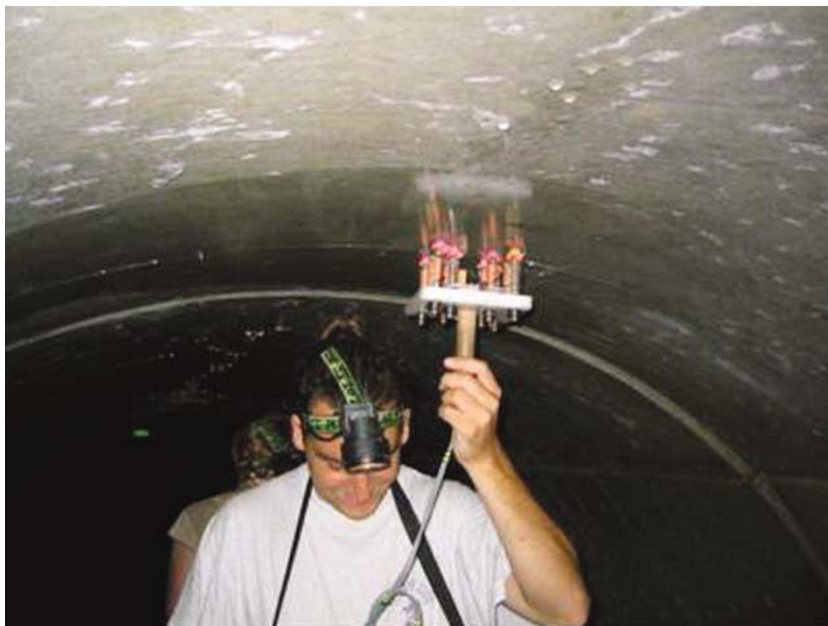
Electrical resistivity of concrete is mainly affected by the electrolytic conductivity through the porosity of material, which is affected by the quality of the concrete. When operated in a static mode (electrodes in contact with the structure under investigation), the resistivity tomography leads to excellent estimates of the concrete thickness over the rebars. With special attention, each individual rod can be mapped. The resistivity of the concrete alone can be indicative of the integrity (and residual compressive strength) of a concrete structure. Damaged areas and cracks in concrete can act as preferential routes for fluid flow. Mapping of the electrical resistivity distribution will help in diagnosis of defects in concrete structures. A special device has been developed (Figure 5; Lataste, 2002) to measure the concrete cover. The four probes deliver an electrical current between the two lateral probes and measure the potential difference between the other two probes. The apparent resistivity is calculated and can be exploited by drawing electrical resistivity profiles.

**Figure 5:** Electrical resistivity measurements

Each electrical resistivity value is the average value of three measurements at three locations on the same segment in a direction parallel to the axis of the duct. Locations were determined to minimise the influence of rebars which have been detected previously. Three measurements were taken to reduce the statistical uncertainty on resistivity assessment through the assumption of a 'homogeneous condition' for each segment. Measurements were conducted in September 2005 and took about four hours.

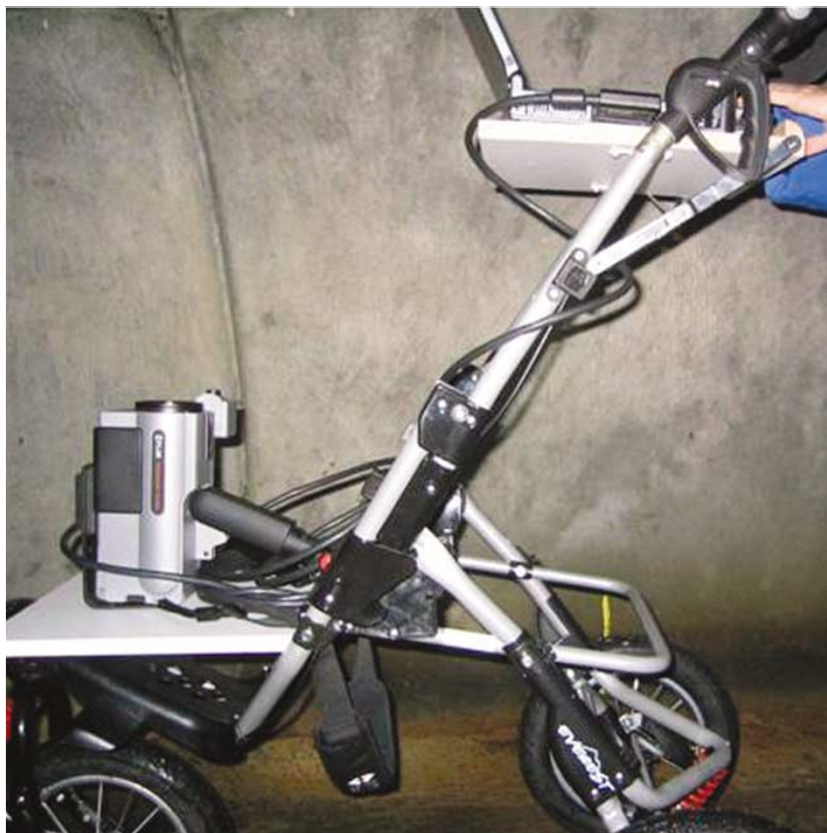
Infrared thermography is a very attractive technique as a new application to civil engineering structures as it is a noncontact, time-saving and cost-saving method. Furthermore, the equipment is often small and practical to use (Figure 6). This technique provides thermal images that represent the spatial distribution of the thermal radiation of the surface of the concrete (apparent surface temperature). To analyse results, it is necessary to combine thermal images with visual images.

The temperature value given in the results is the average temperature of the concrete surface (where there was no surface debris). The distance between the camera (FLIR SC2000, standard objective) and the concrete surface was 120 cm, which gave image sizes of  $38 \times 46 \text{ cm}^2$ . It was not possible to distinguish the cracks directly on thermal images because of the instantaneous field of view of the camera (1.3 mrad, which corresponds to a 1.56 mm crack width at a 120 cm distance). The surface temperature of the concrete is directly linked to emissivity, thermal diffusivity and evaporation of the concrete (Sirieix

**Figure 6:** Infrared thermography measurement device

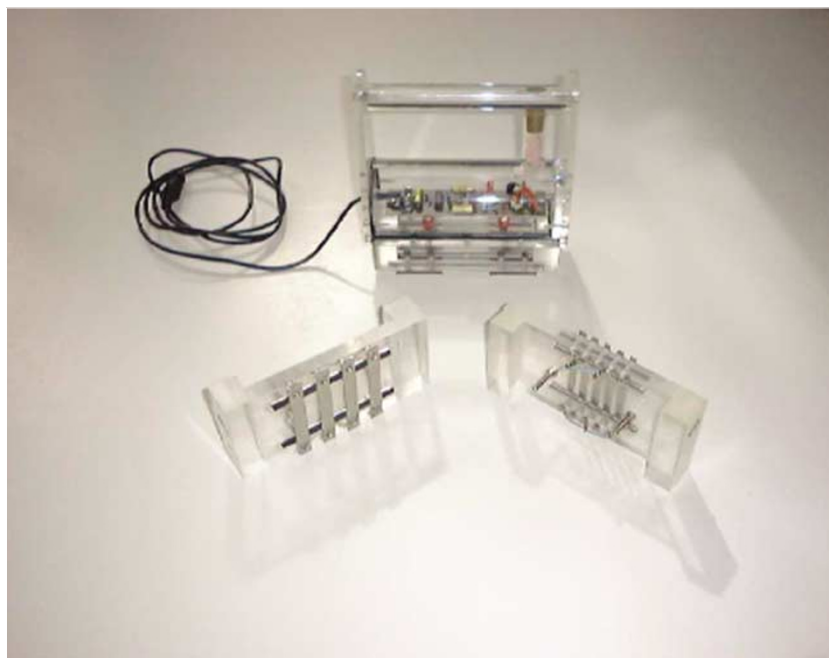
The capacitor method was mainly developed for measuring the moisture content of structural concrete, by the Laboratoire Central des Ponts et Chaussées (Baron and Tran, 1977; Blaszczyk *et al.*, 1993). The principle is to obtain the change in dielectric properties of concrete between two electrodes from the resonant frequency of an oscillating circuit. The electrodes are two parallel metallic plates laid on the concrete (Klysz *et al.*, 2003). These electrodes form a capacitor with the concrete, the capacitance of which is dependent on the geometry of the electrodes ( $7 \times 10 \text{ mm}^2$ , see Figure 7) and on the dielectric constant of the concrete. Thus, the resonant frequency depends on the concrete's properties. These measurements have been shown to be very sensitive to the concrete moisture content (Derobert *et al.*, 2005).

Each value is the difference between one measurement (taken on the keystone of the duct section) and a reference value taken in open air (without concrete between the electrodes) for the same geometry. Measurements were conducted in June 2005 and took four hours.

**Figure 7:** Capacitor apparatus (Photo courtesy of X.Dérobot)

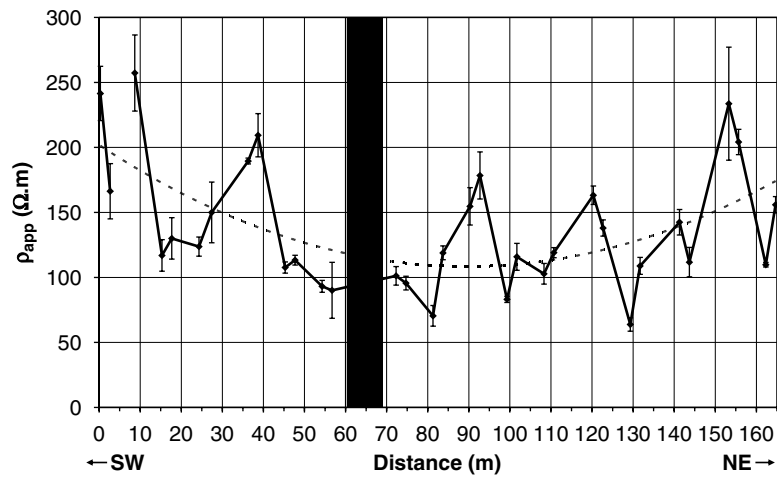
The combined results are shown for each of the three test methods in Figures 8–10. They show a similar trend of the data along the duct in that they are quite constant in the central sections (between approximately 40 and 130 m) and show an increase at either end,

**Figure 8:** Average values and error bars of electrical resistivity measured in three points, along the keystone of the duct

Figures 8–10 suggest a correlation between the results provided by the three techniques, since all three patterns show a similar trend, despite the local (error bars for each average value) and global variations.

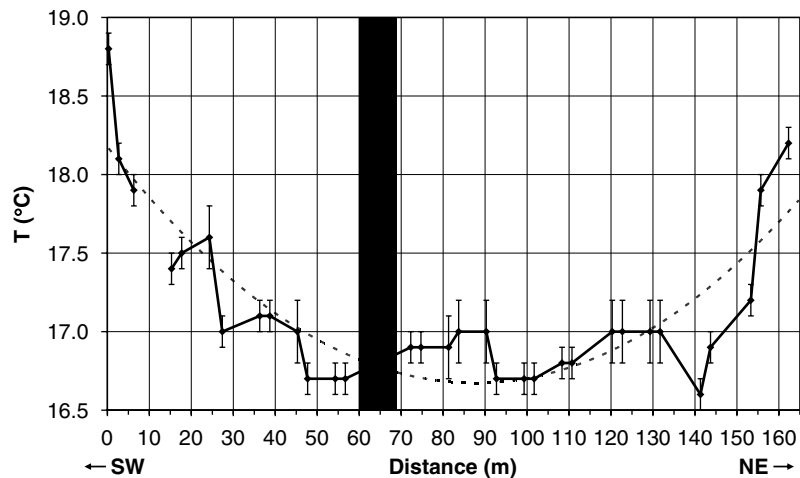
**Figure 9:** Average values and error bars of the surface temperature of the keystone as measured by thermal imaging. Each image was 38×46 cm<sup>2</sup>

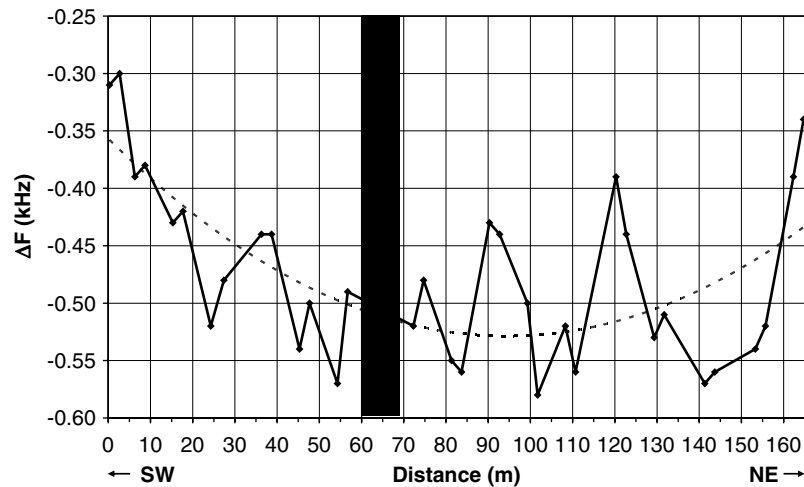
**Figure 10:** Difference in frequency as measured by the capacitor method
