Methodology for the rehabilitation of ancient gypsum plasterwork

Journal of Building Appraisal (2007) **3**, 195–212. doi:10.1057/palgrave.jba.2950075

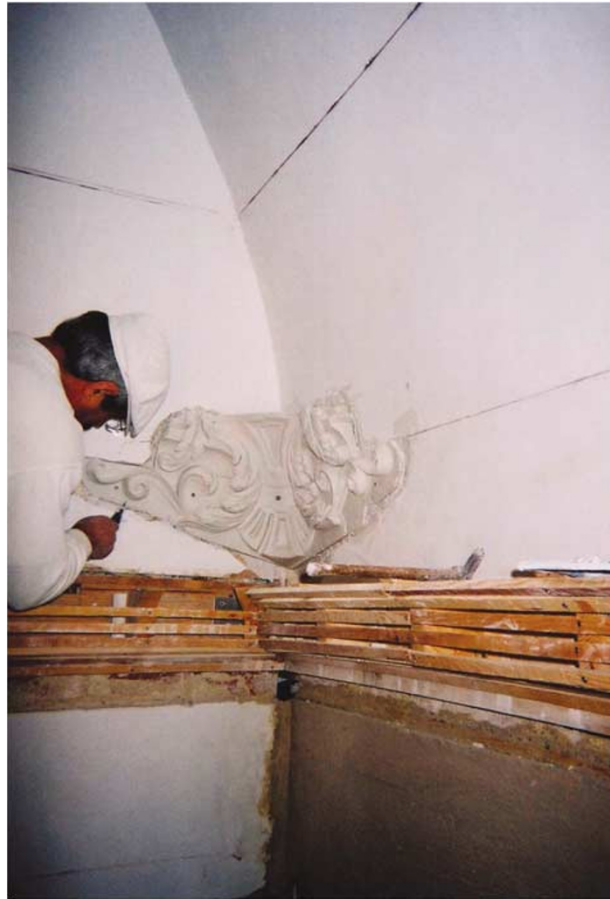
Figure 1: Reinstatement of the decoration in gaps of great dimension in a ceiling (Freixo Palace in Porto) (Cotrim *et al.*, 2006)

The 2003 document on rehabilitation of the Freixo Palace in Porto (Figure 1) is also important in the context of the present study (Cotrim *et al.*, 2006).

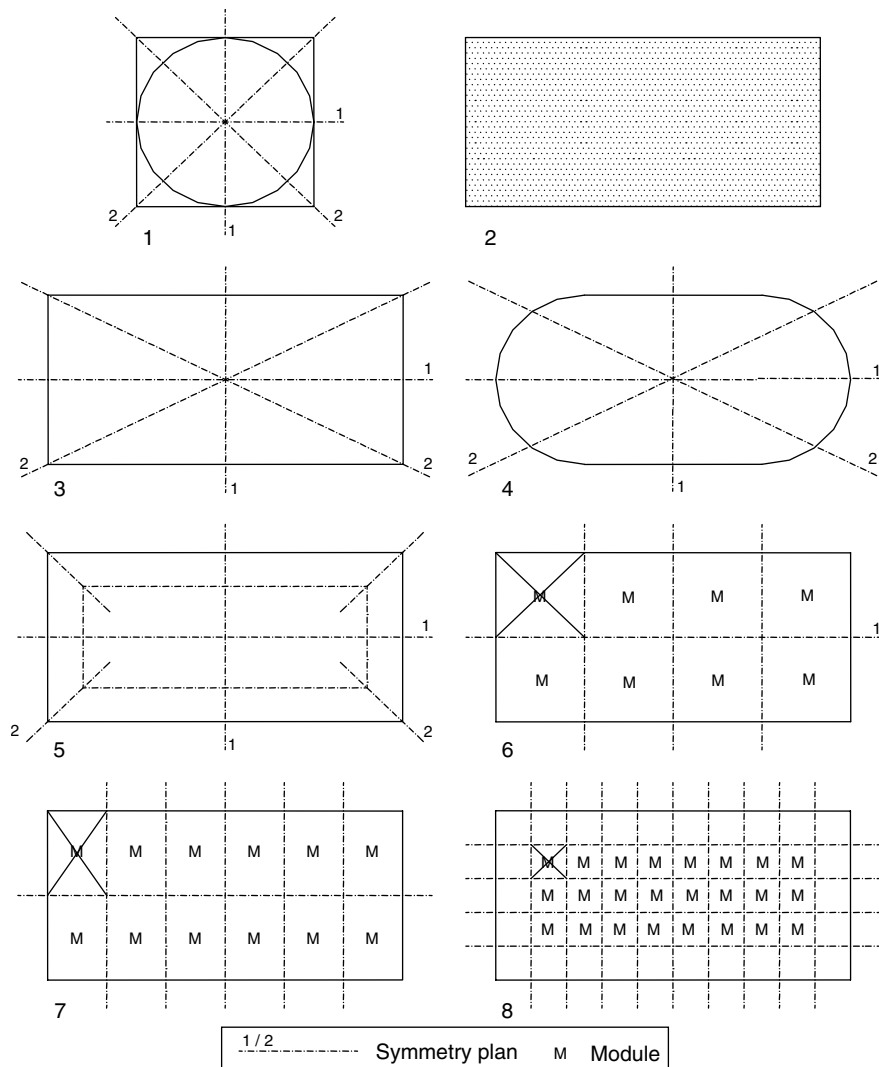
Figure 2: Composition diagrams of gypsum-plastered roofs. Symmetric compositions: diagrams 1, 3, 4, and 5. Modular compositions: diagrams 6, 7, and 8. Nonsymmetric compositions without modules repetition: diagram 2

A morphological and composite appraisal is necessary to determine the design of the plastered elements for symmetry, repetition, and shape (Figure 2) among others, and is essential for the process of reintegrating missing patches. It is performed using current easy-to-use appraisal methods, such as photography, drawings at conventional scales and hand-drawn sketches indicating dimensions, and the register of formal, stylistic, and chromatic characteristics (Gleeson, 2002). Nevertheless, whenever deemed necessary, more sophisticated technical means must be used, for example thermography.

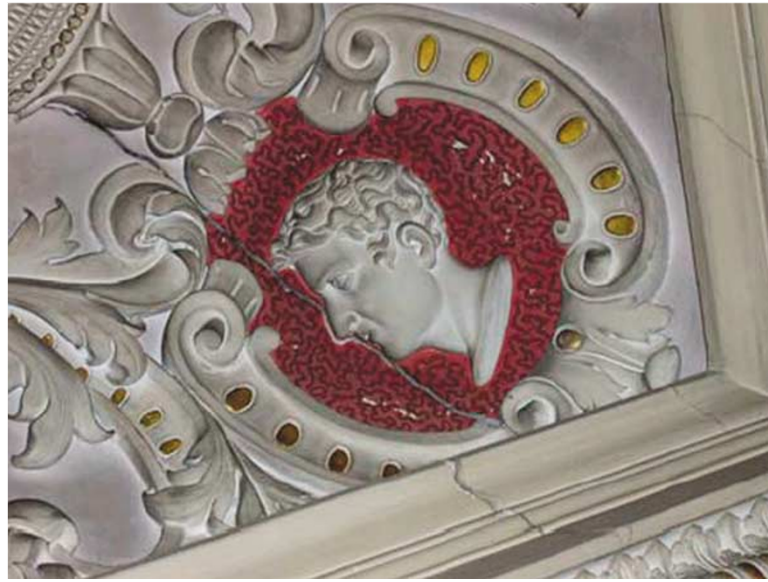
Figure 3: Cracking in ornaments (Marquis of Tomar Palace in Lisbon)

- (a) damp areas;
- (b) the effects of dampness;
- (c) the existence of efflorescence and cryptoflorescence situations, and the configuration of the respective salts;
- (d) decayed or powdery areas;
- (e) cracks (dimensions, location, and geometry) (eg Figure 3);
- (f) patches with loss of adhesion;

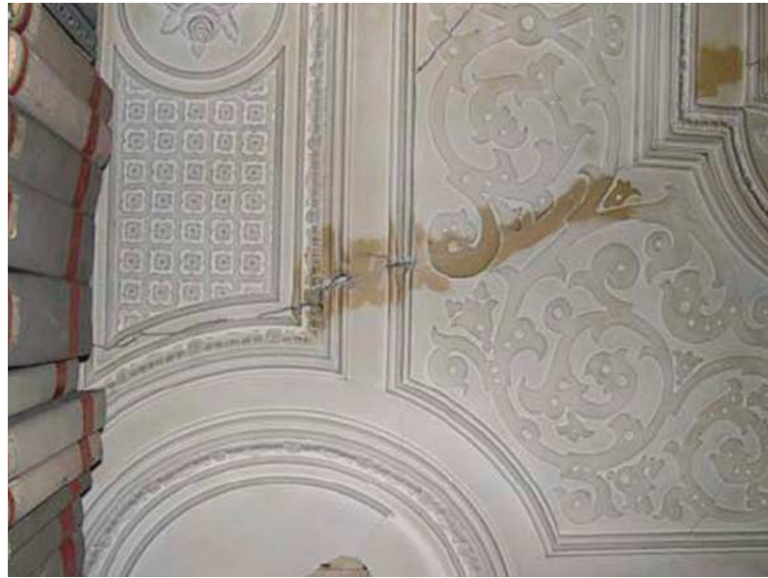
Figure 4: Stains caused by water entrance (Marquis of Tomar Palace in Lisbon)

- (a) inadequate interventions due to the use of incompatible materials or coarse corrections;
- (b) incorrect repainting;
- (c) occasional water entrances (eg Figure 4);
- (d) damage caused by fire or vandalism.

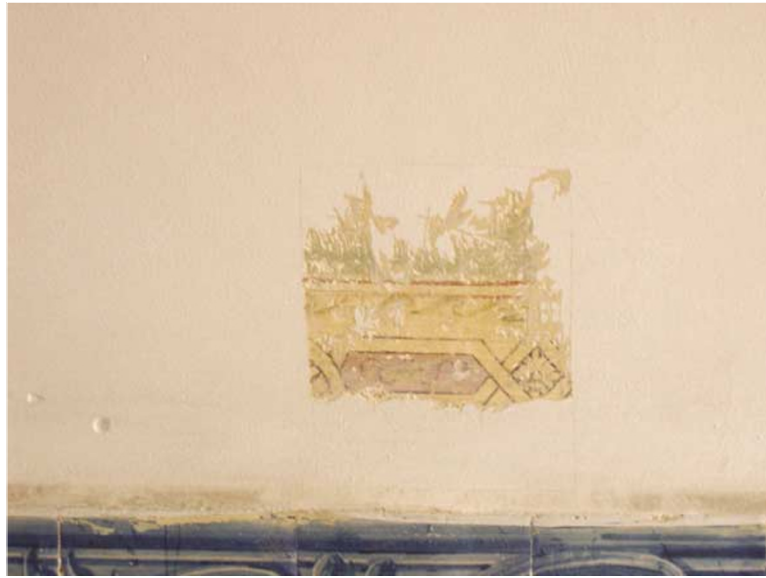
Figure 5: Removal of contemporary paintings to inspect hidden polychromes (Marquis of Pombal Palace in Lisbon)

Finally, concerning polychromes, inspection is relevant from an artistic, historical, and archaeological point of view. One has to carry out the studies necessary for their rehabilitation, which involves complex actions of cleaning and restoration. In the case of ancient paints covered by recent painting layers, rehabilitation demands the almost surgical removal of these layers in limited areas, called *windows*, of an adequate dimension to visualise the polychrome or the decorative compositions (Figure 5).

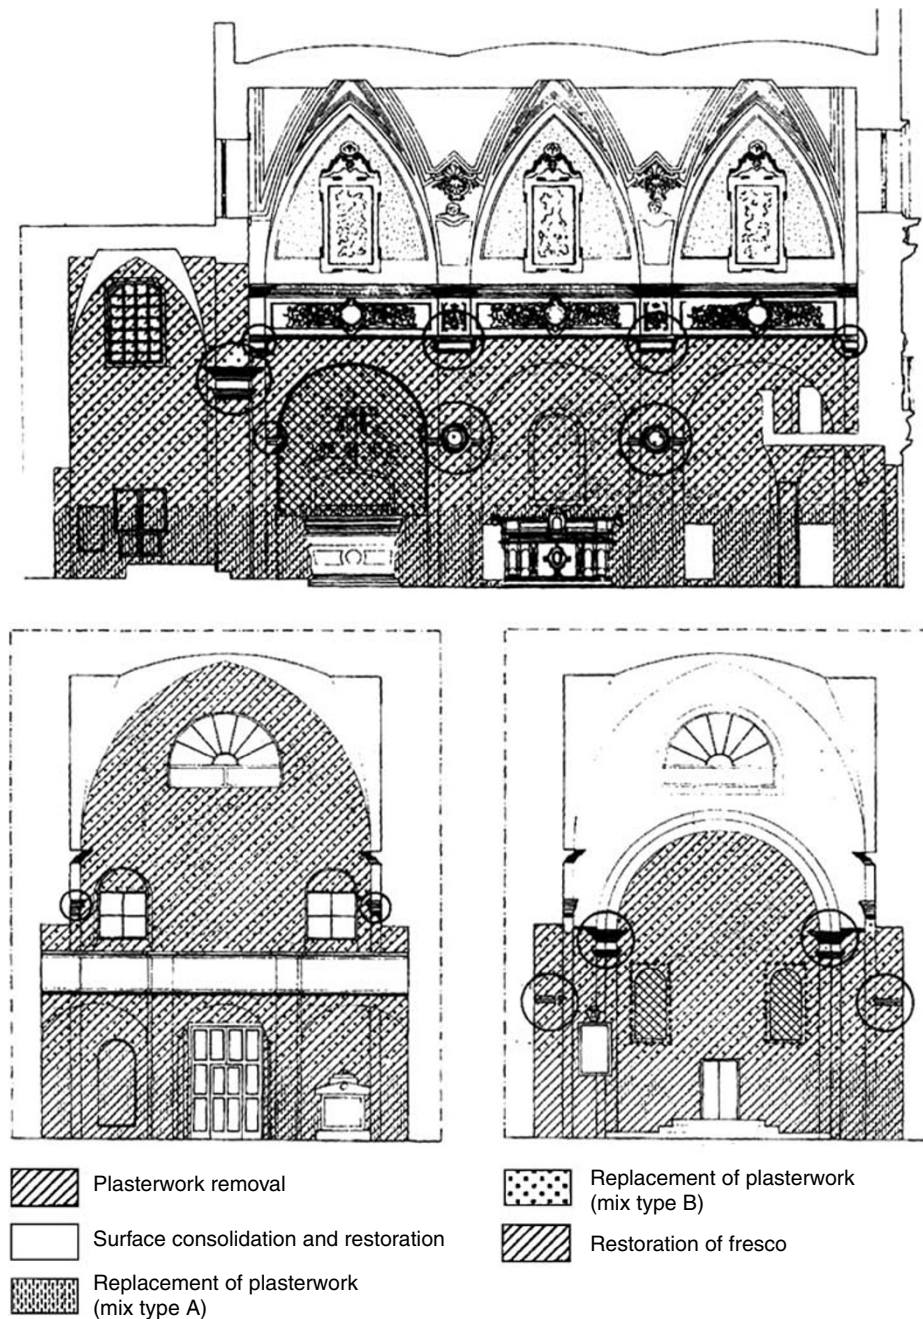
Figure 7: Interior elevations of a church, an example of register of interventions to be made in different areas

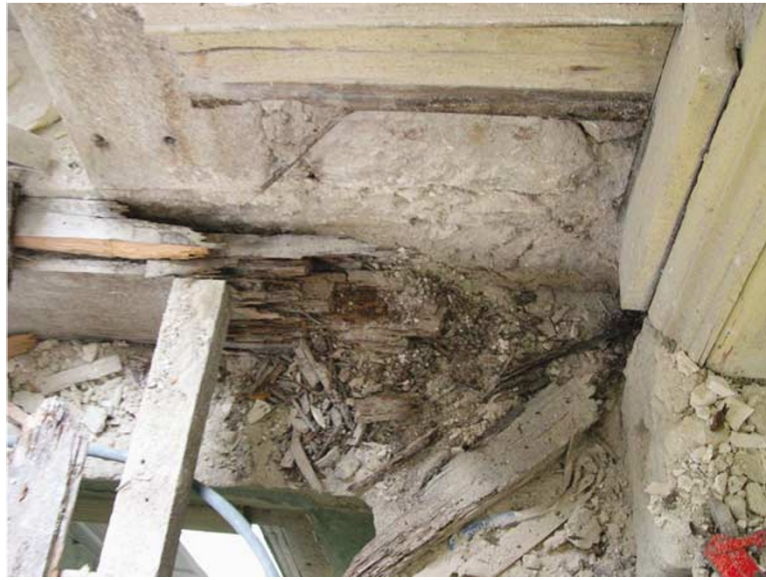
Figure 8: Rot of timber beam next to outer wall, visible only after the pavement was dismantled (Morais Villa in Ponte de Lima, Portugal)

Floors are generally made of timber, in which the damage found in most cases is due to bad conservation of the support due to water entrance (Cotrim *et al.*, 2006). This anomaly can only be clearly identified after dismantling the coverings and right before the execution of the rehabilitation works (Figures 8 and 9), however, corroborating the need for an exhaustive inspection, namely at the level of the roofs beams system, in order to determine the elements to be replaced or treated on site .

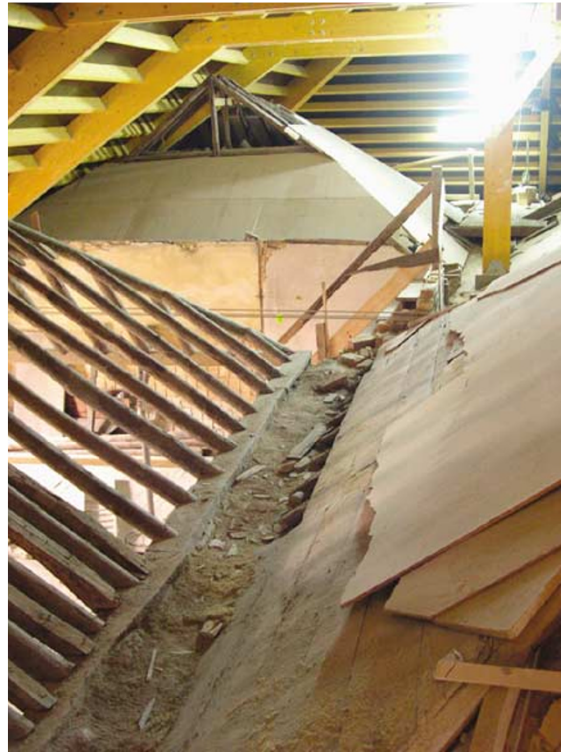
Figure 9: Extrados of plastered roofs: original structure and new support of the roofs (Marquis of Pombal Palace in Lisbon)
