Forms and factors of deterioration of urban art murals under humid temperate climate; influence of environment and material properties

Abstract This study describes the different alteration forms in 25 street art murals created between 2007 and 2018 on different substrates and located in different cities in NW Spain. The deterioration forms described affect the entire layer of the paintings as well as the substrates, with the most common being loss of colour (fading), loss of the pictorial layer -with or without loss of part of the substrate and biodeterioration. Physical, chemical, mineralogical and micromorphological analyses of samples from 10 murals revealed that (1) the deterioration mechanisms are related to environmental conditions and also to the inherent properties of the painting materials and to paint-substrate interaction, (2) the deterioration is closely associated with inherent aspects of urban art and (3) the loss of the pictorial record sometimes occurs in a very short period of time. The study findings highlight the need for preventive conservation measures in artworks (generally commissioned) that are intended to last.

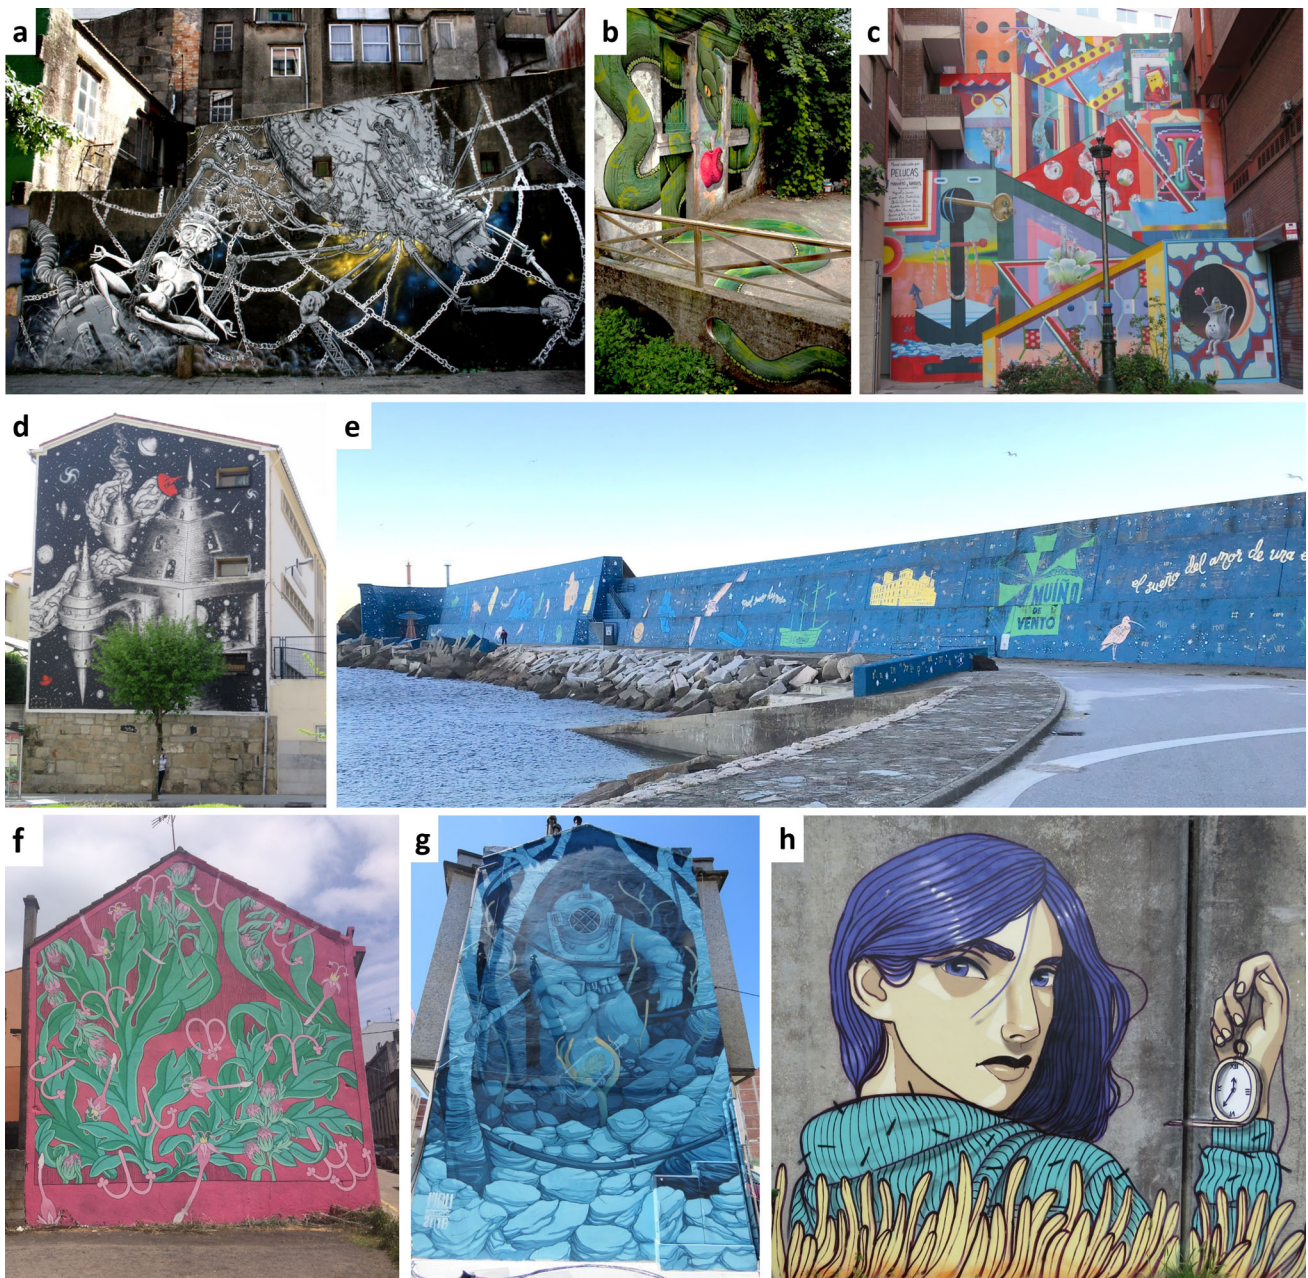
Fig. 1 Some of the artworks selected for this study. **a** Entaraña (AW17); **b** Pecado original (AW19); **c** Untitled (AW10); **d** Génesis y Gnosis (AW12); **e** A Guarda escrita nas estrelas (AW21); **f** Reforestando Artemisa Vulgaris (AW22); **g** A Orixe 2 (AW23); **h** Tempo (AW25)

[34]. The documented information included title, location, year of execution, type of structure, substrate material, artistic technique, paint brand, existence of an underlayer and state of conservation (deterioration forms). In addition, the extent of all deterioration forms was identified. Of the 10 artworks selected, 5 were painted before 2018 (AW16–20; AW17-Fig. 1a, AW19-Fig. 1b) and the other 5 were painted more recently, in 2018 (AW21–25; AW21-Fig. 1e, AW22 Fig. 1f, AW23-Fig. 1g, AW25-Fig. 1h).

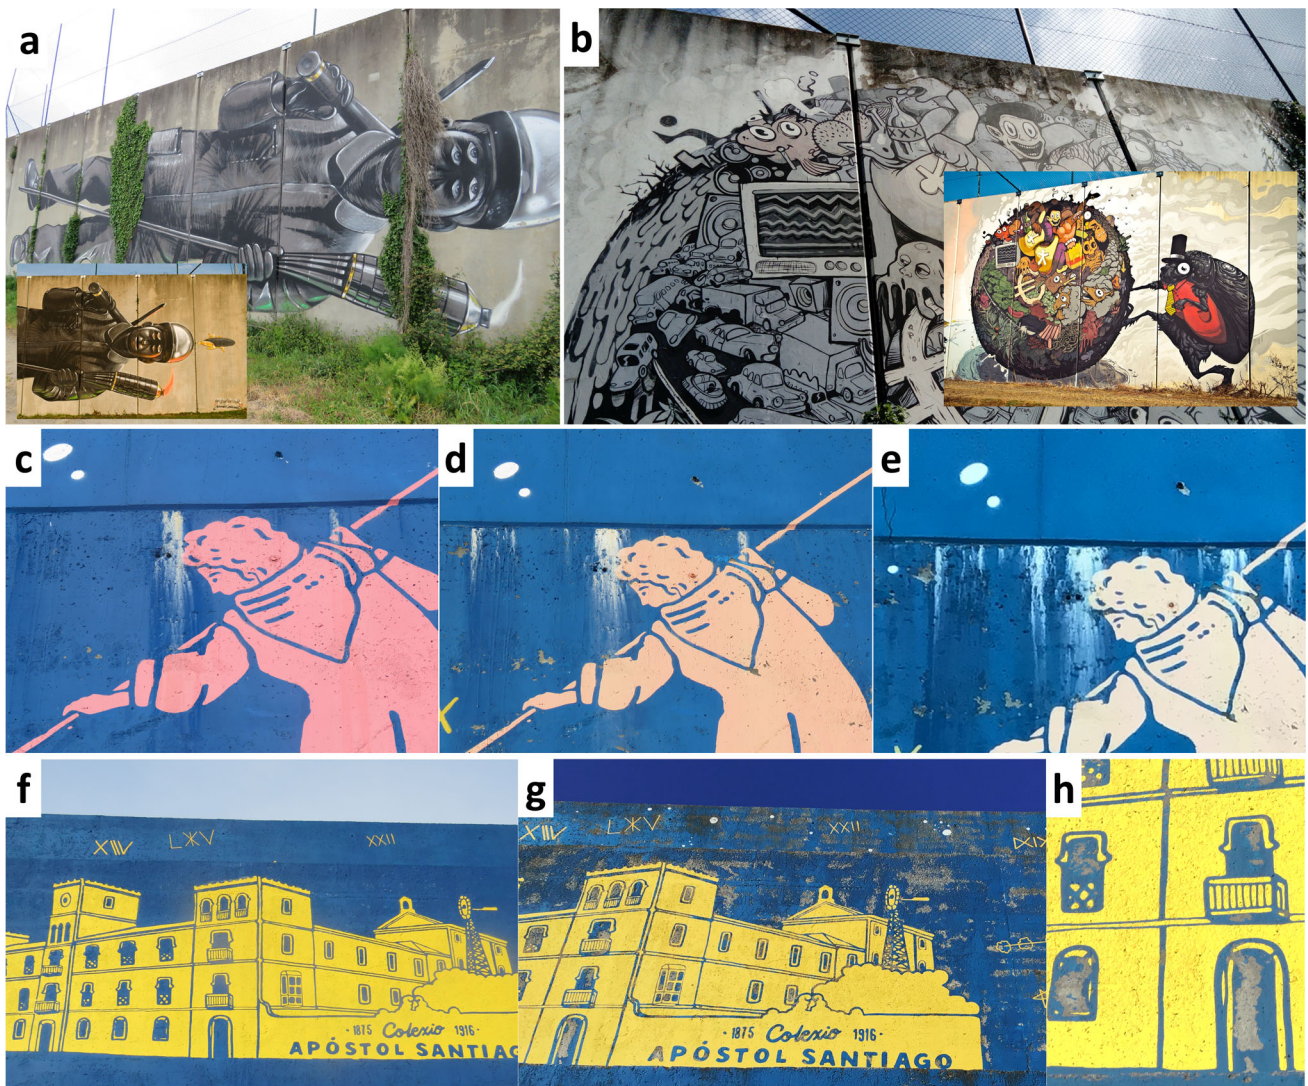
Fading is the most common deterioration form, affecting 22 of the 25 artworks. The pictorial layer is (apparently) physically intact, but has undergone a visible colour change towards whitish/greyish faded tones (Fig. 2a, b). No clear relationship was observed between the presence and intensity of this type of alteration and the degree of exposure of the murals to direct sunlight; there was also no apparent relationship between the intensity of the fading and the type of the substrate, as it affected paintings on both rendered and unrendered brick and concrete surfaces (Table 1). In some of the artworks (AW18 and AW20: Fig. 2a, b), the loss of colour is so intense that only grey tones are observed.

Fading can occur quite rapidly, as observed during monitoring of the deterioration of AW21. In this artwork, a clear relationship was also observed between the colour of the paint and the rate at which it faded: the pink and orange paints had visibly faded 12 months after completion of the artwork and the fading was even more intense after 24 months (Fig. 2c–e), while the colour of the blue, yellow and green paints was scarcely altered (Fig. 2f–h).

Fig. 2 Fading affecting AW20 (a), AW18 (b) and AW21 (c–h) artworks; c–e images of a detail of a pink-painted iconography from AW21 taken in 2018 (c), 2019 (d) and 2020 (e); d–f images of a detail of a yellow-painted iconography over the blue base paint of AW21, showing the progression of the deterioration from 2018 (f) to 2020 (g and h)

Taking the above results into consideration and in accordance with previous findings [22–24, 27, 42, 43, 46–51], the fading observed in the artworks under study can be attributed to the effects of UV radiation on the organic polymers contained in the paints (i.e. binders or chromophores). The observed differences between the artworks under study in regard to the intensity of fading is probably due to the different paint formulations. It is also possible that the substrate influenced the colour changes in the paints. Alonso-Villar et al. [27] reported that minimal loss of adherence between the paint and substrate (favoured by the type of substrate, e.g. by smooth substrates such as brick and pre-cast concrete, or by the paint formulation) may lead to changes in the perceived colour, although the loss of adherence does not represent a risk of loss of the pictorial layer.

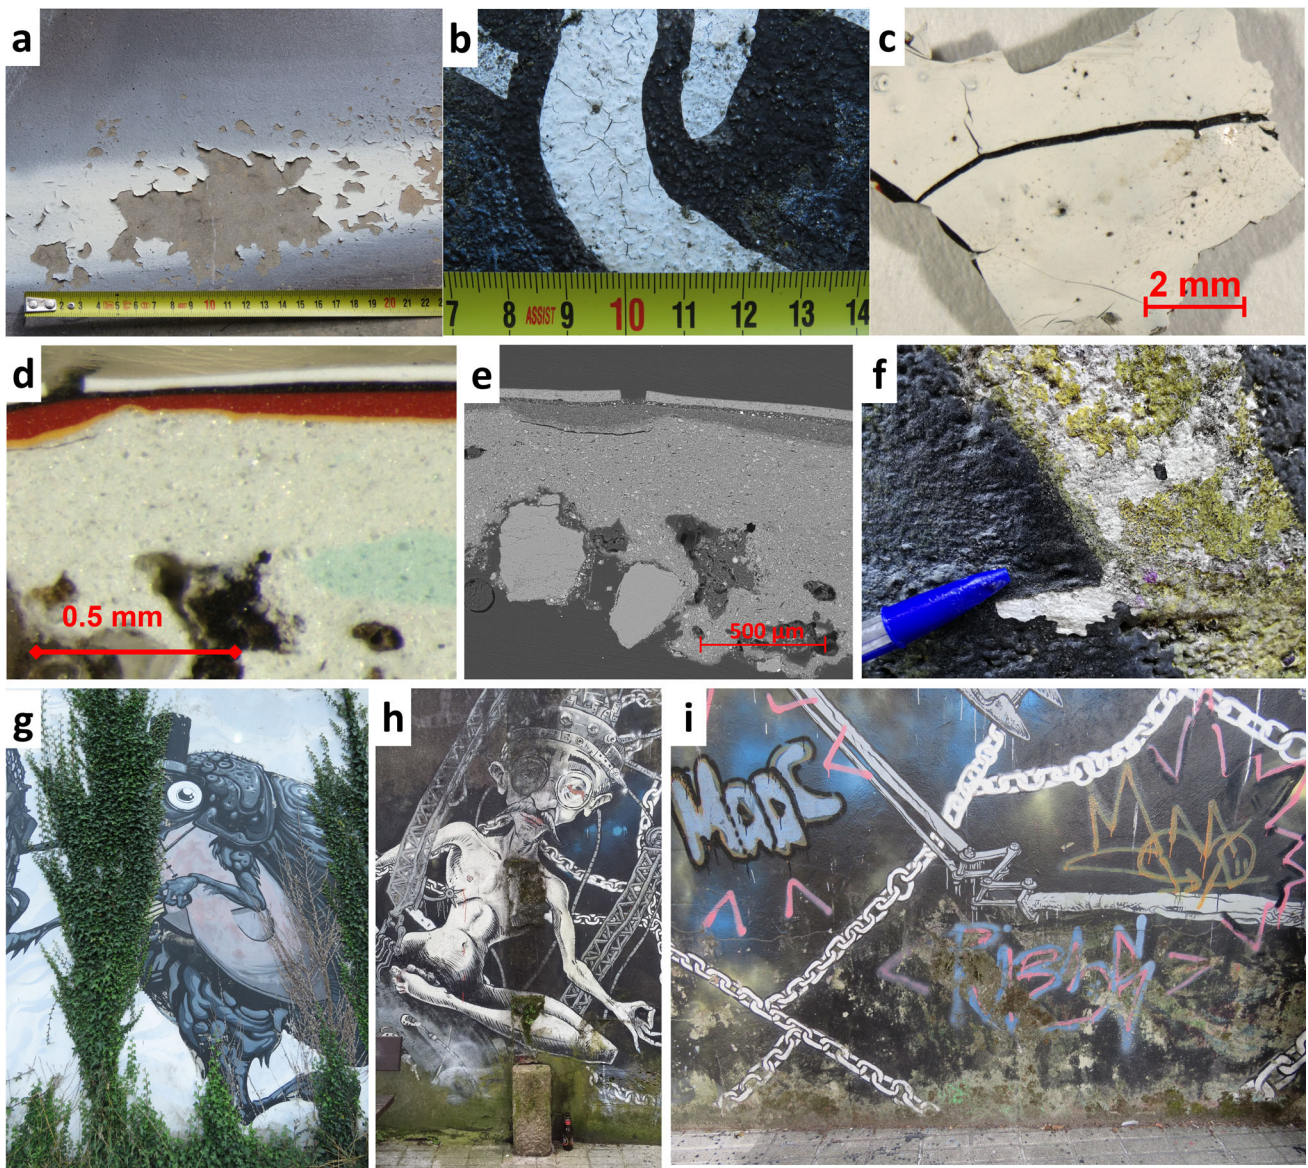
Fig. 7 **a** Peeling affecting AW20; **b** craquelure affecting white paintings on AW17; **c** micrograph of the surface of a craquelure sample from AW17; **d** and **e** micrographs of the cross section of the craquelure sample depicted in **c**, taken with optic microscopy (**d**) and SEM BSE mode (**e**); **f** biological colonization affecting AW16; **g** growing of vascular climbing plants on AW18; **h** biogenic black patina on AW17; **i** green patina, abrasion and vandalism on AW17

(4) *Craquelure*. Another manifestation of the deterioration affecting the integrity of the pictorial layer is craquelure, defined as a network of very fine cracks that specifically affect the pictorial layer and that eventually lead to loss of the layer. Craquelure was only detected in two of the artworks under study and, in one of these, only in some colours of paint: in AW20 (Fig. 2a) only the fluorescent orange was affected (Figs. 2a and 7a) and in AW17 (Fig. 1a) the white paint was affected (Fig. 7b). Examination of the samples by optic microscopy (Fig. 7c, d) and SEM (Fig. 7e) confirmed that the cracks only affect the surface layer of the painting, and there was no evidence that these fractures develop from the substrate. These observations appear to support the idea that the craquelure is due to failure related to shrinkage during polymer drying processes or to an excess of paint [77].

It is defined as the loss of pictorial material (with or without the substrate) caused by rubbing or scraping with an object. This type of deterioration is very common in artworks that are accessible to the public, in which the abrasions are caused by impacts from objects, people or vehicles (Fig. 7i).
