Concrete damaged analysis in strengthened corbel by external bonded carbon fibre fabrics

Abstract

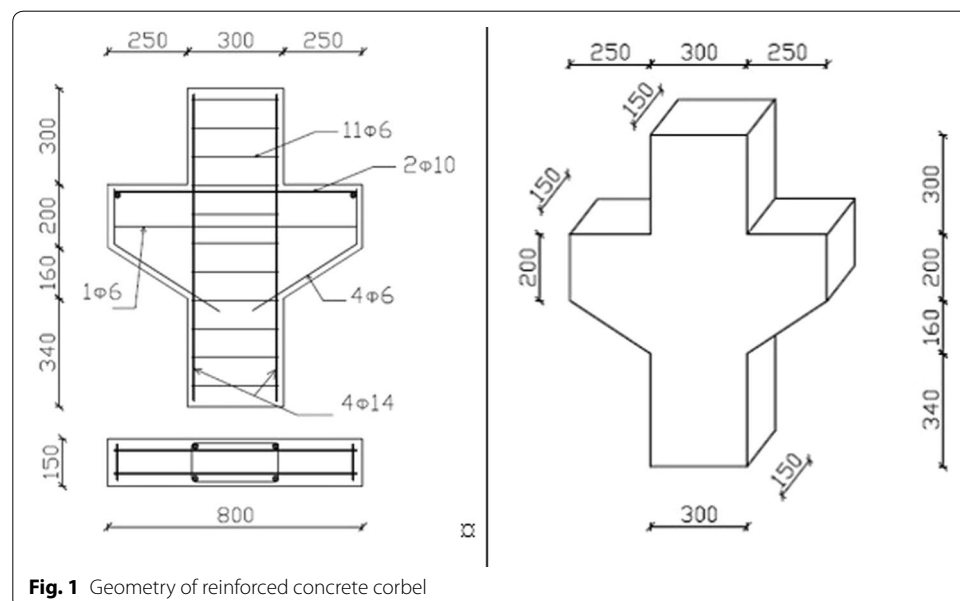
The sizes of specimens are presented in Fig. 1. The 1000 mm long column supporting two short trapezoidal corbels cantilevering on either side is 150 mm by 300 mm in cross section. The specimens have cantilever projection length of 200 mm, with a thicknesses of 150 mm at both faces of column and free end. All reinforced concrete corbel specimens have the same sizes and are reinforced in the same way.

The control specimen without strengthening is denoted "C0". The letter "C" means the Corbel and 0 (zero) marks the state without strengthening. The damaged specimens are denoted C0_45, C0_65 and C0_90 %. The names of the strengthened test specimens is CB3u, made up as follows: the first letter "C" is as previously Corbel. So, the second letter represents the type of strengthening (e.g. B for Bandage). Then the digit indicates the number of layers (e.g. 3). Finally the small letter denotes the type of composite material

Three of the reinforced concrete corbels were subjected to a three points bending test, Fig. 1. The cracking and failure modes were reproducible with an accuracy of 7 % of ultimate load. With these results, the experimental program of this paper is established. The tests were carried out at ambient temperature.

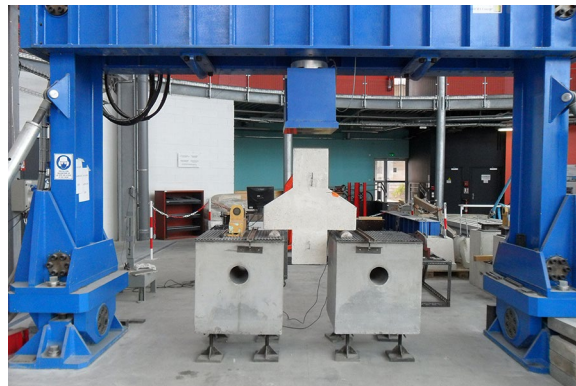
Fig. 2 Flexure bending test of strengthening reinforced concrete corbel

(e.g. u for unidirectional). The strengthened specimens after damage are indicated by CB3u_45, CB3u_65 and CB3u_90 %. All the corbels were soumitted using three-points bending test, Fig. 2. All tests were performed with a average loading speed of 0.2 kN/s. The registration system data was recorded every 0.1 s.

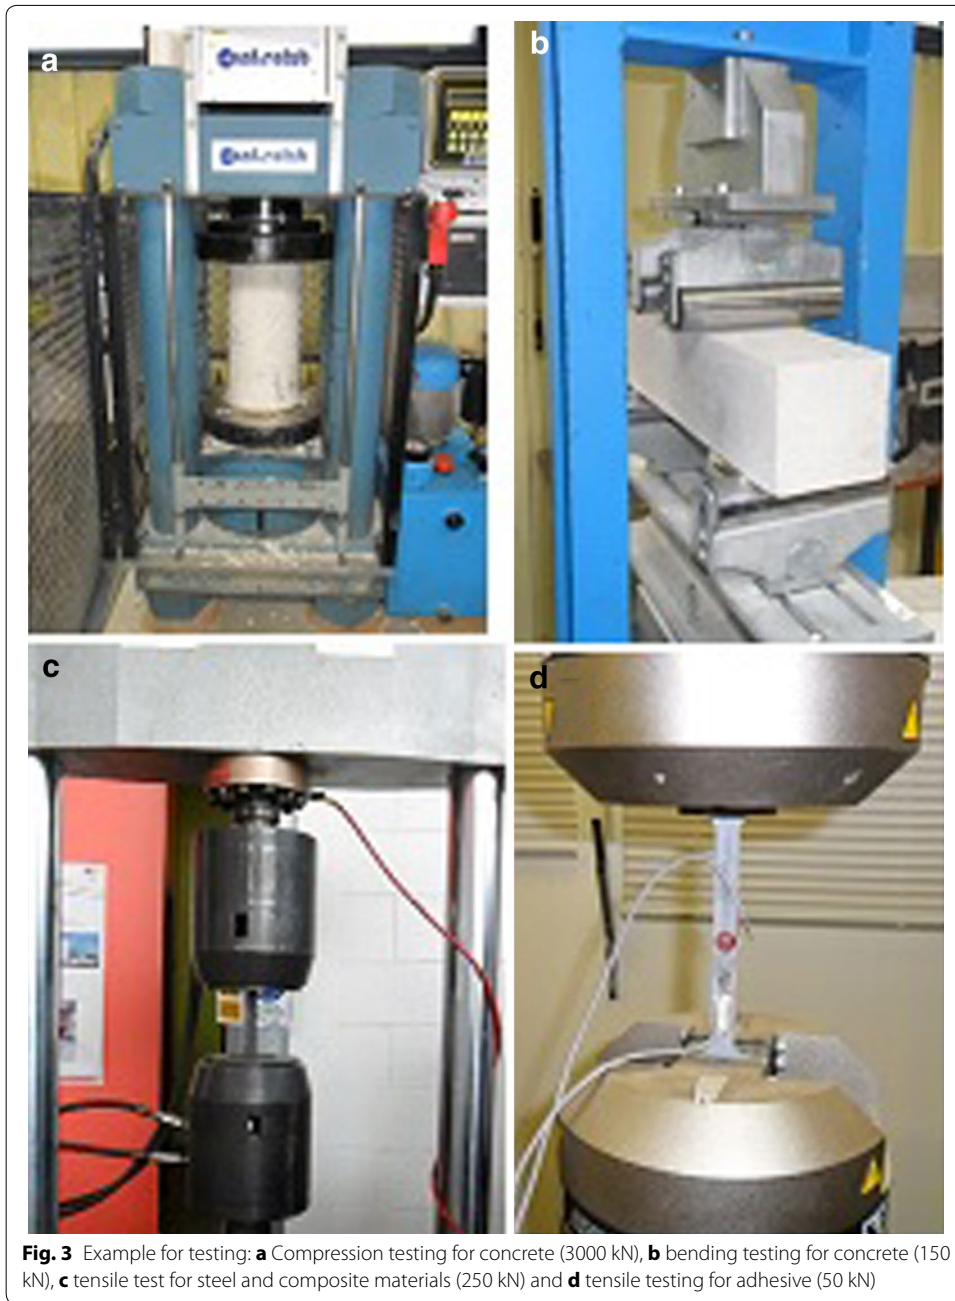
Five concrete cylinders by 160–320 mm were also cast and tested after a period of 28 days when each short corbel was tested, to determine compressive strength of concrete. The tests were performed using a compression machine “CONTROLAB” (Fig. 3a) with ultimate load value of 3000 kN. The applied compressive loading speed is 0.05 MPa/s.

Prismatic samples in concrete, 10×10×40 cm dimensions are also tested using a bending machine with an ultimate load of 150 kN (Fig. 3b). The loading speed is 0.17 kN/s. The test results give us an average value of tensile bending strength of 4.87 ± 0.67 MPa.

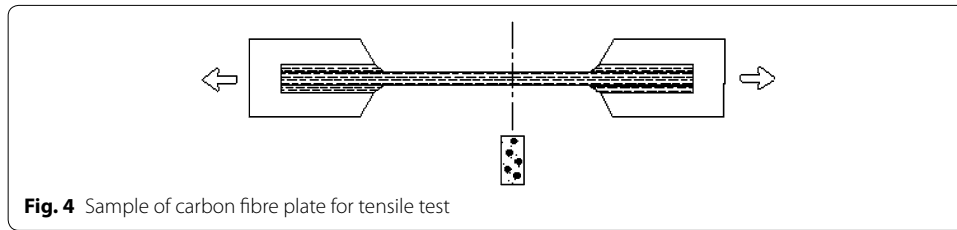
Fig. 4 Sample of carbon fibre plate for tensile test

The carbon fibre fabrics is composed of 99 % carbon fibres in warp and 1 % of weft yarn in white thermoplastic fibres. The fabric thickness is 0.2 mm (Fig. 4). The composite carbon fibre fabrics have an elastic linear behaviour up to failure. The high deformation at failure is 0.8 % for the unidirectional carbon fibre fabric.

The experimental results of three carbon fibre plates in the longitudinal direction are showed in Table 1. The yield strength of composite plate corresponds to the maximum ultimate stress.

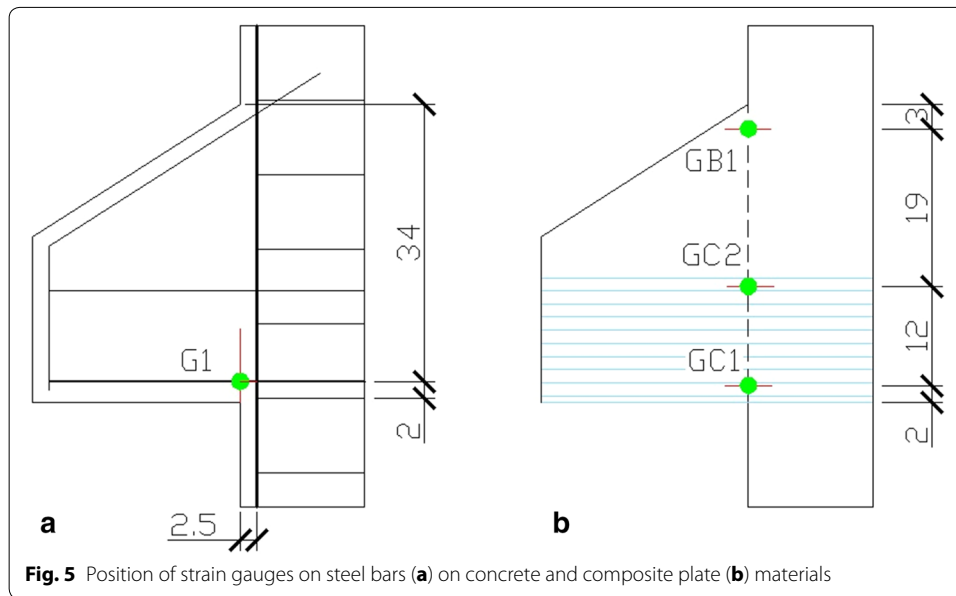
The results Load (F) versus deformation (ϵ) are plotted for different materials as shown in Fig. 5a, for reinforced steel and in Fig. 5b for concrete and composite plate. Thus, the positions on steel G1, on the composite plate GC1, GC2 and finally GB1 in the compression zone cross section.

The obtained curves $F(\epsilon)$ describes the local behaviour of carbon fibre fabric, steel bar and concrete. The change of slope $dF/d\epsilon$ corresponds to the appearance of micro-cracks or a change of state. The change of sign of $dF/d\epsilon$ corresponds to the initiation of fast crack propagation around the ultimate load of structure.

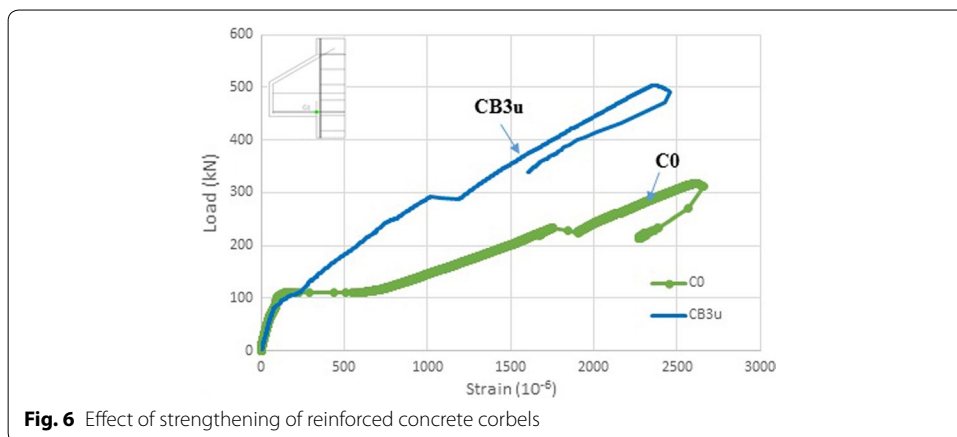
The Fig. 6 shows the effect of reinforcing into the behavior of both corbels. One of them is reinforced while the other remains unstrengthened. The two curves in Fig. 6 have two characteristic points marked by each bearing. The first landing represents the growth limit of the bending crack and the second landing is at the onset to the oblique crack and local yielding of steel. Thus, the steel yielding is compensated by the composite plate.

The first bearing is less important than in the case of strengthening due to the concrete containment by the carbon fibre fabrics. Technical strengthening increases the carrying capacity of the structure ultimate load by more than 50 % and improve the stiffness and inflexibility of specimens. Three areas were identified: elastic area, cracking propagation area limited by appeared oblique crack and the last area where it noted the opening of the oblique crack up to failure, Fig. 6.

The results of damage effect on the behavior of repaired reinforced concrete corbels are shown in Fig. 7. In fact, the results show that mechanical damage has an effect on the ultimate damaged load F_{Du} . The curves show a similarity between C0_45 and C0_90 % on the one side and, CB3u_45 and CB3u_90 % on the other side. The three fields that appeared in the case of repair, were reduced to two fields by 40 %. The curves also show the elastic linear to failure for strengthened reinforce concrete corbel of 90 % damaged. The elastic domain disappears. Even at 90 % of damage, the ultimate load of strengthened corbel without damage was reduced by 20 %.

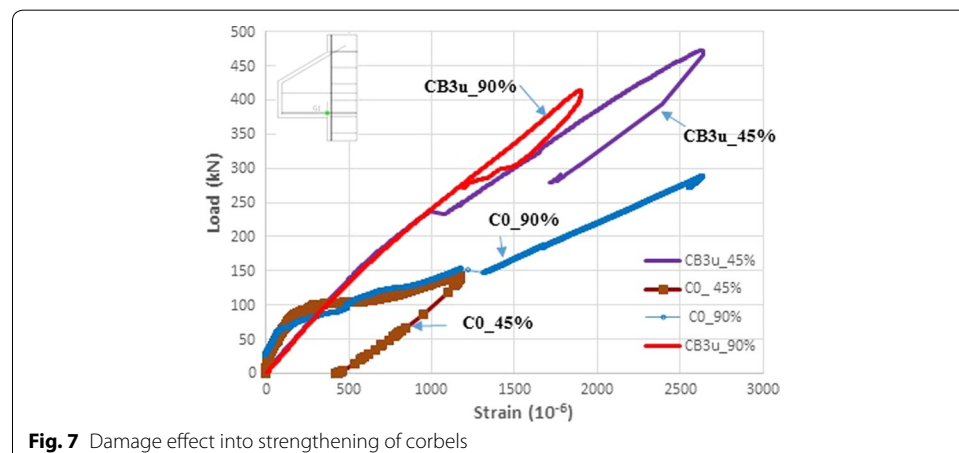
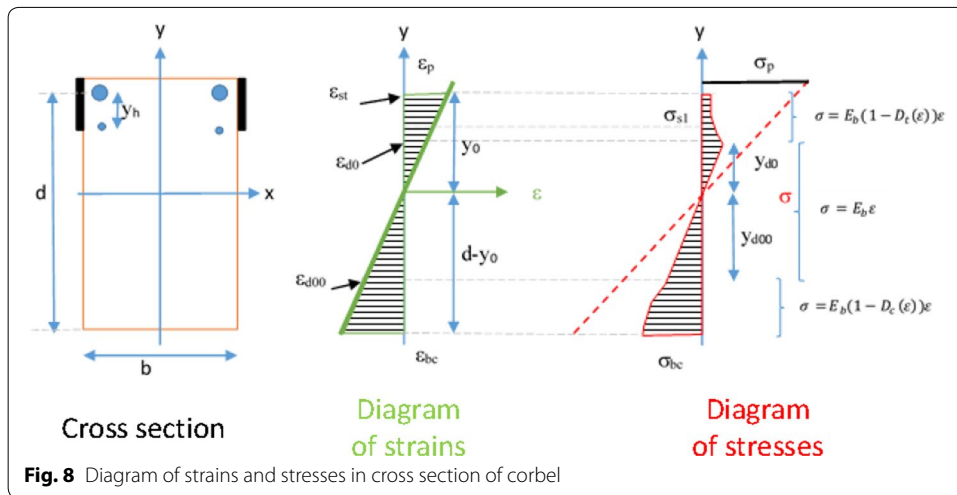
From the Fig. 8, the damage factor is defined by Eqs. (1) and (2) where $D(\varepsilon) = D_t(\varepsilon) + D_c(\varepsilon)$ where $D_t(\varepsilon)$ and $D_c(\varepsilon)$ are respectively tensile and compression damage factors. The factor ε_{d0} indicates the damage threshold strain in the tensile zone and ε_{dc0} the one in the compression zone. The relation between those two parameters is highlighted by Eq. (3).

From the two diagrams of Fig. 8, the resultant stress of generalized stresses expression is equal to zero:

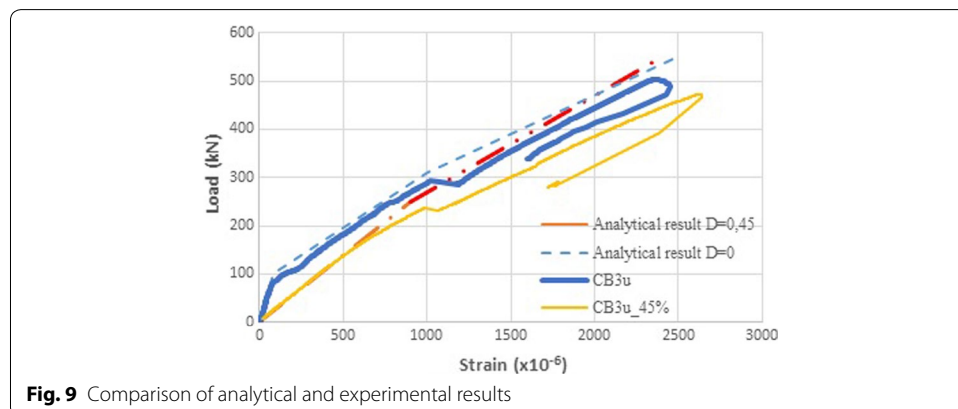
Fig. 9 Comparison of analytical and experimental results

In Fig. 9, the analytical results get closer to the specimen’s real behaviour because this approach, taking account the concrete damages in tension and in compression. The identification of the parameters ε_{d0} , A, B and ε_{dc0} are good. This new approach is better than the previous ones and must be pursued to improve this analytical consideration

taking wrapping effect. The wrapping effect was not taken into account in this analysis and must be considered for the next study.
