RESEARCH ARTICLE

Environmental impacts of forest road construction on mountainous terrain

Erhan Caliskan

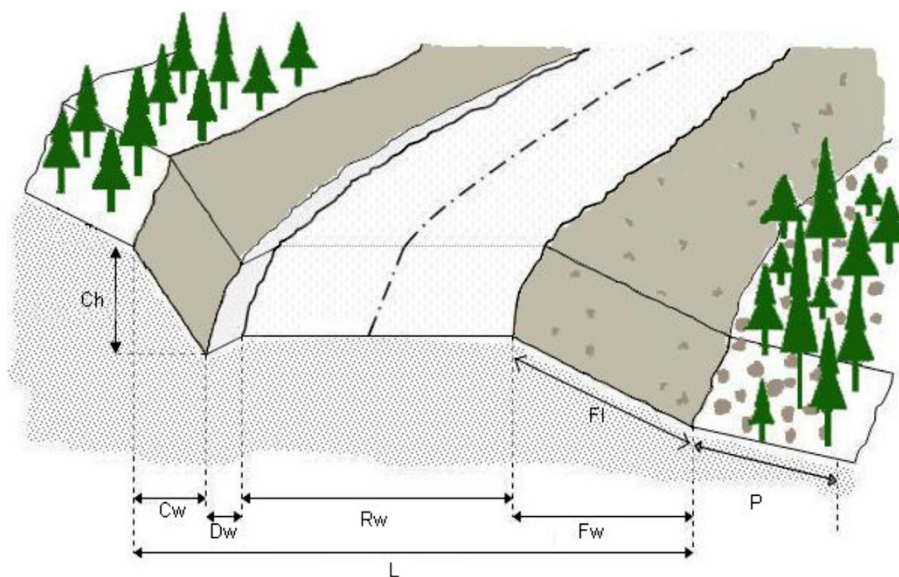
Figure 2 The decision variables measured from each cross section along the sample road.

The entire construction process in the areas of the study was observed in the field, and data was collected during and after construction. To characterize road sections, nine decision variables were measured from each cross section. These variables include cut-slope height (Ch), cut-slope width (Cw), ditch width (Dw), road width (Rw), fill-slope width (Fw), fill-slope length (Fl), road construction zone width (L), effect distance length (P),

and ground slope (S) (Figure 2). Surveying instruments such as clinometers, steel tape, laser range-finders, miras, poles and altimeters were used in the field studies.

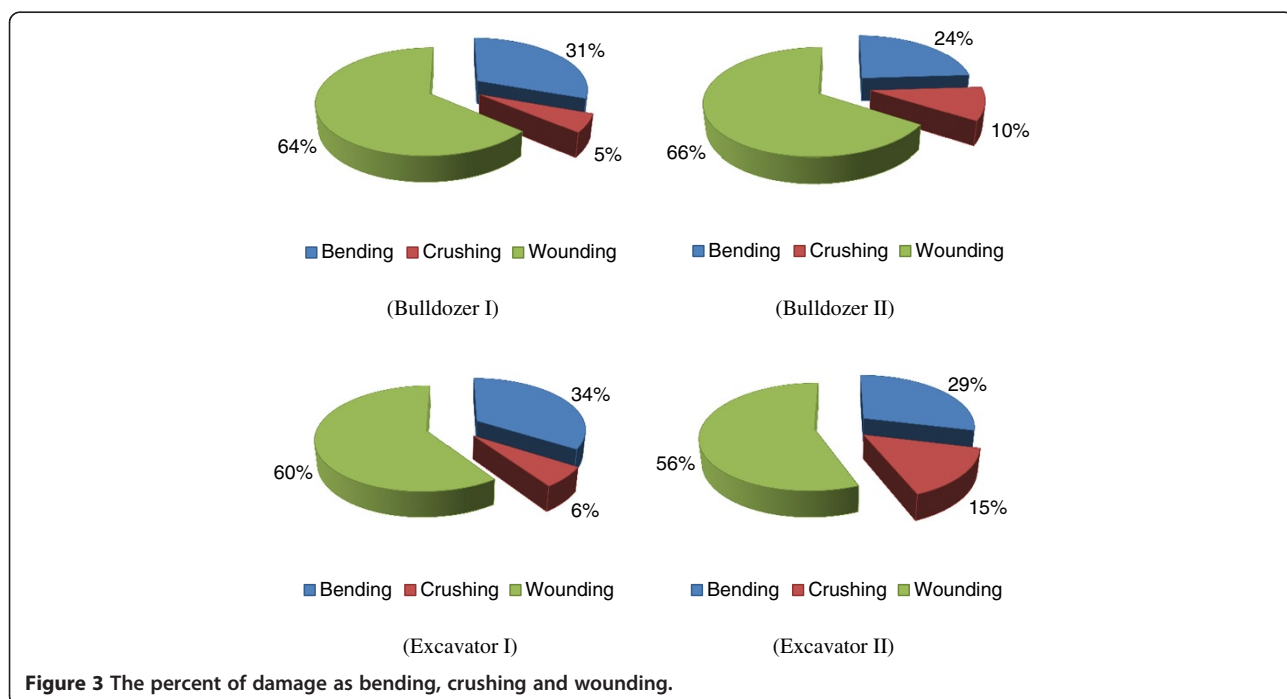
Figure 3 The percent of damage as bending, crushing and wounding.

The percent of damage in terms of wounding, bending and crushing of trees are 64%, 31% and 5% respectively (for BulldozerI), 66%, 24% and 10% respectively (for BulldozerII), 60%, 34% and 6% respectively (for ExcavatorI) and 56%, 29% and 15% respectively (for Excavator II). The percent of damage in terms of wounding, bending and crushing is shown in Figure 3. The number

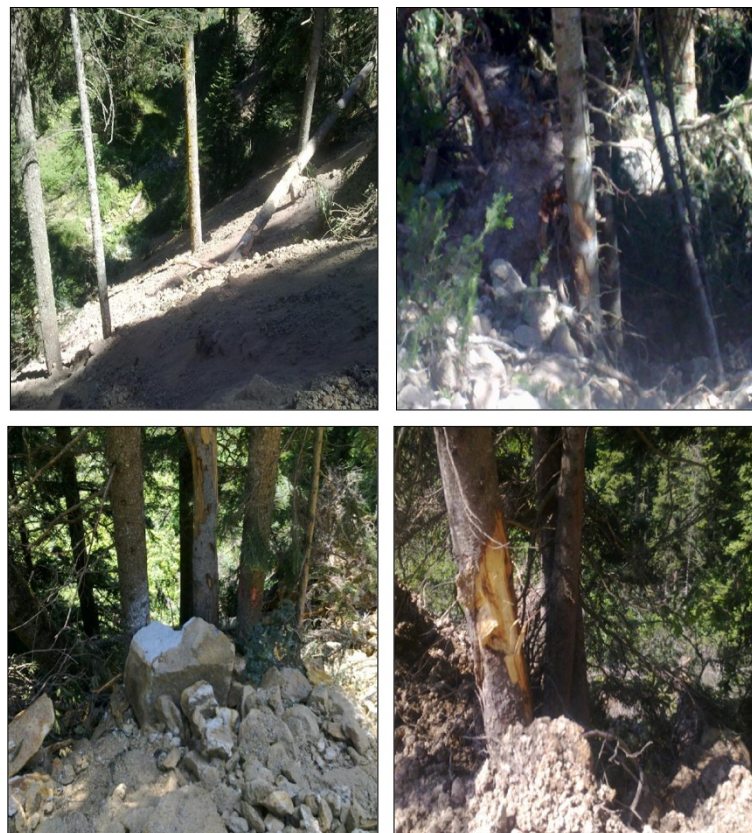
Figure 4 Tree damages during forest road construction.

damage in these regions. Also, direct economic loss occurred due to poor timber quality. The damage caused by road construction are shown in Figure 4.

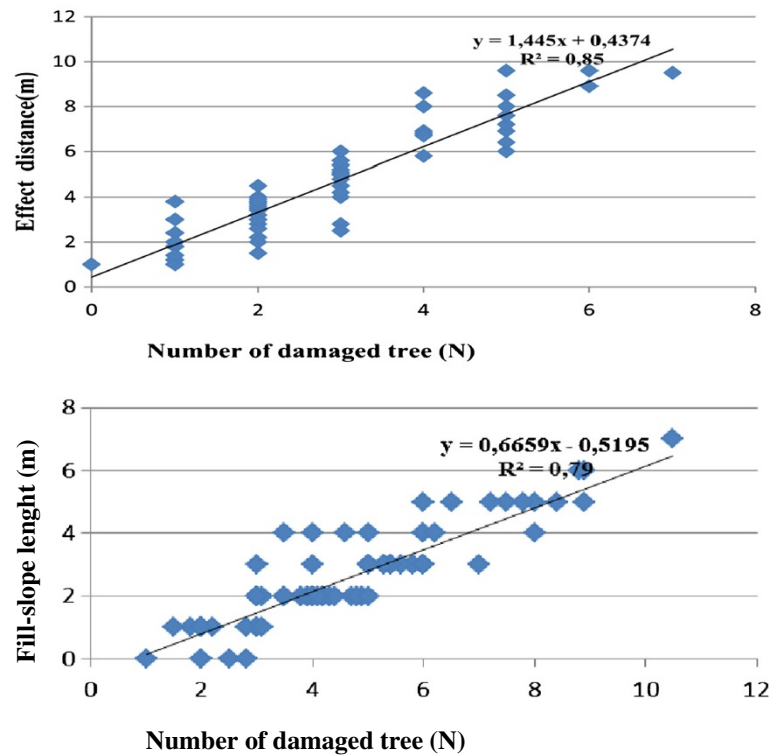
Figure 5 Relationship between the number of damaged trees, the length of effect distance and the length of fill slope.

analysis, it was determined that there was a significant relationship at a 99% confidence level between the number of damaged trees and independent variables such as gradient of the terrain, cut area, length of the fill slope, length of the effect distance, number of trees and type of machine. The graphics of the relationships that are considered to be important in the correlation matrix are given below. In the graphics, it can be seen that as the length of effect distance increases, the number of damaged trees also increases. In the same way, as the length of the fill slope increases, the number of damaged trees again increases (Figure 5).

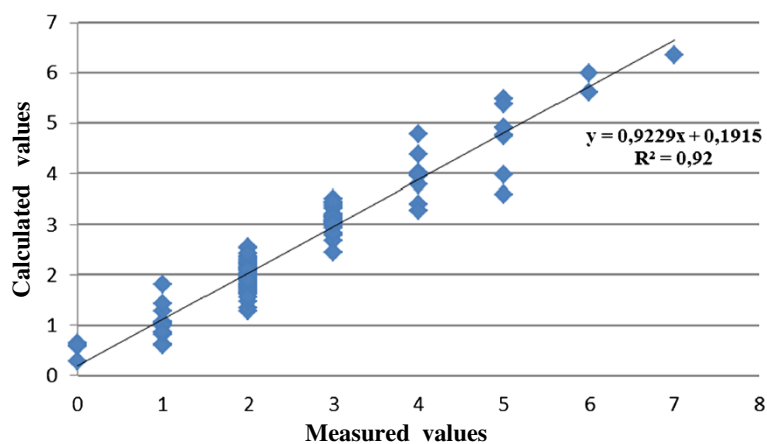
Figure 6 A comparison between the calculated and measured values of number of damaged trees.

of excavators. The graphics of the measured values and the calculated values belonging to the regression model are seen in Figure 6.
