# Investigation of the renewed diseases on murals at Mogao Grottoes

**Keywords:** Mogao Grottoes, Murals, Diseases, Conservation materials, Investigation

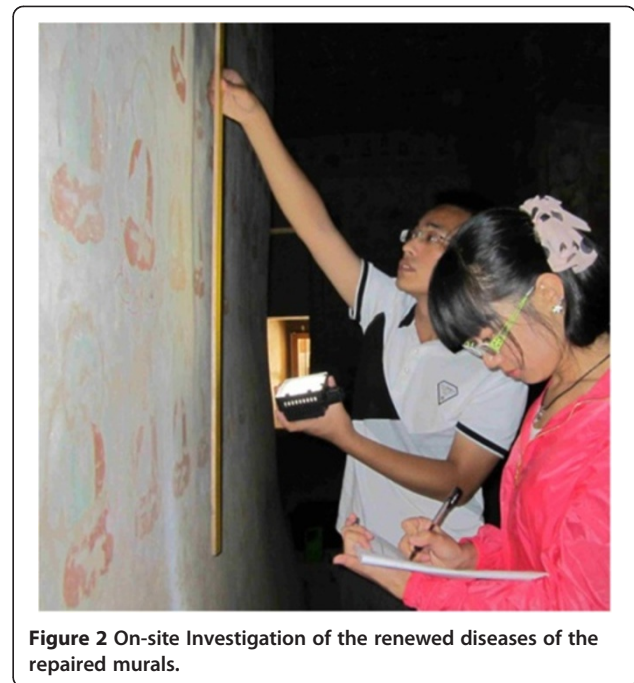
During the investigation, the disease area was measured using rulers (see Figure 2). Keyence VHX-2000 microscope (Dino-Lite AD413T) was used to observe the salt aggregation on the surface of the murals. Infrared thermography (NEC G100) was applied to identify the detachment of murals.

**Figure 2** On-site Investigation of the renewed diseases of the repaired murals.

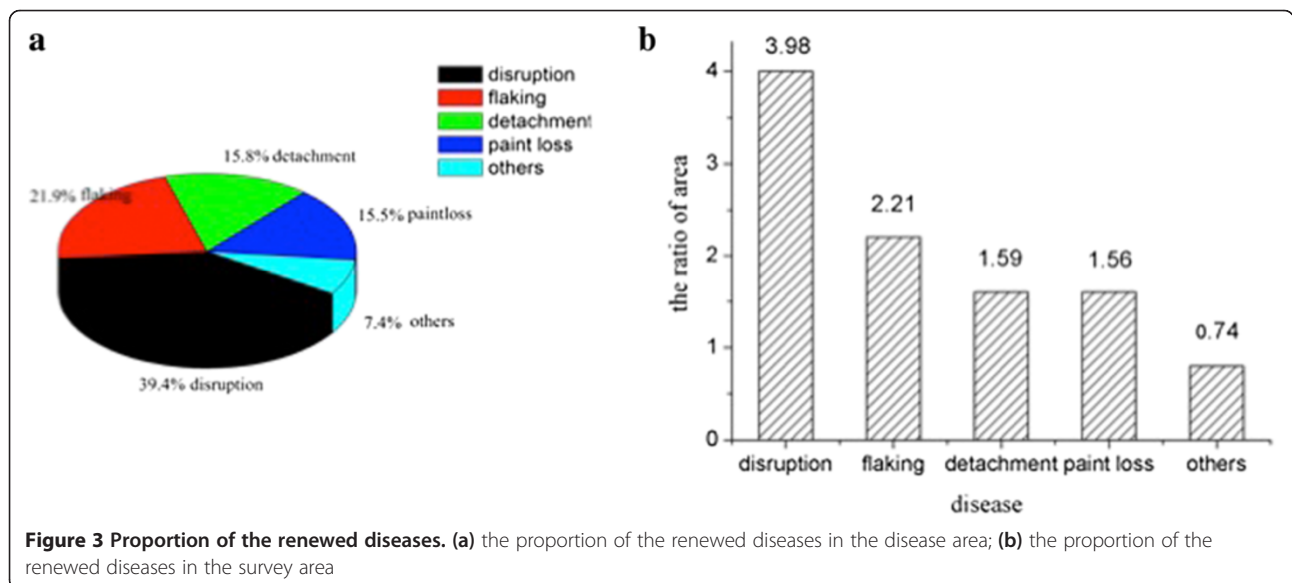
The diseases which were investigated include flaking, paint loss, deep loss, disruption, detachment, net cracks and punctate loss. These diseases can be divided into slight, mild and severe levels according to the damage degree. In this survey, the total area of the repaired murals is 411.38 m<sup>2</sup> (the survey area). The area of the murals repaired by PVA is 138.72 m<sup>2</sup>, the area of the murals repaired by the hybrid emulsion is 116.89 m<sup>2</sup>, and the area of the murals repaired by gelatin solution is 155.77 m<sup>2</sup>. The total area of the repaired murals with the renewed diseases is 41.54 m<sup>2</sup> (the disease area). The detail of the survey results is shown in Table 1. The survey result indicates that the renewed diseases at Mogao

Grottoes mainly include disruption, flaking, detachment and paint loss (Figure 3).

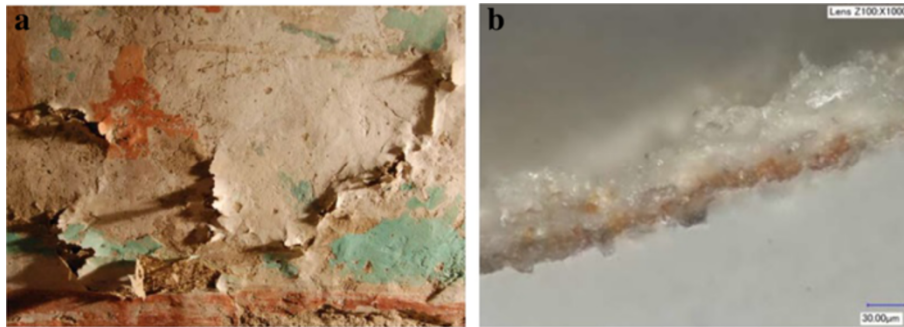
of mural becomes loose during this process. Disruption is characterized by the crumbling of soil and paint layer. Therefore, the formation of disruption is mainly influenced by the following factors. First, soluble salts in the mural plaster and rock are the basic material resources to cause disruption. Second, the alterations of temperature and humidity in the caves drive the water migration. Finally, the cycles of salt solvation – crystallization with water directly lead to disruption.

The most severe disruption disease in one investigated cave is on its west wall and the other two walls close to the west wall, but disruption on its east wall is slight. The major soluble salts causing the mural disruption in Mogao Grottoes are Na<sub>2</sub>SO<sub>4</sub> and NaCl from the plaster layer and rock [33-36]. The analysis of soluble salts in this cave shows that the plaster layer contains Cl<sup>-</sup>, Na<sup>+</sup> and SO<sub>4</sub><sup>2-</sup>, which are mainly distributed in the west wall and nearby. The salts analysis of the rock body also indicates that the content of soluble salts in the west wall is 2~3 times higher than the east wall, because the salt distribution is affected by the depth of the cliff [4]. The renewed disruption on the west wall is severe. A large amount of soluble salt crystallization can be seen on the disruption with the help of microscope (Figure 4).

**Figure 4** Disruption on the west wall. (a) picture of disruption, (b) microscopic picture of disruption in 1000 ×.

Reinforcement and desalination have been used to fix disruption at Mogao Grottoes. PVA has been mainly used to repair the disrupted murals in the early time. In recent years, gelatin solution has been more frequently used as the reinforcement material. In desalination, a series of materials and techniques were used to remove the salts accumulated in the plaster layer [32]. It was found that desalination played an important role to prevent the diseases appearing again. The area of renewed diseases on murals treated by desalination was 50% less than the area of murals without desalination. In this investigation, it was found that disruption usually became more severe in the regions where disruption had never been repaired. The content of soluble salts in these regions was still higher than elsewhere. It suggests that the renewed disruption disease is closely related to soluble salts. However, it is difficult to completely remove the salts in the murals, because soluble salts in the surrounding rock can continuously migrate to the plaster layer.

follows. First, effective treatments should be taken to remove soluble salts in the plaster layer and rock body. Second, efficient environment control should be applied to maintain the caves in a relatively stable condition and reduce the migration of water and soluble salts. In order to avoid direct sunlight and sand erosion, the conservators controlled the environment by installing doors for the caves about 50 years ago. Then, they used sensor devices to monitor carbon dioxide levels. When the content of carbon dioxide exceeds the standard, they will evacuate the caves and keep the caves close for several days. Now, they gradually began to control temperature and humidity. Finally, if the severe disruption has to be repaired, the conservation materials with good water vapor permeability should be used.

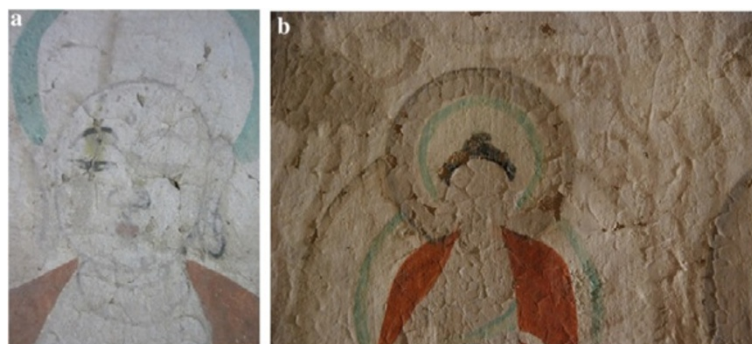
Flaking due to the deterioration of the original adhesion material can be recognized as the separation of the grounding layer or the paint layer from the plaster or lamellar cracking. The reason is that the cohesive decreases with the deterioration of the adhesion material, making the grounding layer or the paint layer separate from the plaster. Especially the murals with dense plaster layer and smooth surface are easy to crack and warp when the adhesive material deteriorates because of the obviously different properties between layers. Flaking usually appeared in the region with thicker paint layer and higher content of adhesive material [23]. Flaking caused by this reason mostly belongs to mild or slight disease. For instance, slight flaking due to thick paint layer can be recognized on the center column in the 44th cave (Figure 5).

Flaking caused by the reinforcement material is quite different. The grounding layer or paint layer is warped in a sheet-like form with relatively thick encrustation. This flaking, with a wide range and large amount, is severe once it appears. The main reason is that the reinforcement material can form a thick layer of encrustation, which is different from the plaster layer in the way they react to humidity and temperature changes. The contraction and expansion deformation between layers leads to the crack and warp of the reinforcement layer. To verify this, a few model samples of Dunhuang mural were prepared in the lab. PVA, acrylic emulsion, silicone acrylic emulsion, and paraloid B72 were used as the reinforcement materials to consolidate the samples which were tested under dry-wet cycles. Obvious flaking was observed on the samples after a few cycles, which was quite similar to the disease in Mogao Grottoes. The experimental results indicated that the degree of flaking was obviously related to the concentrations of the reinforcement materials, and their types as well. Under the same concentration, the degree of flaking varied among different conservation materials: samples reinforced by PVA, acrylic, silicone acrylic were more resistant to the dry-wet cycles, while samples protected by paraloid B72 were more likely to flake (Figure 6). The practice of repairing murals by Dunhuang Academy also

**Figure 5** Pictures of flaking. (a) flaking on the center column in the 44th cave. (b) flaking after using gelatin solution to repair.

The renewed flaking after repair mostly occurred in the caves in which gelatin solution or the hybrid emulsion was used. The appropriate conservation material should not be easy to form a crust layer and its concentration is also important. In this respect, PVA with low concentration shows relatively good effect in repairing flaking.

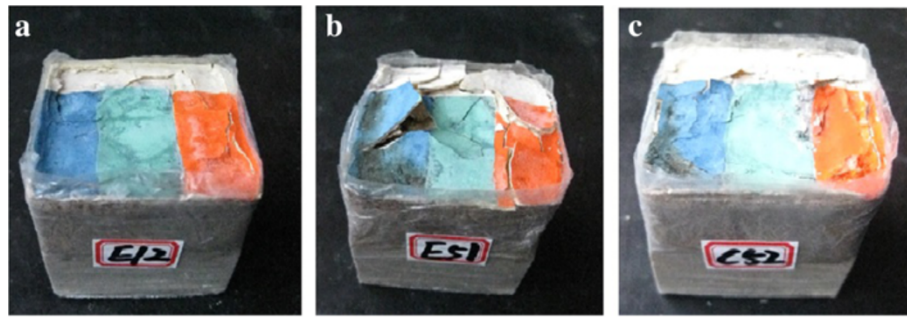
**Figure 6** Pictures of model samples using different reinforcement materials under dry-wet cycles. (a) sample repaired with 1% PVA. (b) sample repaired with 5% B72. (c) sample repaired with 5% acrylic emulsion.

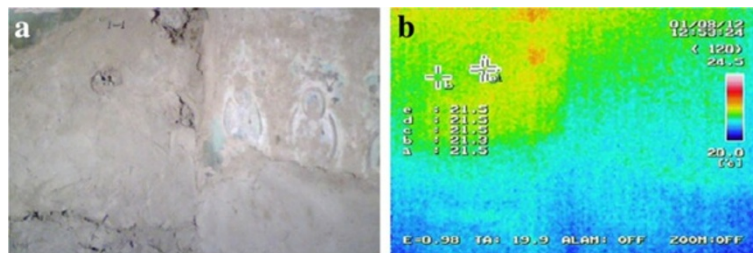
In the 1980s, cement and lime were used to repair the detachment and paint loss of murals. In this survey it is found that detachment was very easy to appear in the place where cement and lime were used. For example, cement was used to repair the plaster loss on the bottom of west wall in the 29th cave and had certain protective effect since then. But severe detachment appeared in the protected area (Figure 7a). According to the picture of infrared thermography (Figure 7b), detachment not only appeared in the part repaired by cement, but also in the position joint with the repaired part. The physical properties of cement and lime are quite different the plaster layer. Each material reacts differently to aging, temperature and humidity change. The differences in the properties can block the movement of water and salts, resulting in the detachment finally. The harm of using cement and lime to repair murals has gradually been recognized and they are avoided in the conservation now.

The investigation showed that the movement of water and salt is the main cause of detachment, and improper grouting and conservation materials also can lead to the generation and development of detachment. Therefore, environment control, using more appropriate conservation materials and techniques and replacing those

**Figure 7** Pictures of detachment. (a) detachment on the bottom of west wall in the 29th cave, (b) the infrared thermography picture of detachment.

materials used in the early time are the effective measures for the treatment of detachment.

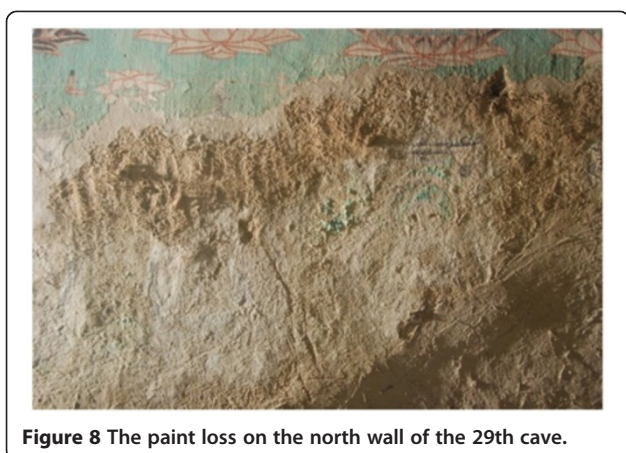
**Figure 8** The paint loss on the north wall of the 29th cave.

Most of paint loss usually occurred in the place where there were severe disruptions. The severe paint loss is characterized by large areas of paint layer dropping off near the disruption areas. Large areas of paint layer were missing because the severe disruption made the paint layer lose adhesion to the plaster layer.

Flaking usually leads to crack, warp and finally drop of the paint layer. Paint losses caused by flaking are common, and most of them are mild or slight. Sometimes, the severe paint loss was caused by the joint influence of disruption and flaking. Figure 8 shows that the severe paint loss is around the area of disruption, and flaking is obvious in the middle of that area. In general, flaking and disruption can lead to severe paint loss eventually. Once the paint layer falls, it's difficult to restore. So the best way to prevent the murals from paint loss is dealing with disruption and flaking in time.
