The 2004 Indian tsunami in Thailand: Surveyed runup heights and tide gauge records

Tsunami accompanied with the Sumatra earthquake of 26 December 2004 affected many countries around the Indian Ocean. Thailand located approximately 500 km east of its source, was also severely suffered from the tsunami. From 24 February through 4 March 2005, we surveyed the damaged areas in Thailand from south of Phuket Island up to the border of Myanmar including four islands. The whole coastal area facing the Andaman Sea could be covered. We measured 37 points in total, the tsunami heights are less than 10 m, except at a few locations. We found that the largest tsunami height reached up to 19.6 m at Ban Thung Dap of Phra Thong Island. During our survey, we also collected five paper copies of analog tide gauge records. In addition that we could detect two other tide gauge records from the web-site. Therefore, totally seven tide gauge records were obtained in Thailand. All of the recorded tsunami waveforms indicate that sea level initially withdrew with duration in 30 to 60 min, followed by the rising-up. This phenomenon corresponds to the eyewitnesses' accounts of the survivors who experienced the

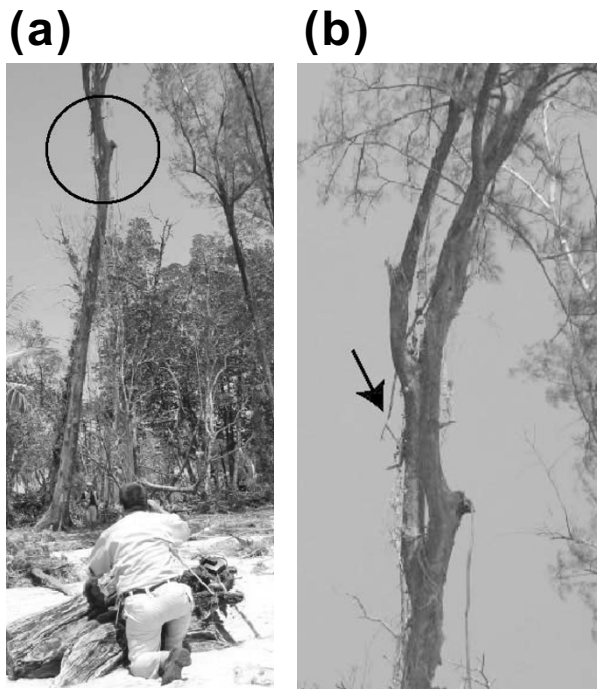
Photo 2. (a) Broken branches due to the tsunami current at Ban Tung Dap, and (b) zoomed up of the circle.

We visited Ban Thung Dap that is located on the southwest of tip of Ko Phra Thong Island. The tsunami height of 19.6 m was found, which is the highest record of our survey on the Thailand coast. This height was measured by the broken branch of a tree due to the tsunami current (Photo 2). This is not a single evidence, but we could also find several evidences at the same level on other trees here.

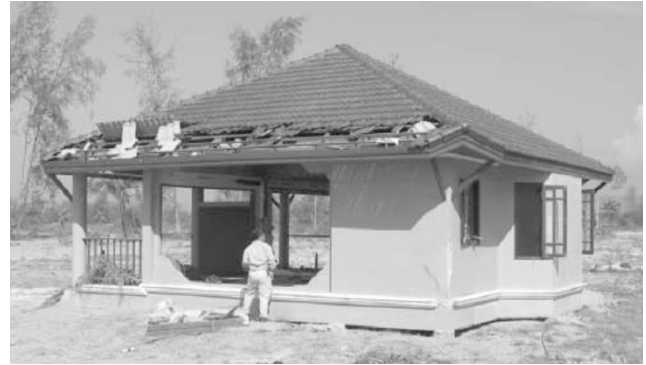
Photo 3. Damaged house by the tsunami at Ban Ma Kap.

Ban Ma Kap is located at the south of Ko Koh Kao Island, and the ferryboat from Ban Nam Kim is served every hour. Both walls and a roof of an one-story house were broken as shown in Photo 3. The tsunami height was estimated to be

6.0 m. We considered that the sea water reached at least the damaged upper most tile of the roof. The population of Ko Koh Kao Island was about 800 before the tsunami. About 400 people were killed due to the tsunami, while most of those casualties were not residents but temporal workers from out of the island.

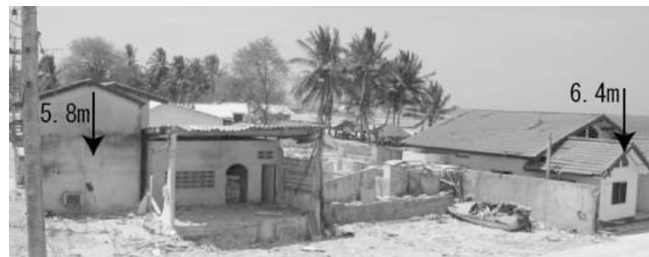
Photo 4. Tsunami height at Ban Nam Kim.

We could measure two tsunami heights that are close to each other as shown in Photo 4, and both of them were based on the water marks of 5.8 m and 6.4 m left on the walls. The distance between two water marks of about 50 m was too far to derive the current speed. This is why the effects of the dissipation are not negligible and the

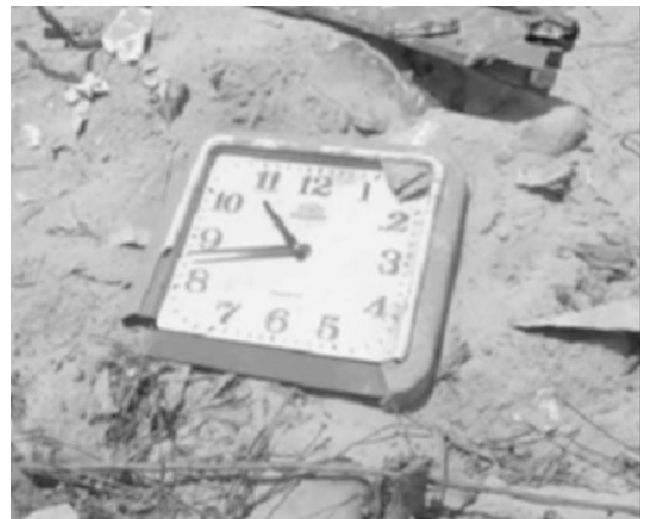
Photo 5. Broken clock at Ban Nam Kim.

Bernoulli (the Torricelli) theorem cannot be applied. We found a clock broken by the tsunami, which stopped at 10:42 (Photo 5). There still remains a doubt that it was correctly working at that time, while the resident in Ban Nam

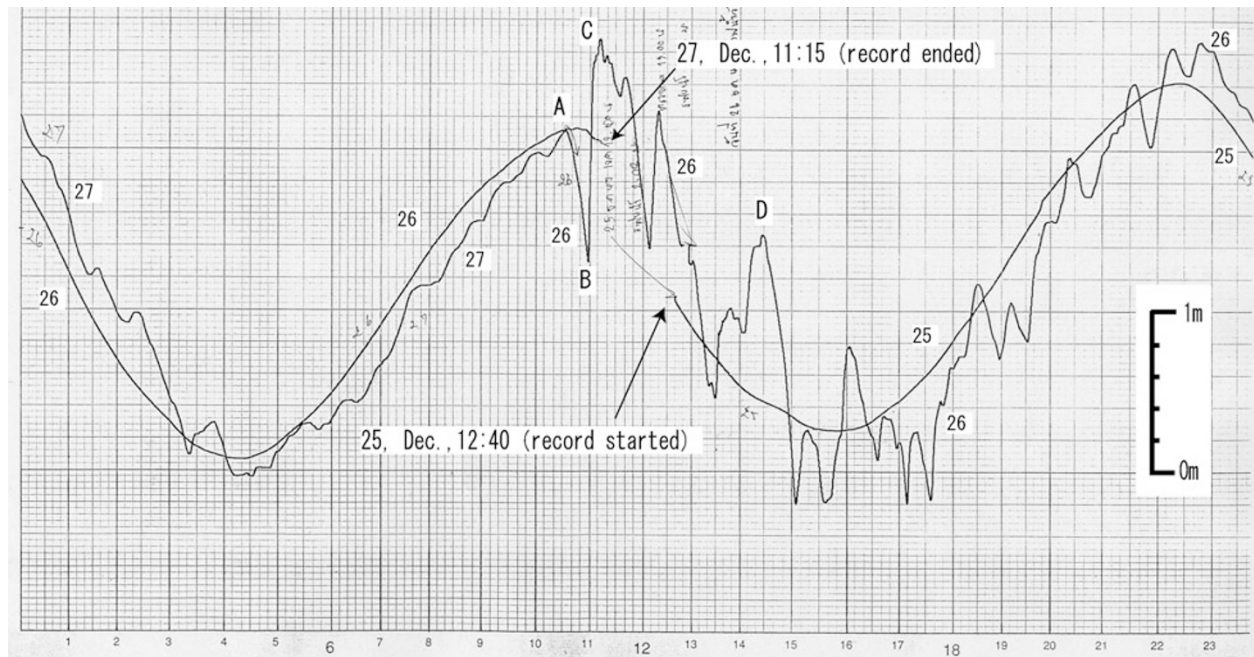
(a) Kuraburi

Fig. 3. Tide gauge records at (a) Kuraburi, (b) Tummakarg (Satun), (c) Kan Trang, (d) Krabi, and (e) Ranong.

Fig. 3(a) was, for example, recorded at Kuraburi from 25 through 27 December 2004, including the tsunami on 26 December 2004. It indicates as follows; the first wave withdrew at 10:32 (indicated by A in Fig. 3(a)), followed by the minimum level of 90 cm at 10:58 (indicated by B), then flooded by 136 cm in peak-to-peak amplitude tsunami at 11:12 (indicated by C). Maximum peak-to-peak amplitude of 140 cm recorded at 14:28 (indicated by D). Period of the tsunami at Kuraburi was about 40 min. The other tide gauge data at Tummakarg (Satun), Kan Trang, Krabi, and Ranong are also shown in Figs. 3(b), (c), (d) and (e). These recorded tsunamis indicate that sea level

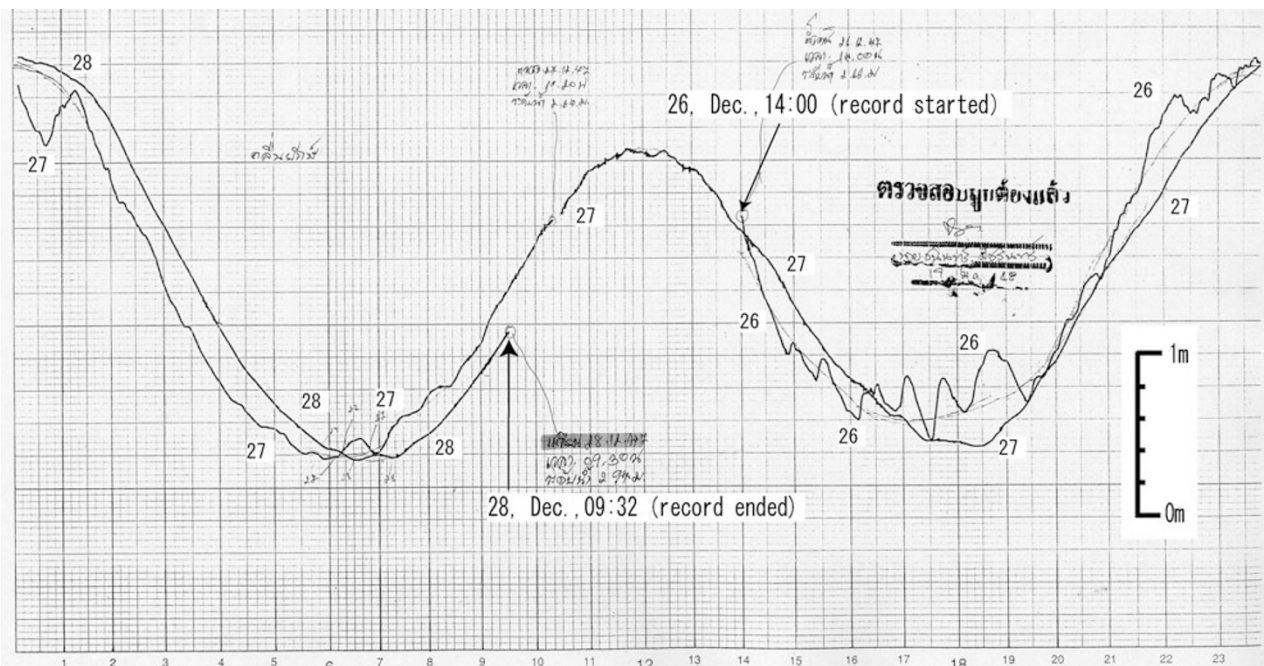
(b) Tummakarg (Satun)

Fig. 3. (continued).

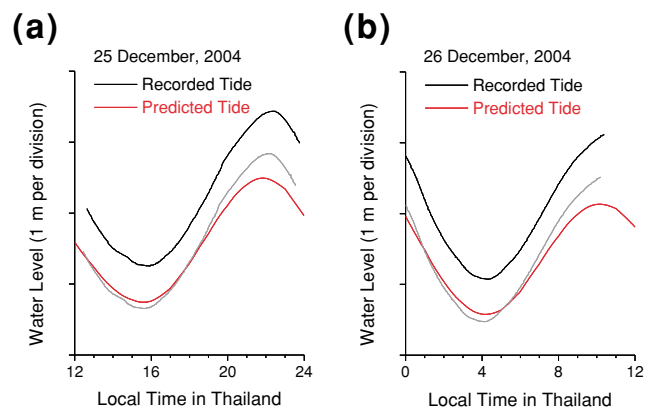
Fig. 4. Comparison of tide gauge records (black lines) with the predicted tides (red lines) at Kuraburi. (a) 12:00 to 24:00 on 25 December 2004, and (b) 0:00 to 12:00 on 26 December 2004. Gray lines shifted from the original tide gauge records are also shown.

When we visited the tide gauge station at Ta Phao Noi on 26 February, 2005, the time recorded on the sheet had been 11 minutes earlier than the corrected time. Because a sheet is replaced every two days, it is now impossible to evaluate that the time difference existed or not at the time of tsunami attacks. It should be noted that we have to pay attention to the read time of the tsunami arrival is correct or not. The better solution of this problem is considered to compare the tide gauge records to the predicted astronomical tide, and then to compensate based on the times at the flood and the ebb. Accuracy of tsunami arrival time recorded on the sheet at Kuraburi tide gauge station has been estimated. Tide gauge at Kuraburi completely recorded astronomic tide before the tsunami with no disturbances (Fig. 3(a)). Therefore, we compare recorded tide to the predicted tide at 12:00 through 24:00 on 25th and at 0:00 through 12:00 on 26th in order to estimate the time differences. Recorded tide at Kuraburi compares to the predicted tide at Ban Laen Po in Fig. 4. If the recorded tides were shifted 12 minutes earlier than the originals, the recorded tides well coincide with the predicted tides (Fig. 4). This is why the recorded tide might be delayed in 12 minutes at that time. The corrected time related to the tsunami at Kuraburi should be shifted by 12 minutes earlier than the recorded time.

the ebb of the recorded tide at Kuraburi with those of the predicted tide on 25 and 26 December 2004, the time was delayed by 12 minutes. Accuracy of time resolution of the tide gauge data is somewhat unreliable, we should pay attention to read the time of the tsunami arrival for each tide station.
