# Tsunami heights and damage along the Myanmar coast from the December 2004 Sumatra-Andaman earthquake

The tsunami heights from the 2004 Sumatra-Andaman earthquake were between 0.4 and 2.9 m along the Myanmar coast, according to our post tsunami survey at 22 sites in Ayeyarwaddy Delta and the Taninthayi coast. Interviews to coastal residents indicate that the tsunami heights were lower than high tide level in rainy season, probably by storm surge. They also testified that the arrival times were between 2 and 5.5 hours after the earthquake but the reliability may be low because nobody felt ground shaking. Much smaller tsunami than the neighboring Thai coast, where the tsunami heights were 5 to 20 m, explains relatively slighter tsunami damage in Myanmar; the casualties were reported as 71, compared to about 8300 in Thailand. The smaller tsunami was probably due to the fact that the main tsunami source did not extend to Andaman Islands. The tsunami travel times and maximum heights computed from a 700 km long source are basically consistent with the observations. For a nearby tsunami source, the tsunami hazard would be more significant in Myanmar, because coastal houses are unprotect

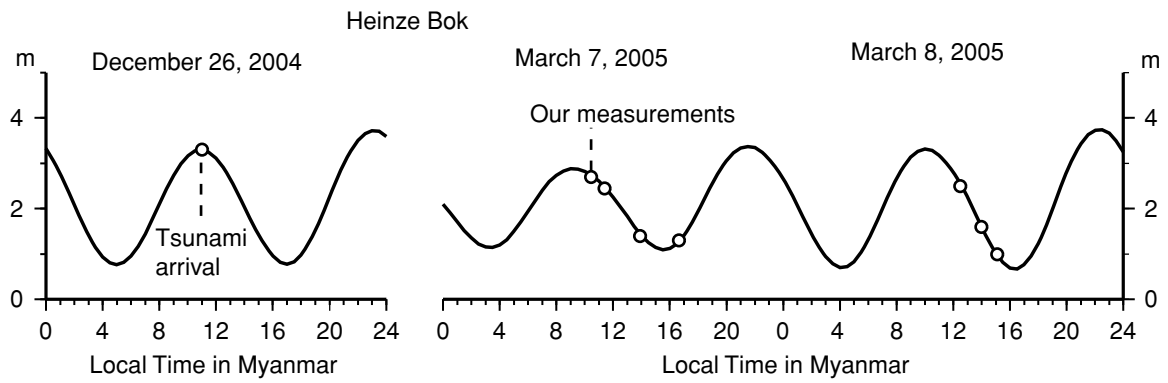
Fig. 4. Predicted astronomical tidal changes at Heinze Bok (Long Island), near Dawei. (a) Tidal change on December 26, 2004. An open circle on the curve shows the time of the tsunami arrival. (b) Tidal change on March 7–8, 2005. Circles on the curve show times of our measurements.

The tide levels at the times of tsunami arrival and the measurement were computed on the basis of astronomical tides, by using computer program WXTide 32 release 4. The maximum differences of the predicted tides with a tide table (United Kingdom Hydrographic Office, 2004) are within 70 minutes and 50 cm at ebb/flood times. For Ayeyarwaddy Delta, tide was calculated based on predicted tides at Bassein River, Diamond Island (15°52.0'N, 94°17.0'E). For Dawei coast, the tide was calculated at Heinze Bok, Long Island (14°24.0'N, 97°47.0'E). For Myeik measurements, the tide was calculated at Mergui (12°26.0'N, 98°35.9'E). For the measurements around Kawthaung, tide was calculated at Pulo Basin (9°59.0'N, 98°29.0'E).

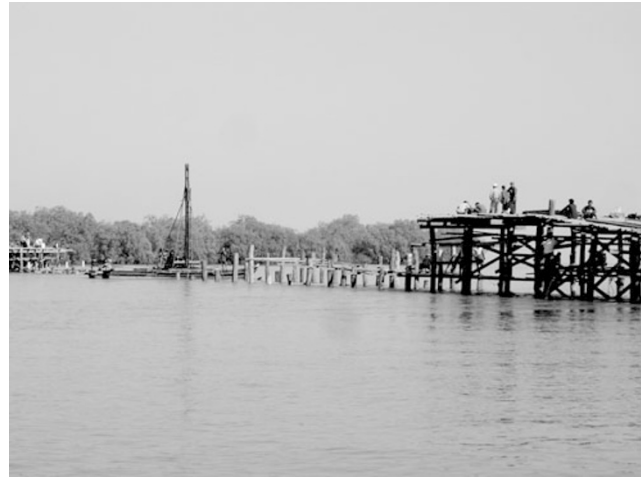
Fig. 7. Destruction of wooden bridge to Plautonton Island.

bridge. The central part of the bridge was destroyed by the tsunami (Fig. 7). Measurement was taken at Plautonton Village (loc 08) on the island. Most houses of the village are built on a mudflat, raising floor level up to one or two meters above the sea surface. Watermark was observed at the interviewee's house. A housewife told us that the tsunami arrived at 10:30 am in three waves with 15 minute intervals. An owner of a grocery store said that two waves with 10–15 minute interval arrived. Because the tsunami arrived during low tide, there was no severe damage to buildings, but some household wares (rice bags, cloths and TV sets, etc) were flooded. One person died in this village. Our measurement indicated that the tsunami height was 1.8 m above the sea level, or 2.5 m after the correction.

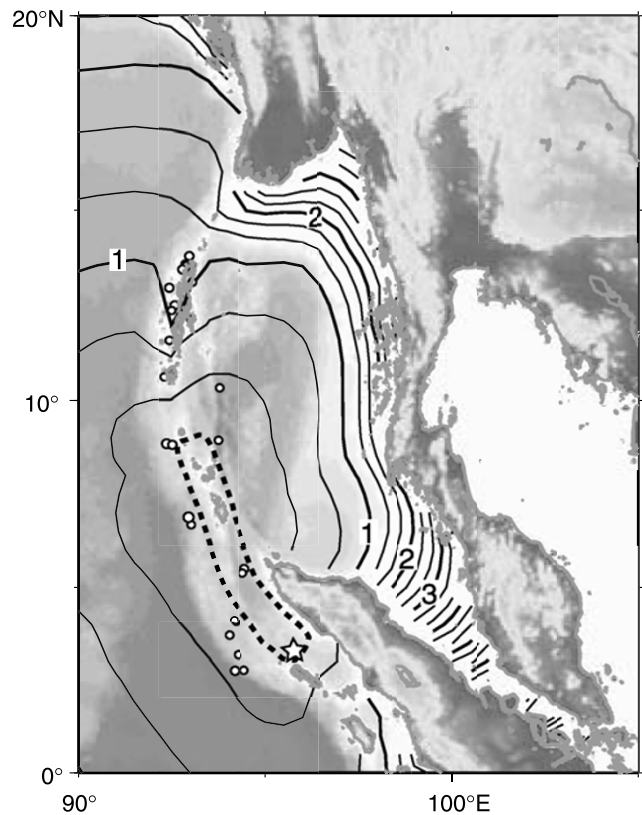
Fig. 10. Tsunami arrival times computed from a 700 km long tsunami source. Counter interval is 20 minutes with labels at each hour. The epicenter (star), 1-day aftershocks (circles) and the assumed tsunami source (dotted curve) are also shown.

The computed tsunami travel times (Fig. 10) shows that the tsunami travel times to the Myanmar coast are 2.5 hours or more, indicating that the first tsunami was expected at around 10 am. Because of lack of ground shaking and the relatively small size of tsunami, coastal residents might not have noticed the tsunami at the first arrival.

Sandwell, 1997). The tsunami travel times were computed on the basis of Huygens' principle, using software ttt (tsunami travel time) version 2.2. The maximum amplitudes were computed by using finite-difference method of the linear long-wave equation (e.g., Satake, 2002).

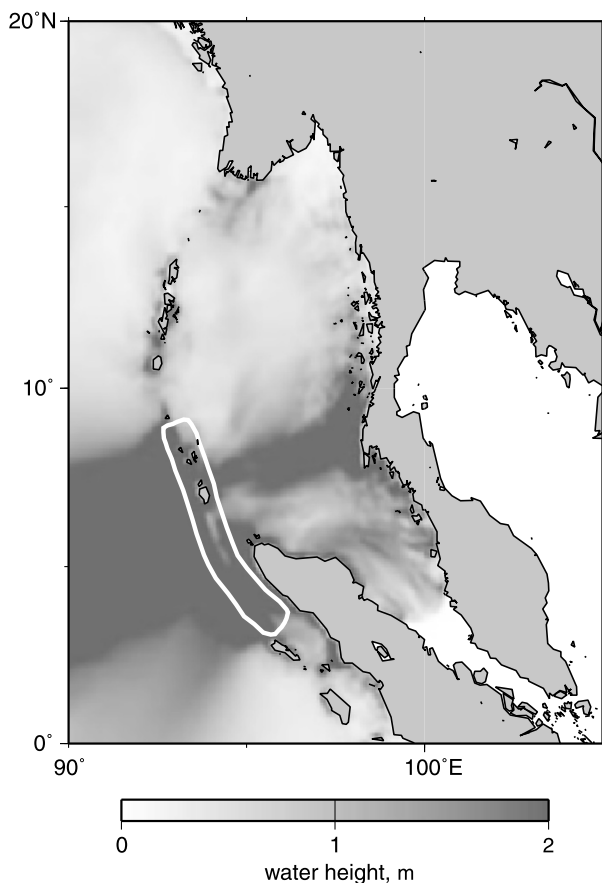
Fig. 11. Distribution of maximum tsunami heights computed from a 700 km long tsunami source. The assumed source region is also shown.

The tsunami source extending in the north-south direction affects the amplitude distribution. Figure 11 shows the distribution of computed maximum amplitudes. The tsunami amplitudes are larger in the northeast direction toward Phuket and southwest direction toward Maldives. The computed tsunami amplitudes are relatively smaller along the Myanmar coast. The amplitudes are slightly large off Ayeyarwaddy Delta, probably because the shallow delta extends to offshore to cause concentration of tsunami energy.
