Liner dissociation in a large-diameter ceramic-bearing acetabular component: a report of five cases

Background: Ceramic-on-ceramic (CoC) bearings for total hip arthroplasty (THA) have been offering very favorable results and survivorship since their introduction. In order to increase range of movement (ROM) and decrease dislocation rates, some manufacturers have introduced larger diameter head (LDH) CoC bearings. This has been achieved with the use of preassembled cup designs, in which the ceramic liner is already fitted into the metal backing and implanted as a monoblock component by the surgeon. In this report we present data from a series of 5 patients with ceramic liner dissociation from a monoblock cup.

Keywords: Total hip arthroplasty, Ceramic liner, Dissociation, Monoblock acetabular component

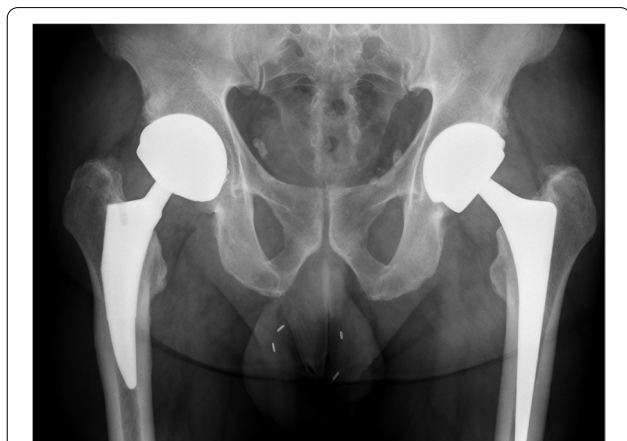
Fig. 1 Postoperative anteroposterior radiograph after implantation of the left THA

A patient with primary osteoarthritis was treated at the age of 56 and 59 with a right LDH MoM THA and a left LDH CoC THA, respectively (BMI: 32.8, cup diameter: 58 mm, Fig. 1, Table 1). Seventy-eight months after the left THA the patient reported sharp hip pain. No trauma had occurred. Ceramic insert separation and pneumarthrosis were observed on x-ray and confirmed by CT scan (Fig. 2a, b and c). The patient was re-operated two weeks later. The revision surgery revealed a wide-open posterior capsule with a large collection of yellowish fluid. Ceramic liner was clearly displaced and mobile (Fig. 3a). After using an adapted extraction tool with minimal bone loss, a new Maxera cup, 4 mm larger than in the index one was implanted (Fig. 4). Titanium shell showed wear signs and titanium debris (Fig. 3b). The patient followed standard post-operative rehabilitation. No complication has been observed at 8 months follow-up.

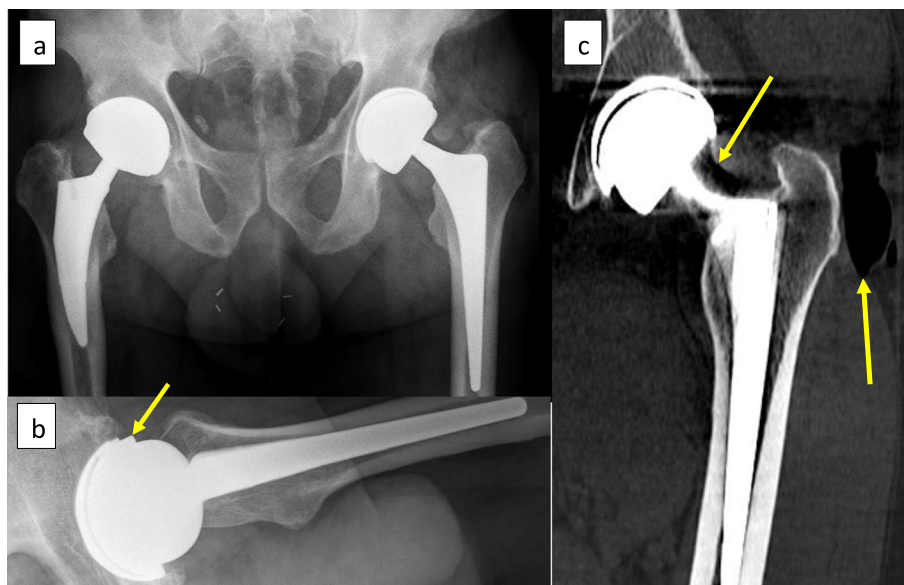
Fig. 2 **a** Anteroposterior pelvic revealing a thin crescent shaped radiolucency between the acetabular shell and the ceramic liner and pneumarthrosis. **b** Lateral hip radiograph with the arrow pointing at the displaced liner. **c** CT coronal view of the left hip demonstrating the thin crescent shaped radiolucency between the acetabular shell and the ceramic liner, 2 arrows are pointing at intra-articular gas and gas around the greater trochanter

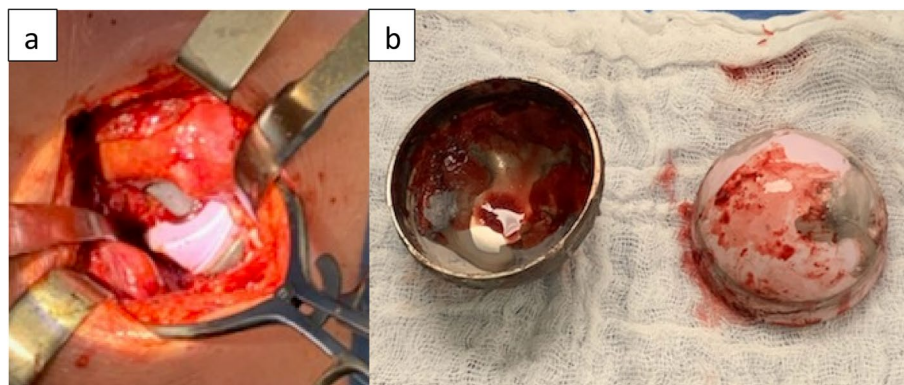
Fig. 3 **a** Intra operative image showing the dissociated liner (mobile). **b** The acetabular shell and the ceramic liner showing important signs of wear and corrosion on the taper surfaces

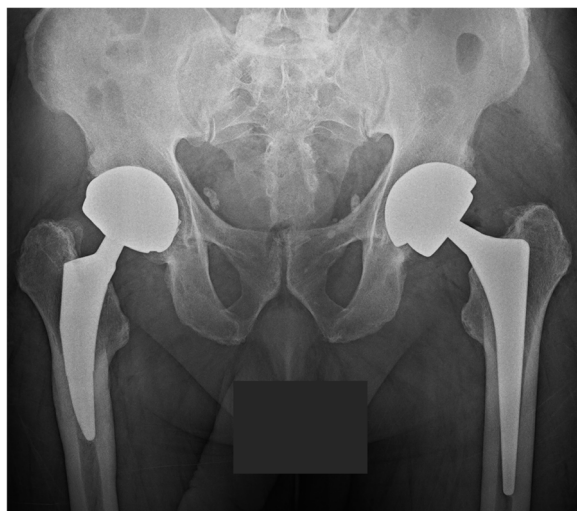
Fig. 4 Anteroposterior pelvic radiographs after revision of the left acetabular component with a new Maxera component 4mm larger (bearing 48 mm)

4 mm larger than in the index THA was implanted. The patient followed a standard post-operative rehabilitation without any adverse events.

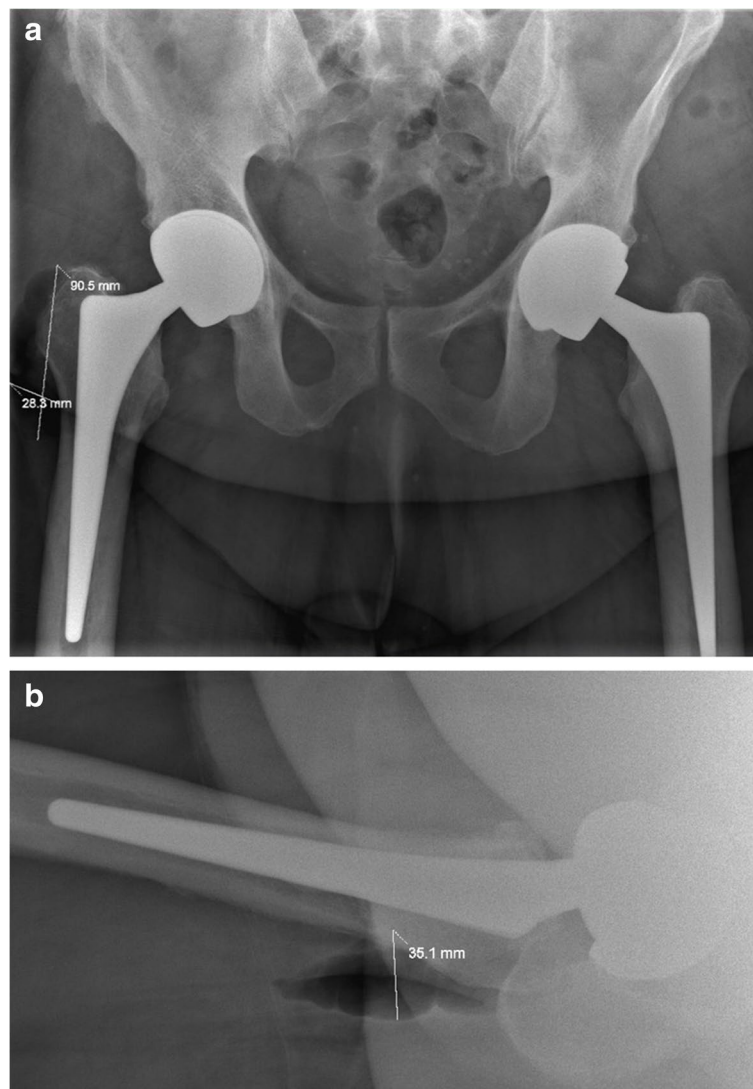
Fig. 5 AP pelvis (a) and lateral (b) radiographs showing periarticular gas and suspicion of ceramic liner disimpaction on the right THA

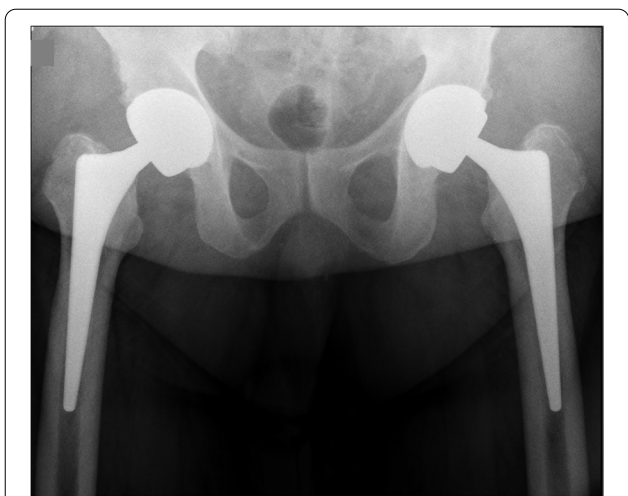
Fig. 6 AP pelvis radiograph, 12 months after the liner dissociation on his right THA. Patient is still been pain free and prefers to pursue a conservative treatment

A 55-year-old male with primary osteoarthritis was treated by simultaneous bilateral CoC LDH THA (BMI: 46.2, cup diameter: 56 mm, Table 1). The patient had a standard and uneventful rehabilitation. At 5-year follow-up the patient reported a sudden hip pain while walking. No concurrent trauma was reported; however, the patient had fallen twice three years after the arthroplasty. Following the fall, the patient did not seek medical advice, since no symptoms were present. The patient was admitted to the emergency unit of another hospital where plain radiographs showed pneumarthrosis and suspicion of ceramic liner disimpaction (Fig. 5a and b). He then came back to our institution 2 weeks later with minimal pain. It was decided to follow a conservative treatment. After 12 months, patient has been pain-free and prefers to pursue a conservative treatment (Fig. 6).

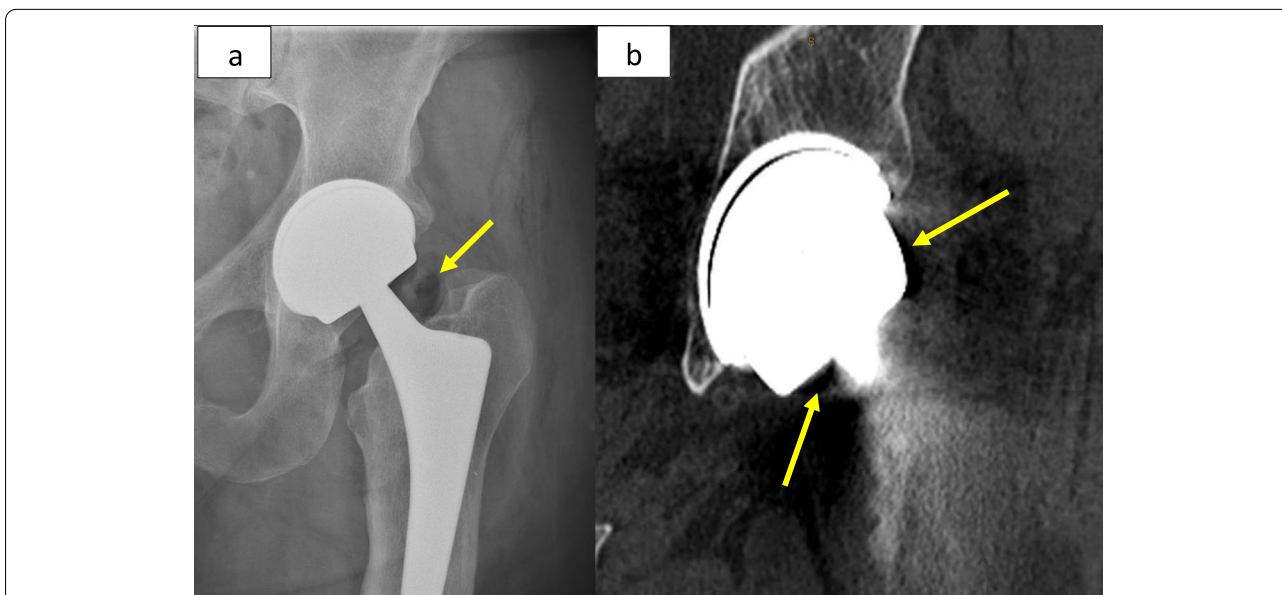
Fig. 7 a Anteroposterior left hip revealing a thin crescent shaped radiolucency between the acetabular shell and the ceramic liner and pneumarthrosis (arrow). b CT-scan view of the left hip demonstrating the thin crescent shaped radiolucency between the acetabular shell and the ceramic liner, 2 arrows are pointing at the intra-articular gas

unable to walk. The patient was admitted to the regional hospital where the x-ray and CT scan demonstrated an intra-articular fluid, gas collection and ceramic liner dissociation (Fig. 7a and b). The patient was re-operated four weeks later (Fig. 8a-d). The revision surgery revealed a partially open posterior capsule with a large collection of yellowish fluid. The ceramic liner was misaligned but not mobile. Upon disimpaction of the Maxera ceramic liner on the side table, the implants modular junctions showed important wear with Ti debris (Fig. 9). With minimal

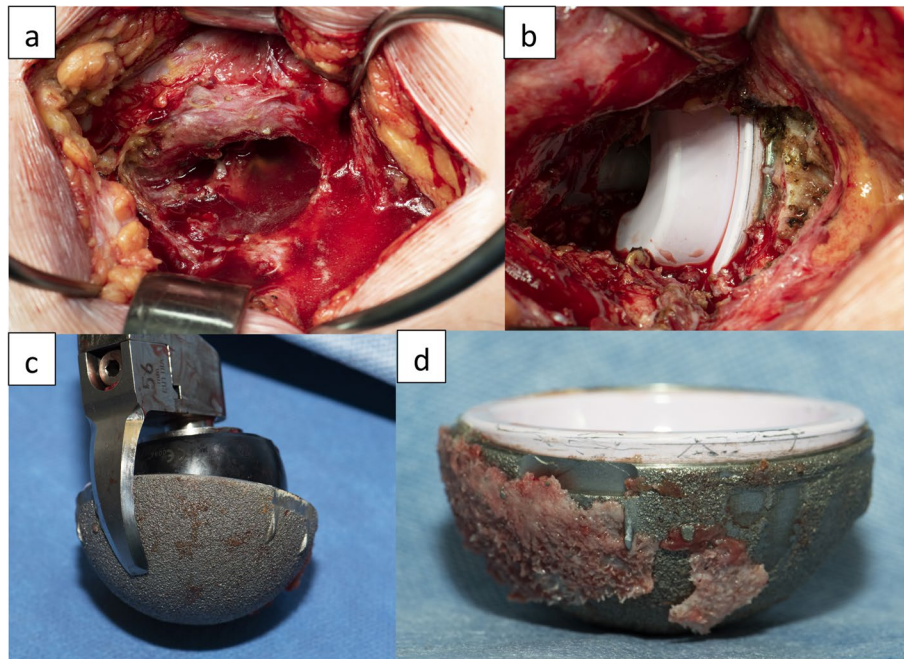
Fig. 8 **a** Revision surgery revealed a partially open posterior capsule with a large collection of yellowish fluid. **b** Intra-operative confirmation of the misaligned ceramic insert. **c** A curved blade explantation system was used to remove the implant with minimal bone loss. **d** The liner inside the explanted cup was misaligned but not mobile. We had to knock multiple times on the side of the cup to disengage the liner

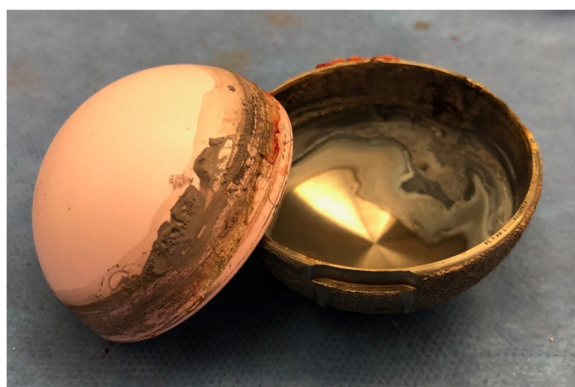
Fig. 9 The acetabular shell and the ceramic liner taken apart and showing important signs of wear and corrosion debris on the taper surfaces

remove the passivation layer of the titanium taper surface and lead to fretting corrosion [20], with subsequent release of Ti particles as observed in the patients we tested for Ti levels. We observed in all our cases pneumarthrosis. Weber et al. [20] has reported six cases of post-THA pneumarthrosis caused by diatomic hydrogen accumulation in modular Ti/Ti femoral stems. The proposed mechanism is cyclic motion that causes abrasion of the external surface of the implant which releases Ti ions that are oxidized when exposed to joint fluid which, in turn, create hydrogen ions. In their cases, mean serum Ti levels were reported to be elevated (33 µg/L). Although the ceramic-titanium interface is different from the Ti/Ti one, the hydrogen accumulation phenomenon could be similar. These levels are much higher than previously published Ti levels ranging between 1.2 and 1.4 in 57 well-functioning Maxera LDH THA cases after 79 months mean follow-up [21]. Because the pneumarthrosis disappeared in the following weeks after the liner dissociation, we believe that the intra-articular air observed was trapped in the space between the metallic shell and ceramic liner until liner dissociation. As shown in Fig. 11, to allow better taper interference, the dome of the ceramic liner does not contact the floor of the titanium shell, leaving a small space between the ceramic liner and the titanium cup. For this reason, a small lucent line may be visible in totally normal cup and should not be interpreted as a liner disengagement. Gas trapped into that space may

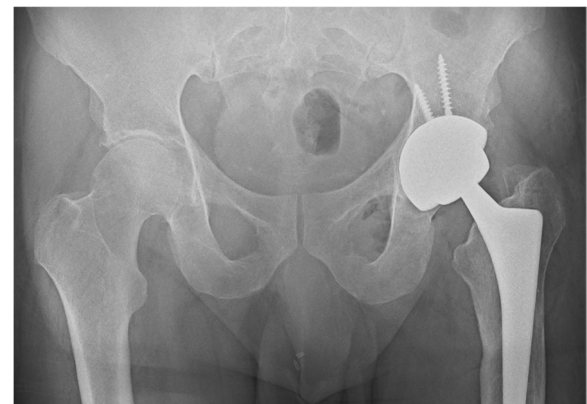
Fig. 10 Post-operative pelvis radiograph showing the revised acetabular component 2 mm larger than the explanted Maxera cup. Modular cup with ceramic acetabular bearing (40 mm) and supplemental fixation with 2 screws

bone loss during explantation, a new modular cup 2mm larger than in the index one was implanted with 2 screws and a 40mm ceramic insert was impacted (Fig. 10).

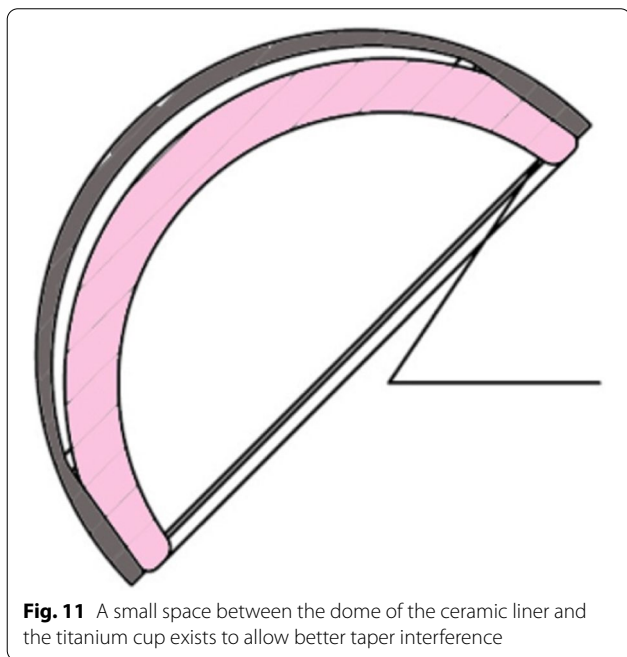
**Fig. 11** A small space between the dome of the ceramic liner and the titanium cup exists to allow better taper interference

also create a positive pressure and play a role in the liner dislodgment.
