Rock varnish on architectural stone: microscopy and analysis of nanoscale manganese oxide deposits on the Smithsonian Castle, Washington, DC

Edward P. Vicenzi^{1*}, Carol A. Grissom¹, Richard A. Livingston² and Zoe Weldon-Yochim¹

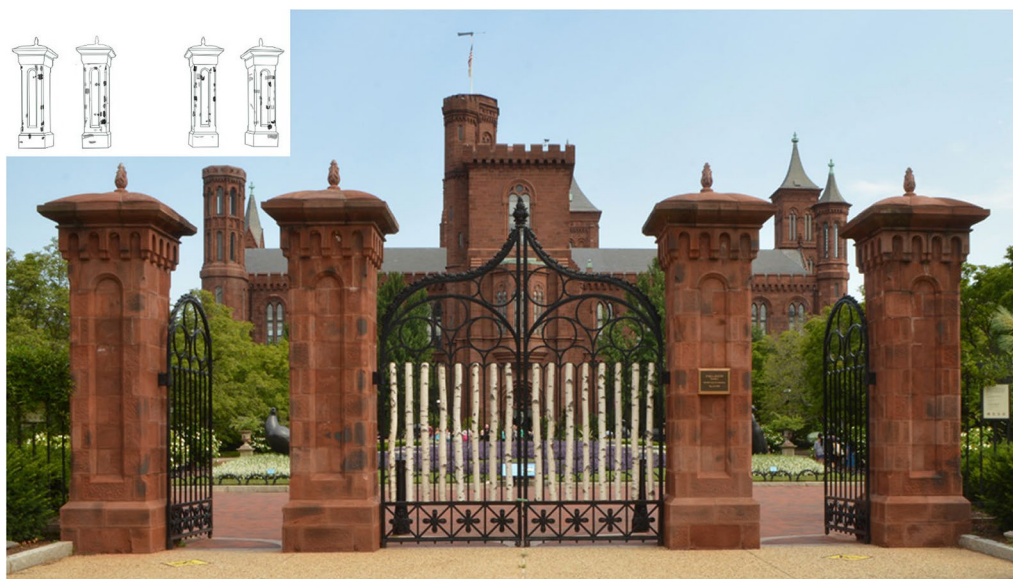
Fig. 2 Enid A. Haupt Garden gateposts with the Castle in the background. *Inset:* drawing depicts locations of rock varnish on the gateposts

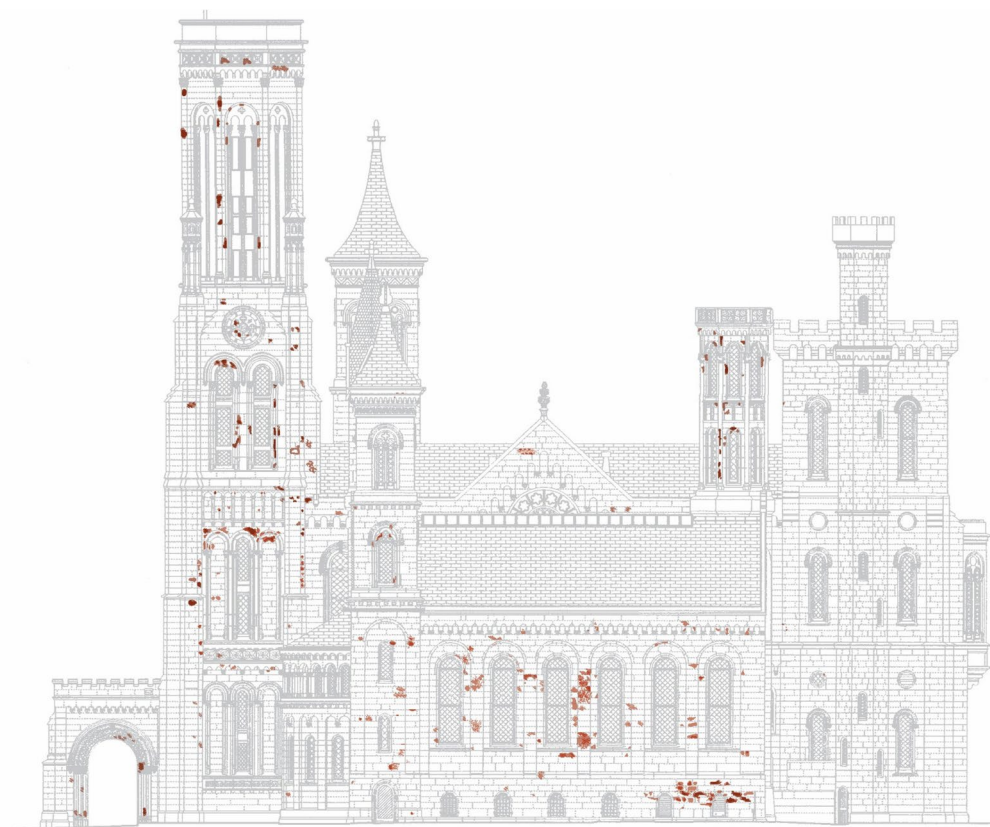
Fig. 4 West architectural elevation of the Castle showing rock varnish. An estimate of the areal distribution of Mn-bearing rock varnish on the building in 2015 is represented by red-brown patches

Irregular black or blue–black patches, measuring as large as 80 cm in long dimension, can be documented on the Castle edifice beginning only in the mid-1990s based on limited photographic documentation of sufficient detail. In 2015 this rock varnish was documented on every face of the building, with the heaviest concentration on the south façade (Fig. 3). The discolored zones are numerous on most façades and are not regularly arranged, nor do they appear to follow either water drainage or soiling patterns (Fig. 4). They are also apparent on the Haupt Garden gateposts, mainly on south faces (Fig. 2). Most patches occur within single blocks, but some span several blocks and are found on mortar in between, as well as on mortar repairs.

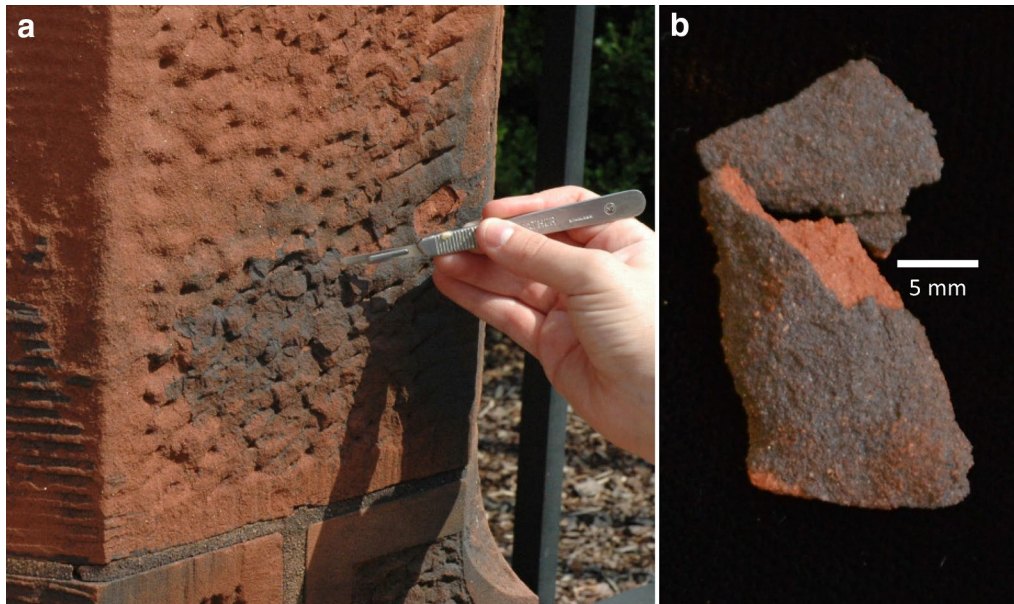
Fig. 5 Close-up view of rock varnish. **a** Sampling a garden gatepost for microscopy and analysis. **b** Hand specimen image of removed surface flake showing marked color contrast between the red bulk rock and varnish

Portable XRF spectra taken from the Smithsonian Castle varnish surface necessarily include chemical information from bulk sandstone given the thin layer of varnish (Fig. 5b) compared to the greater penetration depth of x-ray generation and detection. A comparison of the ratio of the combined varnish plus sandstone to the sandstone interior spectra reveals that the rock varnish is enriched in the following metals (Fig. 6):

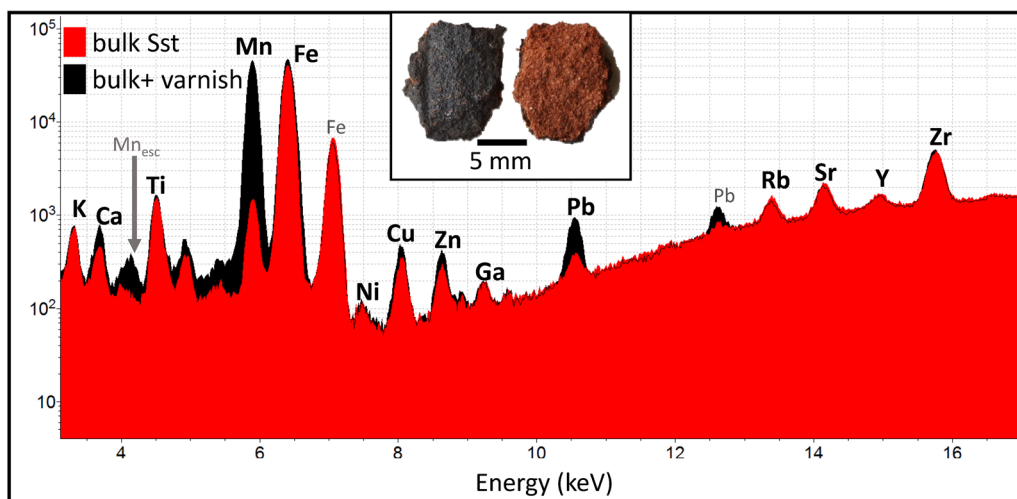
Fig. 6 Portable x-ray fluorescence spectra of a gatepost surface flake with rock varnish. XRF spectral comparison of the bulk sandstone (Sst) versus rock varnish + bulk spectrum. The grey arrow marks a spectral artifact in the black spectrum at 4.16 keV caused by the escape peak for Mn K α . The large dynamic range of XRF data requires a log scale plot. Inset hand specimen images of the flake exterior (left) and interior fracture surface (right)

Other elements (K, Ti, Fe, Rb, Sr, Y, and Zr) are within 10 % of unity for the above ratio (Table 2). The lone exception is Ga, which is depleted in the varnish, yet this peak has the fewest net counts and is therefore subject to the greatest uncertainty. Because the distinctive x-ray signal from the varnish has an interaction volume greater than that layer, it is diluted by unaltered underlying sandstone. As a result, the portable XRF enrichment/

Table 2 Portable x-ray fluorescence spectrometry net intensity results for rock varnish and fresh fractured Seneca sandstone surfaces shown in Fig. 6

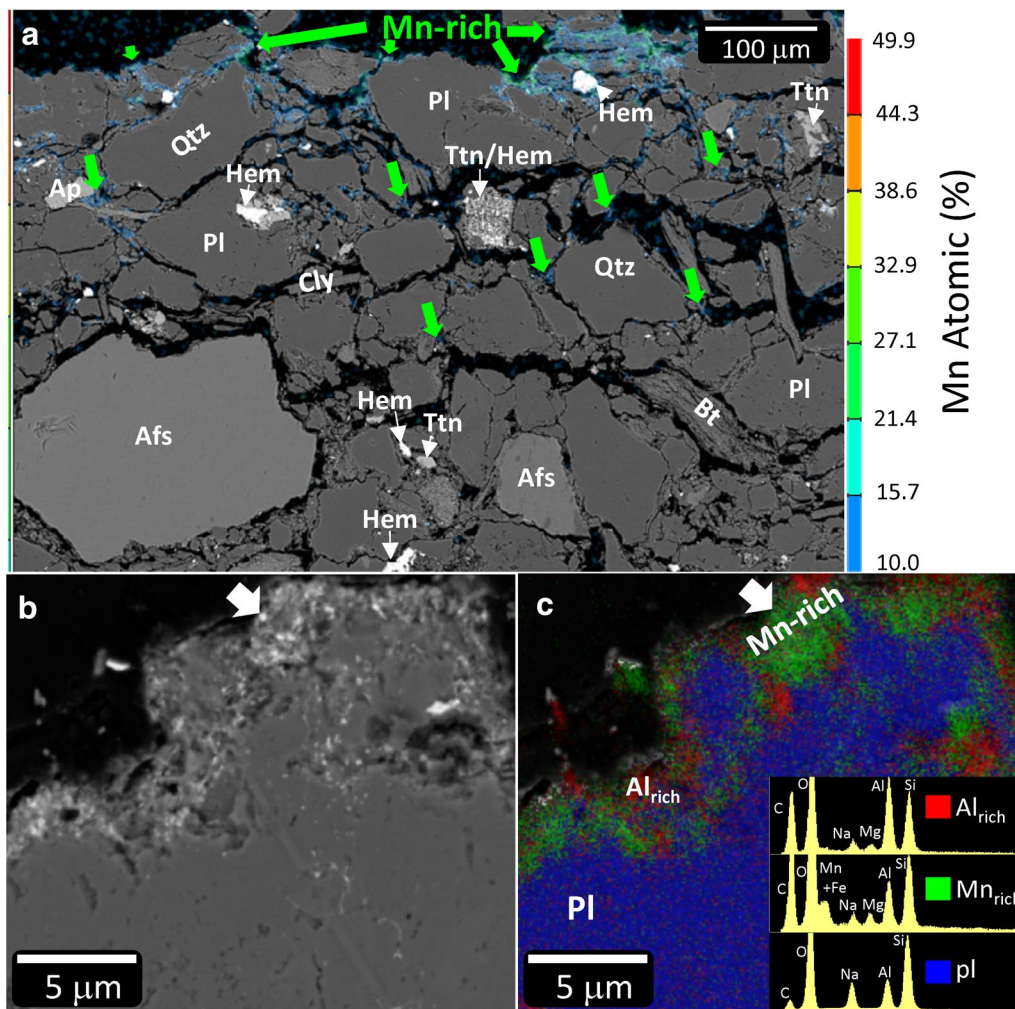
Fig. 8 SEM-based x-ray microanalysis of rock cross sections with rock varnish. **a** Quantified Mn map (threshold >10 atom%) superimposed on backscattered electron (BSE) image of highlighted region in Fig. 7. Qtz quartz, Pl plagioclase feldspar, Afs alkali feldspar, Bt biotite, Ttn titanite, Hem hematite, Cly clay and Ap apatite. **b** Higher resolution BSE image of a cross section at the rock surface where Mn is concentrated. **c** RGB overlay of previous with multivariate statistical (MVS) components that model the hyperspectral x-ray data set. Inset: Component spectra associated with red (Al-rich phase), green (Mn-rich phase), and blue (plagioclase) component images

A detailed examination of the cross section using SEM imaging and x-ray microanalysis reveals that Mn is found throughout the discolored layer. However, Mn is particularly enriched in the uppermost 100 μm or so, and the density of Mn-bearing particles tails-off precipitously with depth from the rock surface (Fig. 8a).

results shows that rock varnish is composed of two components: (1) a Mn-rich phase with a Mn/Fe ratio of ~2 (Table 3), and (2) an Al-rich phase with Al/Si ratio of ~1, which is not inconsistent with clay (Fig. 8c; Table 3). In addition to deposits at the stone-atmosphere interface, nanoscale Mn particles also decorate the grain boundaries of fine grained material within sandstone voids (Fig. 9a, b, d) and along grain boundaries (Fig. 9c).

Rock varnish on the Seneca sandstone described here shares certain similarities with desert varnish: (1) high luster, nearly metallic in places; (2) Mn-rich particle sizes in the nanometer range from <20 to 200 nm; (3) high enrichment in Mn as well as Pb, Cu, and Zn (Table 2); (4) deposition on a lithological substrate containing a low bulk concentration of Mn (Table 1); and (5) mineralogical association with Al-rich silicate dust minerals intimately mixed with the Mn-rich coating (Fig. 8c).

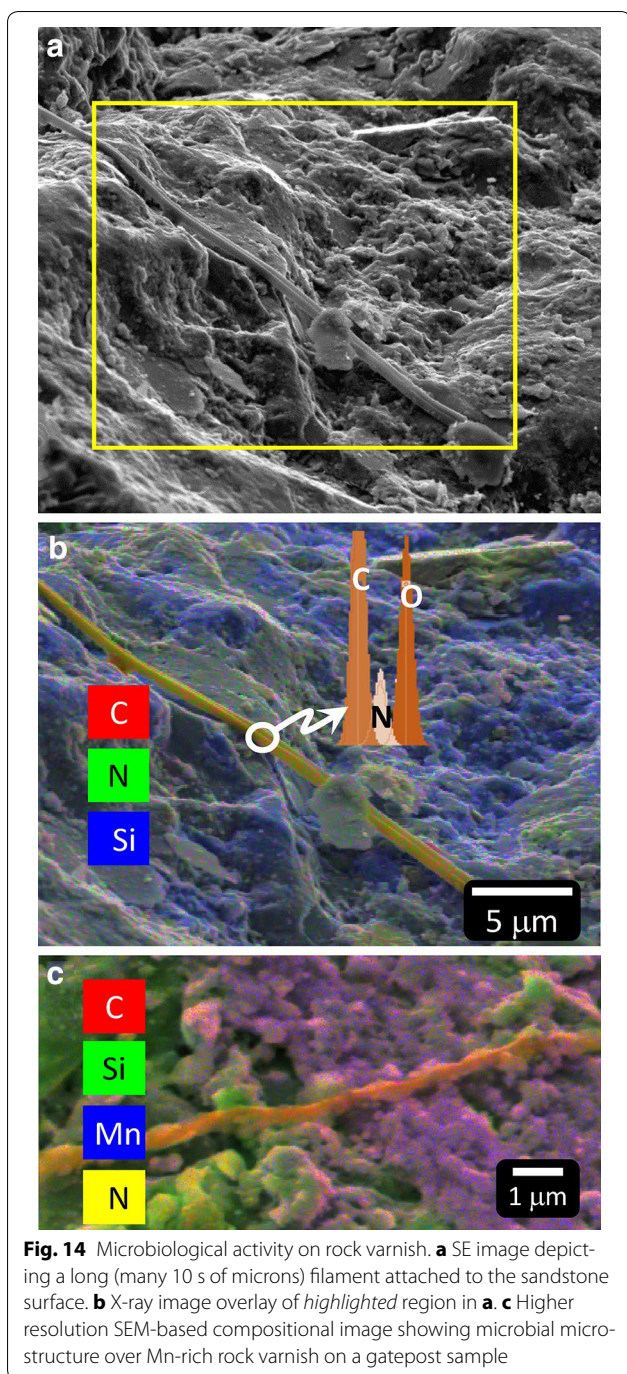
Biological microstructures such as filaments 10 s–100 μ m in length are present on the rock varnish and are rich in carbon and nitrogen (Fig. 14a, b). Higher resolution compositional imaging of such microbial microstructures indicates that some biological activity post-dates Mn-deposition (Fig. 14c).

Based upon rare earth element fractionation observed in desert varnish it has been argued that the degree of element fractionation observed is inconsistent with isochemical leaching and reprecipitation within the same rock [26]. Therefore, the source of Mn must be delivered to the rock surface externally via atmospheric transport and surface leaching/dissolution of airborne dust grains. The final step 3 requires oxidation and precipitation of Mn either by a physiochemical process under acidic oxidized conditions in rainwater [26] or via microbially assisted oxidation as favored by other investigators [7, 11, 27]. The microstructural imagery collected on the Smithsonian Castle varnish offers no evidence for microbial entombment in Mn oxide, and the organisms observed on the surface (Fig. 14) grew upon the varnish and
