Geotechnical and geophysical investigation techniques in Ben Ezra Synagogue in Old Cairo area, Egypt

Sayed Hemeda*

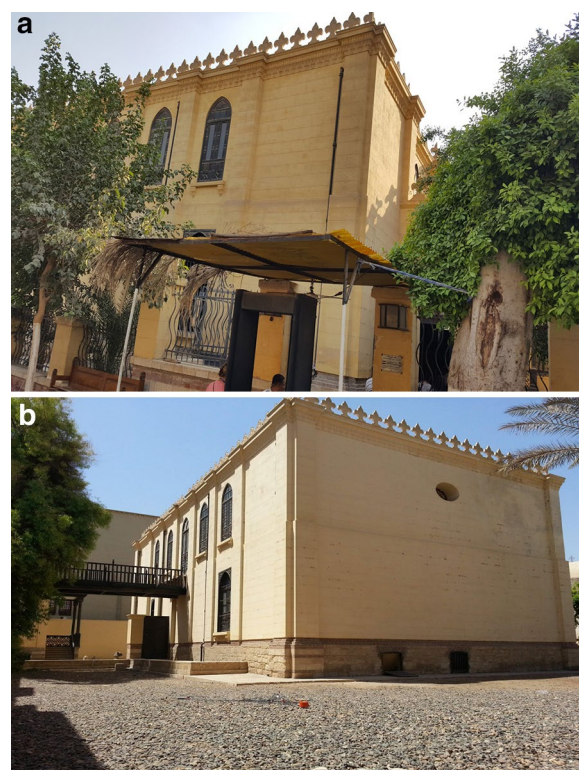
Fig. 1 Ben Ezra Synagogue in old Cairo area, Egypt. **a** Northern façade and **b** Southeast view

The Architectural Design and outline of the Ben Ezra Synagogue or the Jewish temple has a basilica style, as appeared in, as shown in Figs. (1, 2, 3, 4). There are two stories, a lower floor for male admirers and an upper floor for ladies. Steel bars separate the principle lobby into three sections or passageways. The focal corridor has the work area for Torah perusing. Twelve marble columns bolster the rooftop and 6 marble steps prompt the wooden sacrificial stone. The insides are finished in Turkish style botanical and geometric examples.

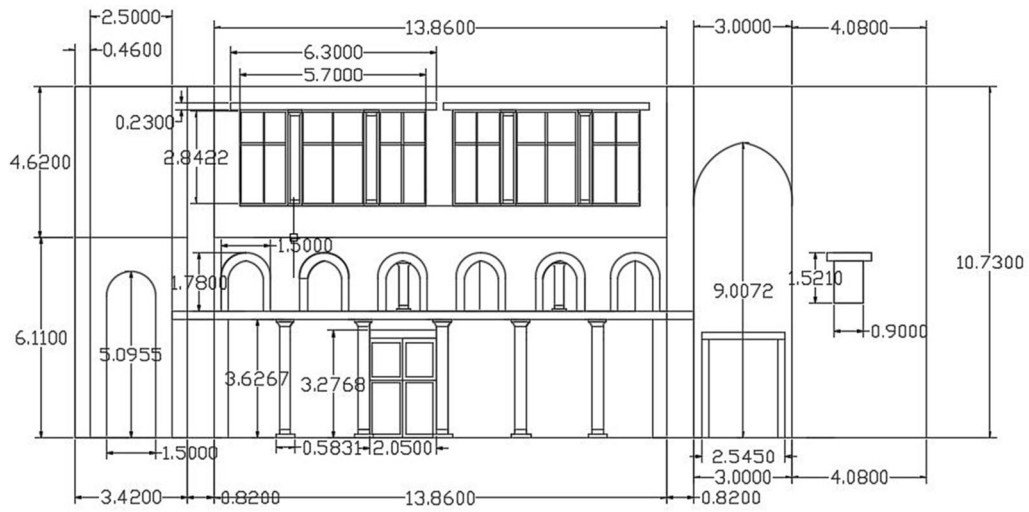
Fig. 2 Cross section of En Ezra Synagogue shows the architecture of the Synagogue and its basilica style

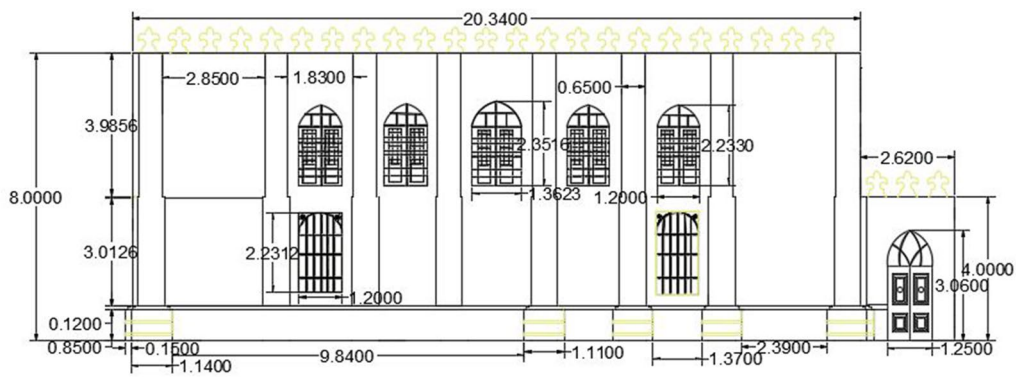
Fig. 3 The northern main facade of Ben Ezra Synagogue

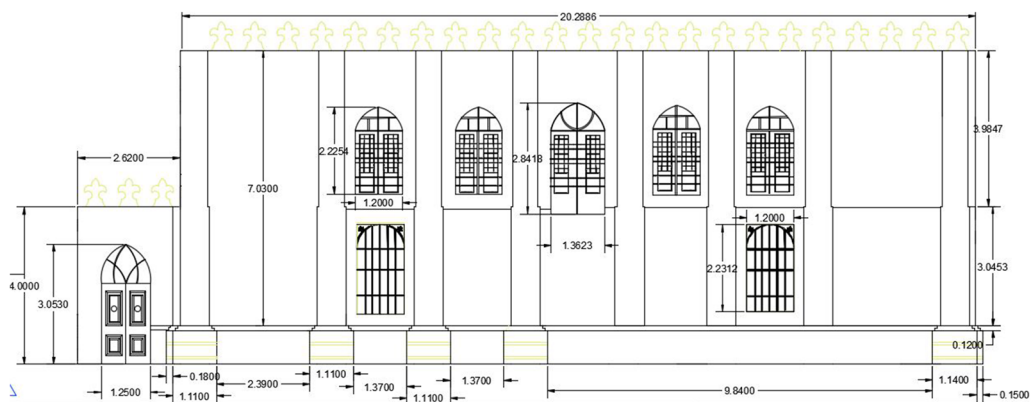
Fig. 4 The southern facade of Ben Ezra Synagogue

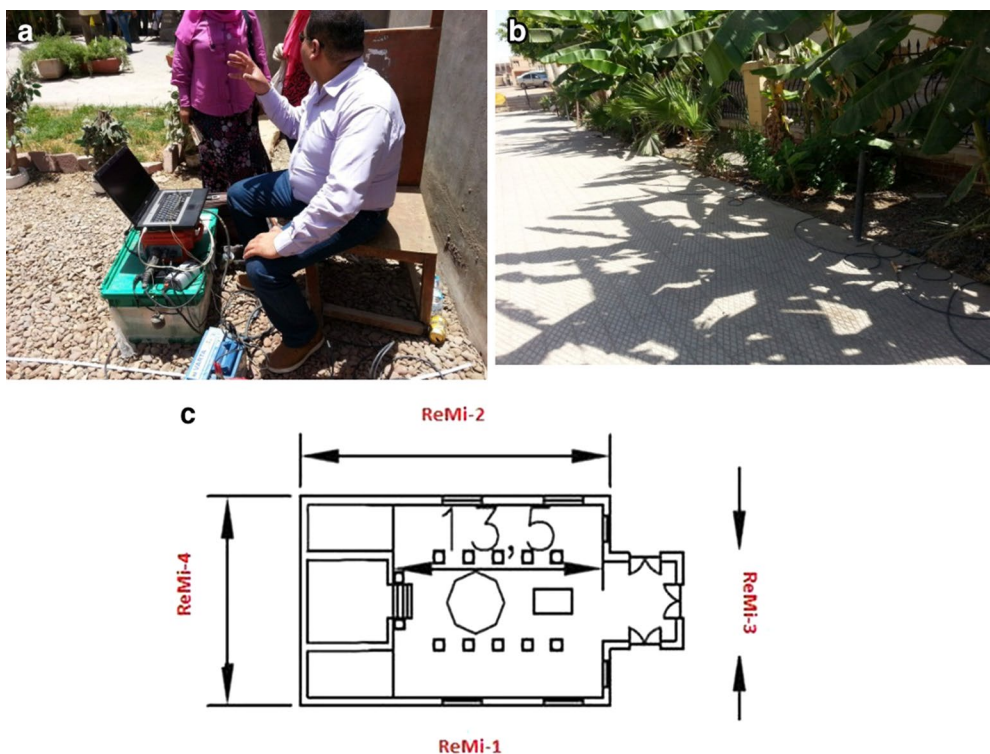
Fig. 6 a, b Samples of ReMi profile conducted inside and around Ben Ezra Synagogue

ES-3000 seismograph was used for the measurement of background ‘noise’ at Ben Ezra Synagogue and its surrounding area. Three profiles were conducted around Ben Ezra Synagogue, as shown in Fig. (6). ReMi analysis presented herein was developed using 12 channels (14 Hz, geophones) set along a straight-line array with different receiver spacing. Receiver spacing for ReMi profiles used. Unfiltered, 30 files of 20 s each were record for surrounding “noise” [25–28].

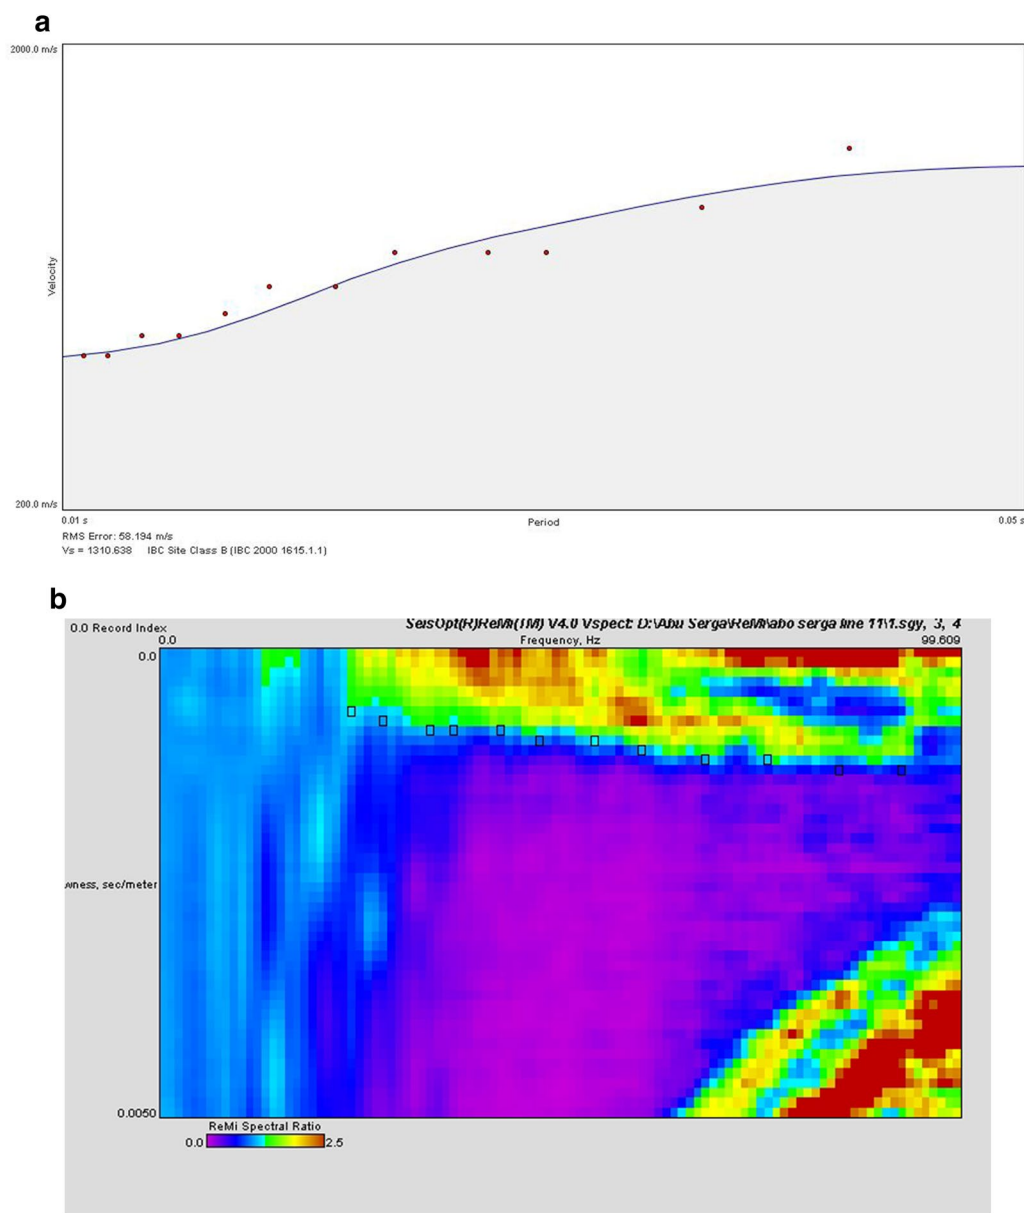
Fig. 8 a Dispersion curve showing picks and fit for Profile ReMi-3. b P-F image with dispersion modeling picks for Profile ReMi-3

The method was applied using the well known Optim Software for ReMi data modeling. Figures 7 and 8 show the dispersion curve and spectrum P-F image (Remi Spectral ratio of surface waves) for ReMi profiles ReMi-1 to ReMi-3 respectively. The excluded models for S-wave velocity with depth for ReMi profiles ReMi-1 to ReMi-3 are shown in Figs. 9, 10, 11. Table 1. Summarizes the receiver spacing for ReMi profiles used. It is noticed that outside Ben Ezra Synagogue, the S-wave velocity detected is about 900 m/s for average depth of about 6.5 m, and reach to 1600 m/s from 15 to 28 m depth.

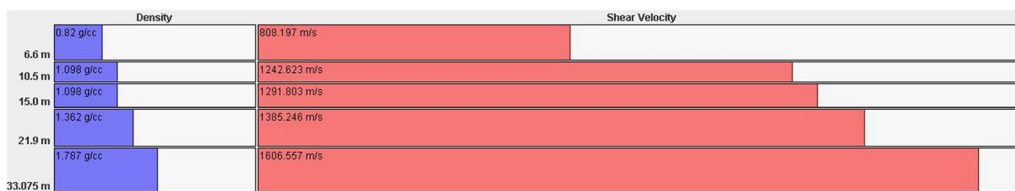
Fig. 9 Shear wave velocity model calculated for profile ReMi-1

The excluded models for S-wave velocity with depth for ReMi profiles ReMi-1 to ReMi-3 are shown in Figs. 9, 10, 11. It is noticed that outside Ben Ezra Synagogue, the S-wave velocity detected is about 900 m/s for average

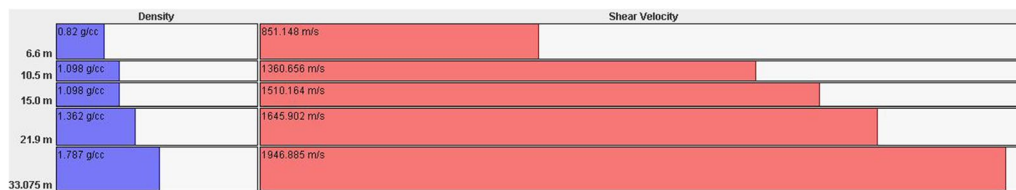
Fig. 10 Shear wave velocity model calculated for profile ReMi-2

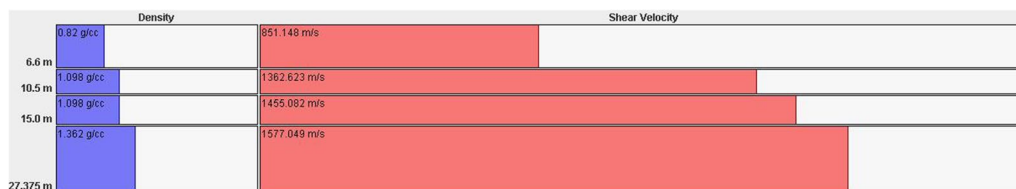
Fig. 11 Shear wave velocity model calculated for profile ReMi-3
