Weathering mechanism of red discolorations on Limestone object: a case study from Lingyan Temple, Jinan, Shandong Province, China

Abstract

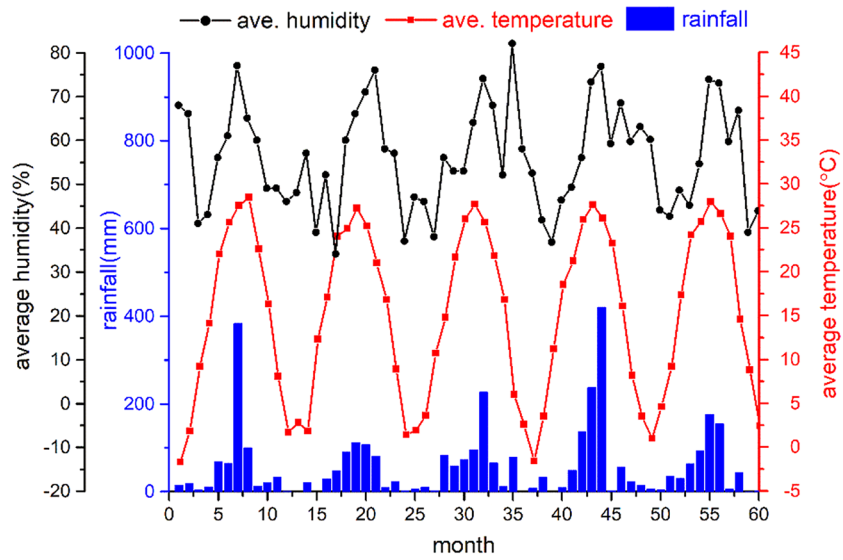
Fig. 2 Climograph of Jinan city from January 2013 to December 2017 (The data were downloaded from the climatic data center, National Meteorological Information Sharing Website)

as a warm climate, abundant rainfall, and four distinctive seasons. In the last 5 years, the temperature has ranged from maxima of 39.1 °C in the summer to minima of −12.9 °C during the winter (Fig. 2). The region receives an average of 715.4 mm rain per year, and the rainfall distribution is mainly in June, July, and August. Besides, the annual average humidity is 56% Relative Humidity (RH), and a maximum of 82% RH in November. Furthermore, the dominant wind throughout the year is southwest directed, and southeasterly wind prevails in the summer. The annual average wind speed is 2.3 m/s, and the maximum wind speed is 13.9 m/s [24]. The above environment parameter and a relatively higher location with well-developed vegetation determine a damp foggy microclimate, which provides sufficient water (i.e. rain, moisture) for stone objects forming wet deposits.

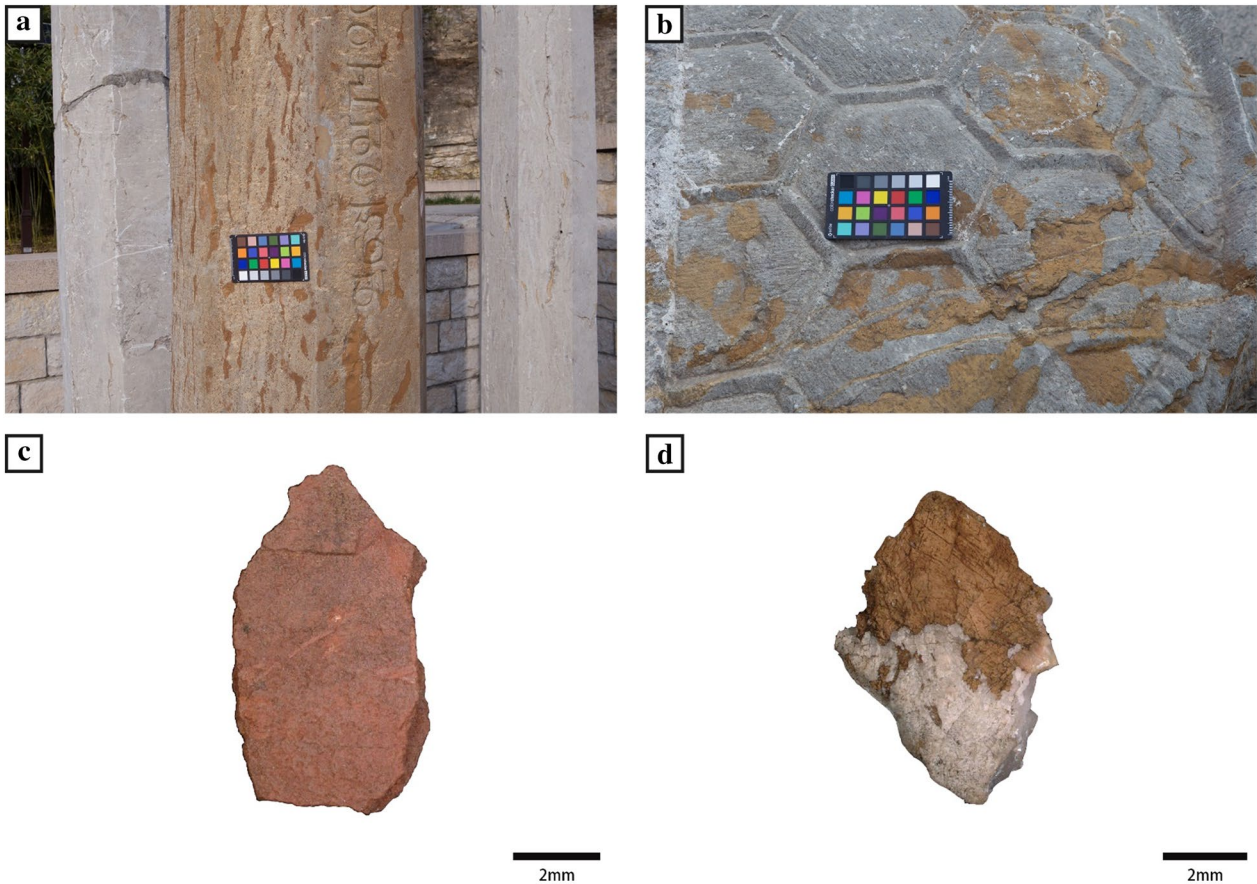
Fig. 3 Weathering features on stone objects: red discolorations on the monument (a), red discolorations on the sculpture (b), red discoloration (c), and red discoloration coexist with quartz (d)

In the red discoloration area, a variety of solutional features, specifically the vertical trace, was detected. At some sites, the color change occurs on the vertical surface of the monument (Fig. 3a). At other sites, the color variation occurs on the horizontal surface of the sculpture (Fig. 3b). Most of them presented thick and rigid crusts that are strongly adhered to the stone surface

(Fig. 3c). An acid-resistant mineral, such as quartz are always found on the rims of these red discolorations, indicating the formation process is dominated by acid reaction [25] (Fig. 3d).

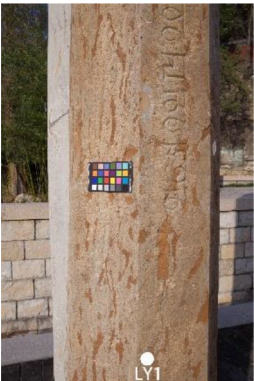
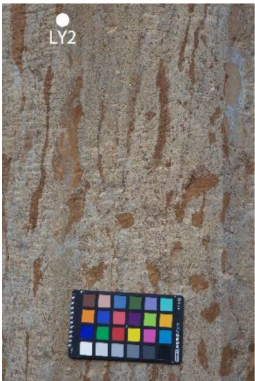
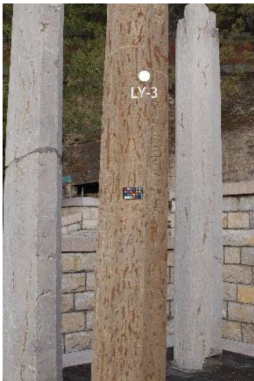
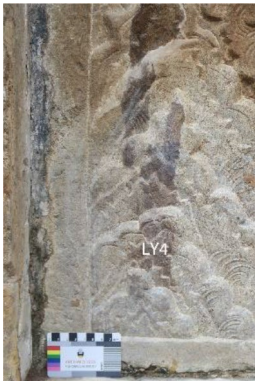
Table 1 Characteristics of the samples and an example of an area treatment with chemical cleaning

Sample	LY1	LY2	LY3	LY4
Analysis	XRF, XRD, FTIR, Raman	XRF, OM, SEM-EDS	XRD	Chemical cleaning
Description	At the east of Thousand Buddha Hall, the second monument	At the east of Thousand Buddha Hall, the second monument	At the east of Thousand Buddha Hall, the second monument	Basement of Pizhi Pagoda, the six relief
Sampling sites

Three samples were taken from the visible fissured area of the monument using scalpel, hammer and tubes. One area was used for chemical cleaning test and colorimetric measurements. Descriptions of representative samples/areas and the analyses performed are presented in Table 1. Before performing any analyses, the sample was first observed under a microscope and then treated with different methods for accurate analysis.

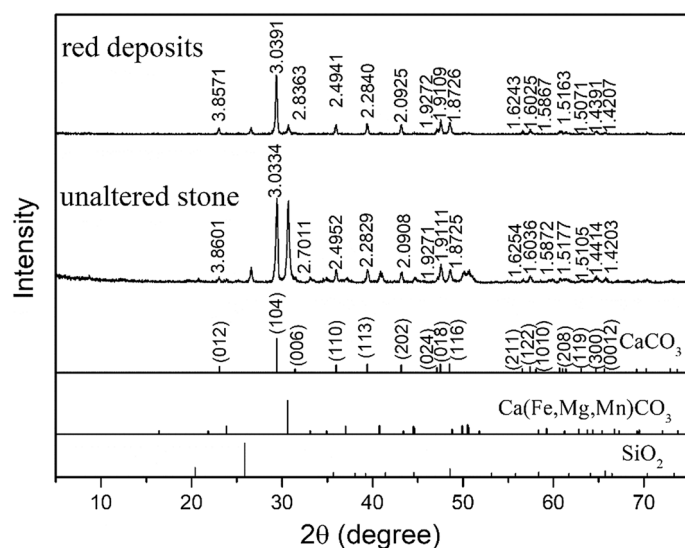
Fig. 4 XRD patterns of the red discolorations

In order to identify the chemical composition, the reference intensity ratio (RIR) method was used to analyze the data, rather than the intensity of the peak channel alone [27]. Figure 4 illustrates the XRD patterns of the red discolorations (LY1) and unaltered stone (LY3). The mineralogical composition of red discolorations contained large quantities of calcite (77.9%), and

remarkably high amounts of quartz (15.3%) and kutnohorite (6.8%). Similar composition was detected in the unaltered stone (LY3) and consisted of 45.9% calcite, 11.8% quartz and 42.4% kutnohorite. The high concentration of Ca can be accounted for the calcite content, whereas kutnohorite is not responsible for the higher Fe content. Some iron-compounds were apparently below the detection limit (5%) [28]. Furthermore, in comparison with the unaltered stone (LY3), it is clear that the d-space values of the weathered stone objects (LY1) have a slight shift of (012), (202), (104) and (0012) peaks, and the structure change is always associated with acid corrosion [29, 30].

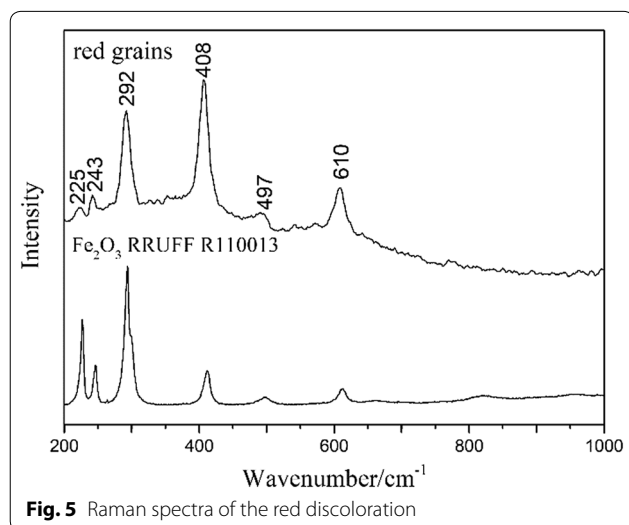
Fig. 5 Raman spectra of the red discoloration

It is generally accepted that the Raman band positions are specific to particular chemical groups, and it is extra sensitive to the short-range order, which is a widely used characterization of weathered samples [31]. Figure 5 presents the Raman spectra of the red grain in the LY1 sample. The result showed in good agreement with the rust (around 225, 243, 292, 408, 497 and 610 cm^{-1}), which is an insoluble dark red powder [32]. In the red discoloration sample, hematite can be accounted for the high concentration of Fe content. The mineral formation process is frequently associated with dissolution, precipitation and oxidation of iron ions. Dissolution occurs by the adsorption of protons to iron compound surface sites, which results in the promotion of Fe detachment from the bulk oxide through the weakening of the Fe–O bonds [25].

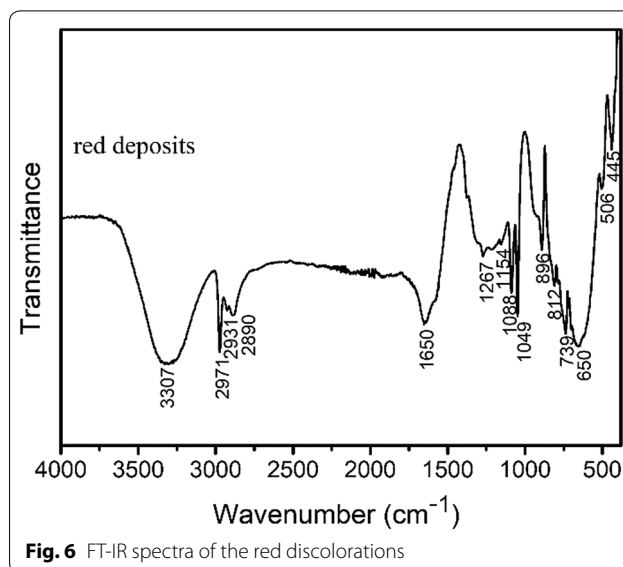
Fig. 6 FT-IR spectra of the red discolorations

As regards spectroscopic investigations, FTIR analysis cleared up the bonding of LY1 sample (Fig. 6). From the spectrum, the weak peaks at 445 cm^{-1} [33] and 739 cm^{-1} [34] assigned to the Fe–O band for the rust. The stretching vibration of Mn–O band and Fe–C band

occurred at 506 cm^{-1} and 1154 cm^{-1} is associated with kutnohorite [35, 36]. Moreover, the peaks at 2890 and 1049 cm^{-1} attributed to the presence of Fe–OH groups [37]. The hydrated group indicates that water plays a crucial role in the discoloration process.

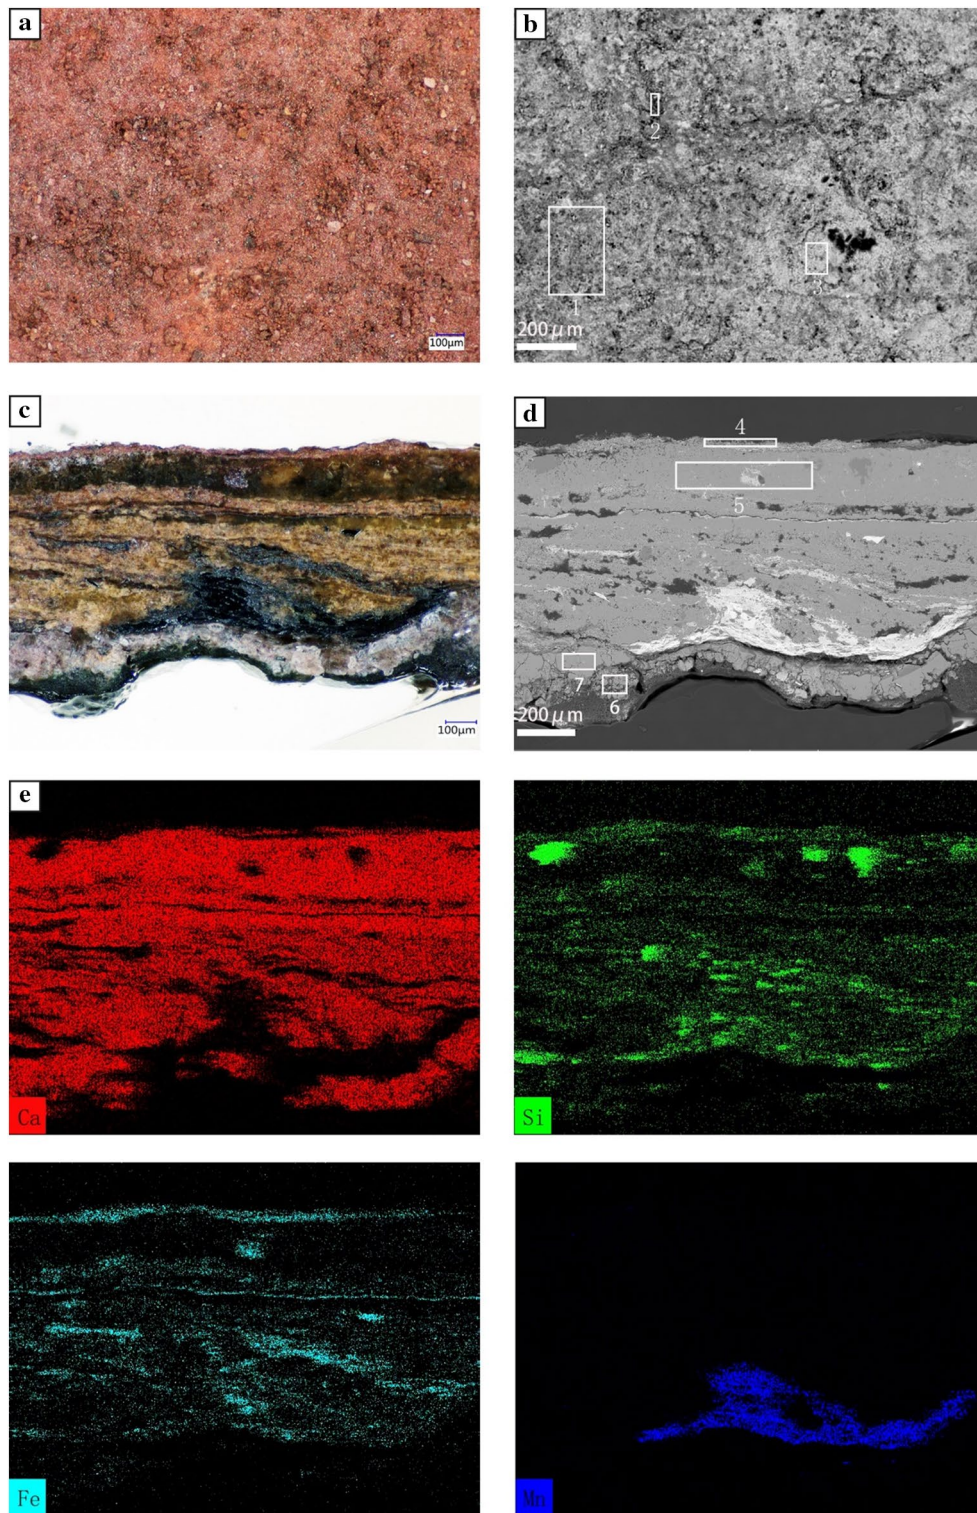
Fig. 7 The surface section of the LY2 (a), BSE image of the surface section (b), the cross section of the LY2 (c), BSE image of the cross section (d), and the relative EDS mapping (e)

The SLM observations and SEM–EDS analysis were carried out on untreated sample surface and polished cross-section (Fig. 7). In the surface section of LY2, plenty of etching pits present on the weathering surface (Fig. 7a). A large number of particles present as lamella and granular structure (Fig. 7b). These particles contained Al, Si, K, Ca, and Fe elements, none S or N elements was detected, as shown in Table 3. Carbonic acid works effectively in the reaction process. Moreover, the cross-section of LY2 shows a loose structure and a red layer with 20 μm thickness on the surface of the weathered stone (Fig. 7c), which contained 49.8% Fe and 33.6% Ca elements in the light of the EDS results (Table 3). Fe concentrated in the red discoloration area of the sample (Fig. 7d). The elemental distributions of red discolorations were determined through EDS mapping analysis, as shown in Fig. 7e. Corresponding with the BSE image (Fig. 7d). The result confirms that Fe, Mn, Si and Ca exist in the sample and Fe, Si aggregates in the weathering stone surface. Combining the above XRD results, it further demonstrates that the corrosion of kutnohorite ($\text{Ca}(\text{Fe}, \text{Mg}, \text{Mn})\text{CO}_3$) promotes the formation of iron oxide sediments, and the weathering process stopped in the layer composite of quartz.

Table 3 EDS analysis of positions shown in Fig. 7

Position number	Element content (wt %)						
	Al	Si	K	Ca	Mn	Fe	
1	4.7	7.2	1.9	20.1		66.1	
2	3.1	4.4	1.5	34.1		56.9	
3	3.7	5.3	1.3	2.8		86.8	
4	5.3	8.6	2.7	33.6		49.8	
5		3.6		81.9	1.9	12.7	
6	2.7	3.5		84.4		9.4	
7				97.1		2.9

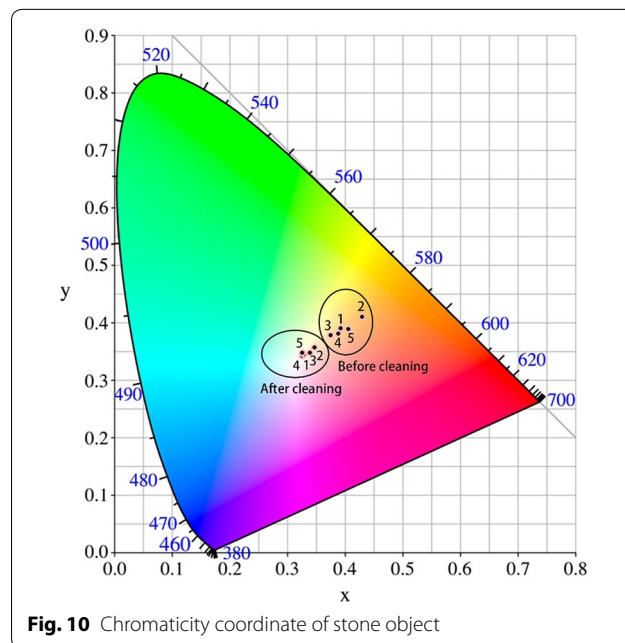
Fig. 10 Chromaticity coordinate of stone object

objective description, the color coordinates of the stone objects were drawn in the chromaticity diagram (Fig. 10). The results show that each cleaning area is located in the white region of chromaticity coordinate, and leaving the underlying stone unchanged. The above phenomenon indicates that the EDTA-2Na bind with an iron element to form water-soluble complexes effectively. This cleaning technique has an excellent ability for removing and stabilizing the discoloration area and modulate the aesthetic value of the stone object, as discussed by Moropoulou [44]. The washing procedures tested during the present study also show the usage of sodium bicarbonate, which accelerates the Fe_2O_3 dissolution process [45]. Generally speaking, the cleaning method depends on the composition of red discoloration.

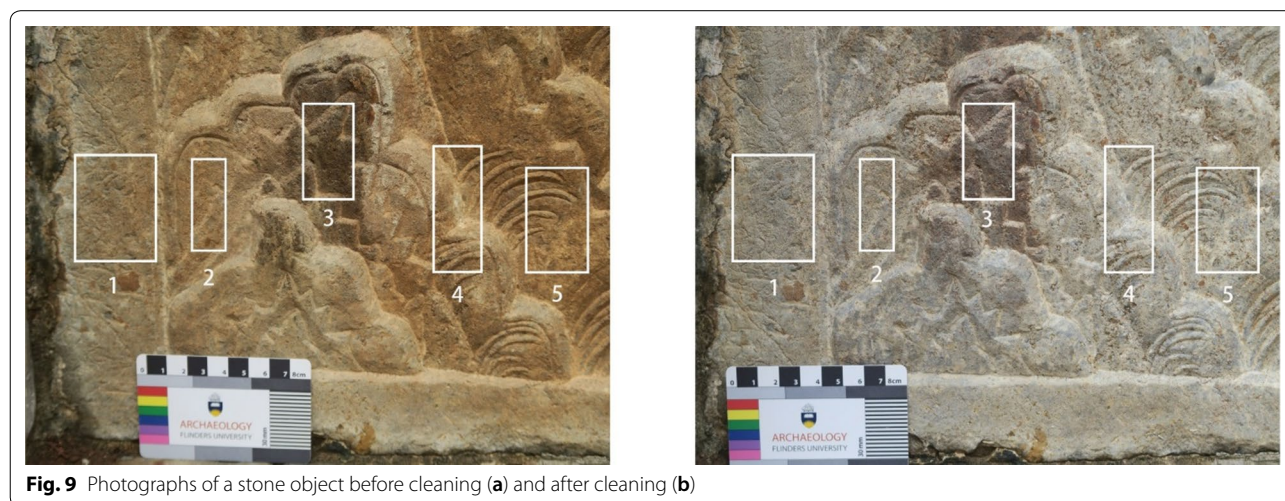
Fig. 9 Photographs of a stone object before cleaning (a) and after cleaning (b)

In the field of stone object conservation, red discoloration is usually considered to be harmful and dangerous because of its ugly appearance and thermal stress fatigue. Surface temperature and thermal gradients created by insolation depend on the thermal characteristics of the stone object. The volumetric change of Fe_2O_3 on thermal expansion and contraction shows a sharp difference from $CaCO_3$, which promotes micro-fracturing of surface grains. As a result, the removal of the red discoloration is considered to protect the objects. A cleaning method for the removal of red discolorations from stone objects must respect the chemical and physical nature of the material of the stone object. In the previous research, the removal of red discoloration from the stone objects by using Sodium ethylene diammonium tetraacetate (EDTA-2Na) proved to be an effective cleaning procedure [41]. EDTA-2Na is a weak acid that facilitates the removal of Fe_2O_3 through the chelating process and can be classified as a soft cleaning procedure [42]. So, EDTA poultices have been applied on the stone

surfaces for removing the red discolorations. It is composed of 5 g of Sodium ethylene diammonium tetraacetate and 5 g of sodium bicarbonate, all 100 ml of water [43]. This technique adopts the following procedures. First, wetting the stone surface by distilled water to soften the staining crusts. Next, applying the poultices to the discoloring area and wipe it with absorbent cotton five times. Last, washing the stone surface by de-ionized water to prevent the influence of sodium three times. Figure 9 shows the cleaning effect of the LY4 sample. It can be seen that most of the red discolorations on the stone sculpture were removed completely after the cleaning, while the shape of the delicate carvings and the stone surface remains unchanged. In order to achieve a more
