Geo-environmental monitoring and 3D finite elements stability analysis for site investigation of underground monuments. Horemheb tomb (KV57), Luxor, Egypt

Keywords: Flash floods, Geo-environmental investigation, Remote sensing, Geotechnical modeling, Horemheb tomb (KV57), Valley of the kings, Underground monuments

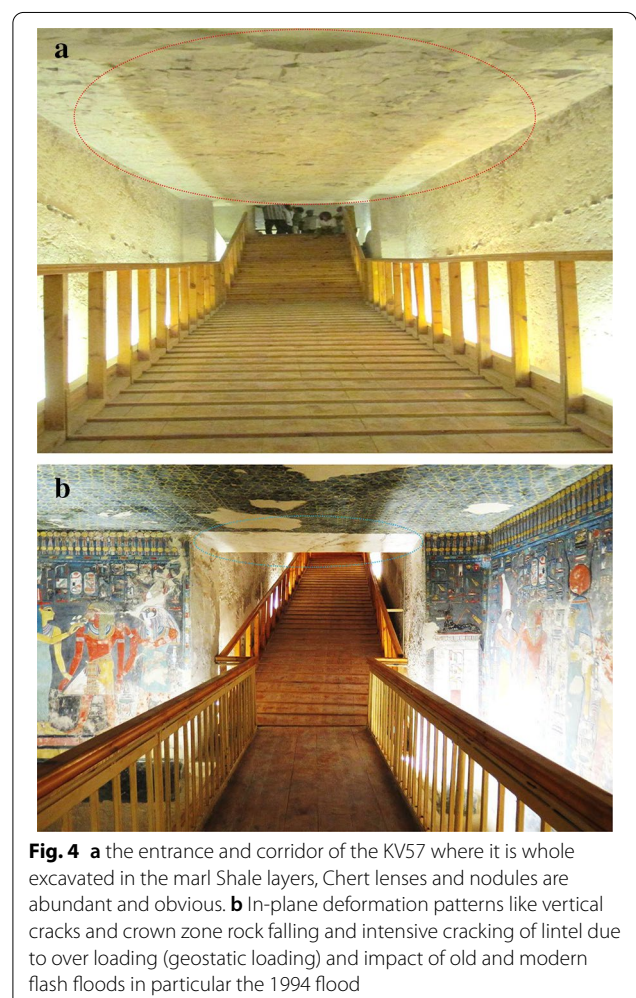
Fig. 4 a the entrance and corridor of the KV57 where it is whole excavated in the marl Shale layers, Chert lenses and nodules are abundant and obvious. **b** In-plane deformation patterns like vertical cracks and crown zone rock falling and intensive cracking of lintel due to over loading (geostatic loading) and impact of old and modern flash floods in particular the 1994 flood

Figure 4a represents the entrance and the main corridor of the Hormoheb tomb KV57 where it is whole excavated in the marl Shale layers, Chert lenses and nodules are abundant and obvious. The In-plane deformation patterns like vertical cracks and crown zone rock falling and intensive cracking of lintel due to over loading (geostatic loading) and impact of old and modern flash floods in particular the 1994 flood, as shown in Fig. 4b. Extensive structural damage of crown ceiling zones and engineering failure of the structural pillars, sidewalls and Ceiling of the Corridors and Chambers in the KV57. Brittle rock, high stress conditions lead to rockbursting (the sudden release of stored strain energy) bursts manifest themselves through sudden. Extensive rock falls from the ceiling is obvious and cracks are active, as shown in Fig. 5. Carved and decorated walls in massive Esna shale Member are in advanced state of disintegration. Showing Chert lenses. The ornamented plaster on top of the Chert lenses and nodules was damaged during the first flash floods that entered the tomb some 3000 years ago. During several restoration projects over the past 200 years, cracks were filled with plaster for protection and stabilization of the tomb, [20]. The impact of the historical and recent flash floods on the mural paintings inside the tomb are severely obvious, as shown in Fig. 6.

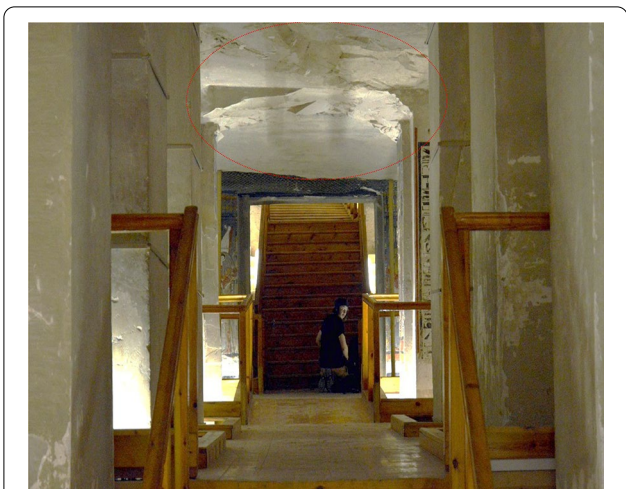
Fig. 5 Extensive structural damage of crown ceiling zones and engineering failure of the structural pillars, sidewalls and Ceiling of the Corridors and Chambers in the KV57. Brittle rock, high stress conditions lead to rockbursting (the sudden release of stored strain energy) bursts manifest themselves through sudden. Extensive rock falls from the ceiling is obvious and cracks are active when the gypsum Pegs are cracked and broken

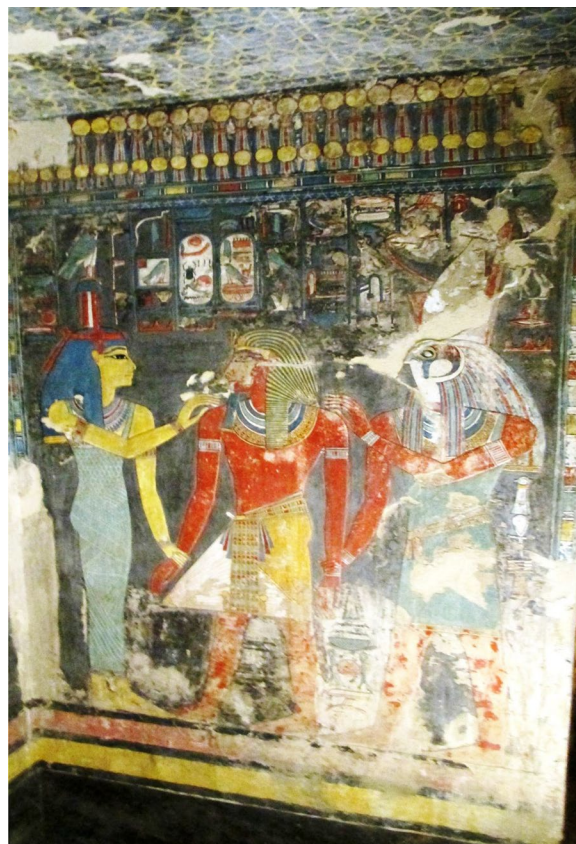
Fig. 6 Carved and decorated walls in massive Esna shale Member are in advanced state of disintegration. Showing chert lenses. The ornamented plaster on top of the chert lenses and nodules was damaged during the first flash floods that entered the tomb some 3000 years ago. During several restoration projects over the past 200 years, cracks were filled with plaster for protection and stabilization of the tomb. The impact of the 1994 flash floods on the mural paintings inside the tomb are severely obvious

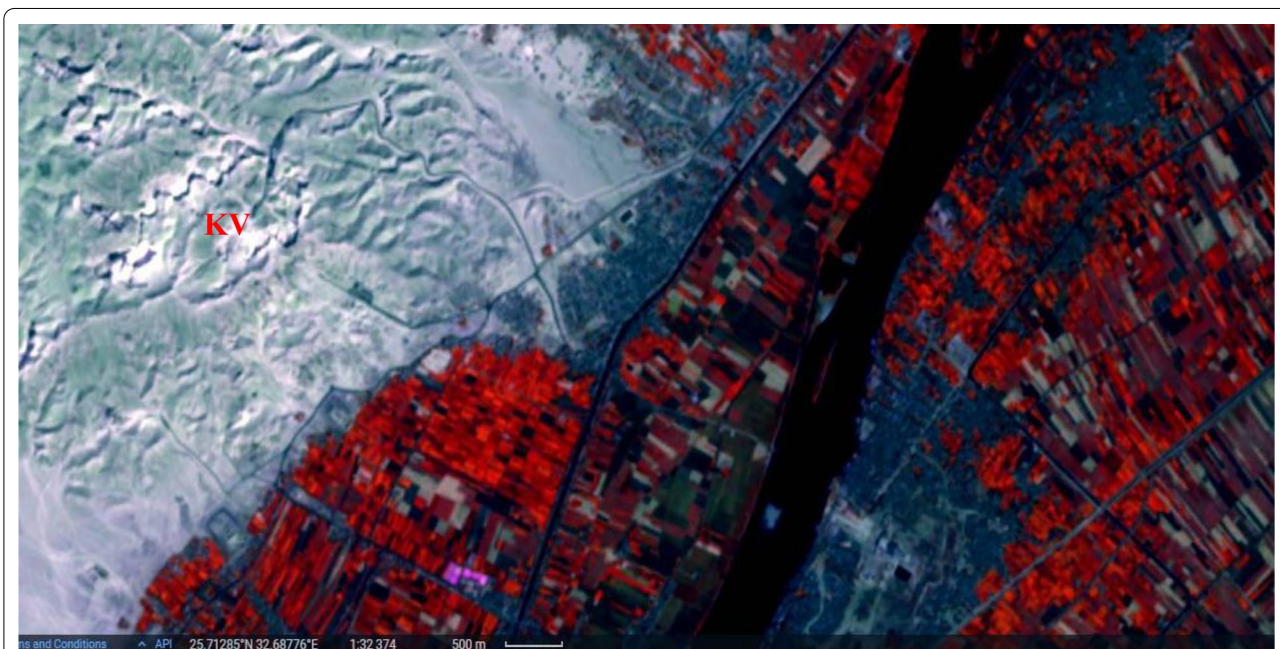
Fig. 8 This band combination good for picking out land from water. In this false color image, land appears in shades of orange and green, and water appears in shades of blue

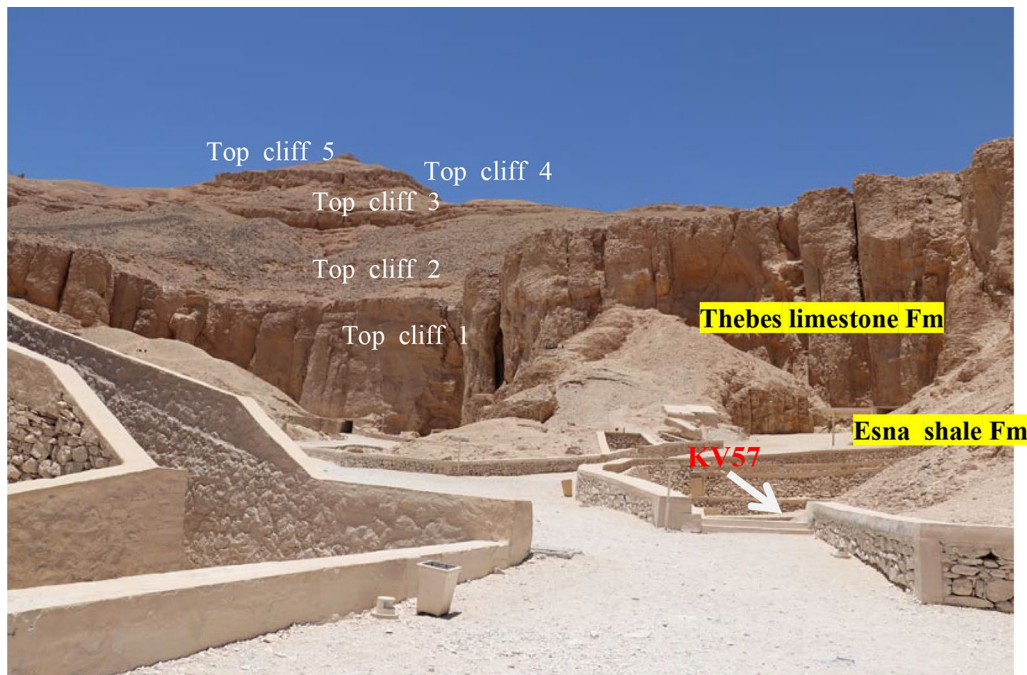
Fig. 11 Location of the Horemheb tomb (KV57) at the east (main) Valley of the Kings (KV), Luxor Egypt. Stratigraphical succession as seen. Characteristic weathering of the Thebes Formation was used to subdivide the Thebes Formation into four units, Member I to Member IV. A 30 m displacement of Member I associated to the Kings Valley Fault is located on the right-hand side approximately 40 m from the tomb of Amenmesse (KV10)

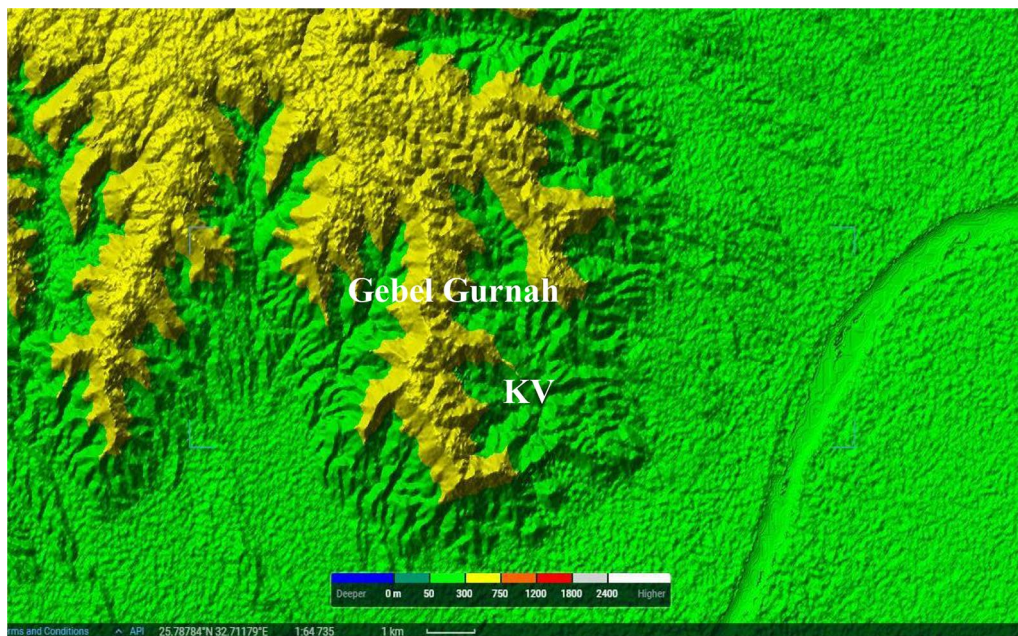
Fig. 12 (DEM), Digital Elevation Model of the valley of kings and the Gebel Gurnah

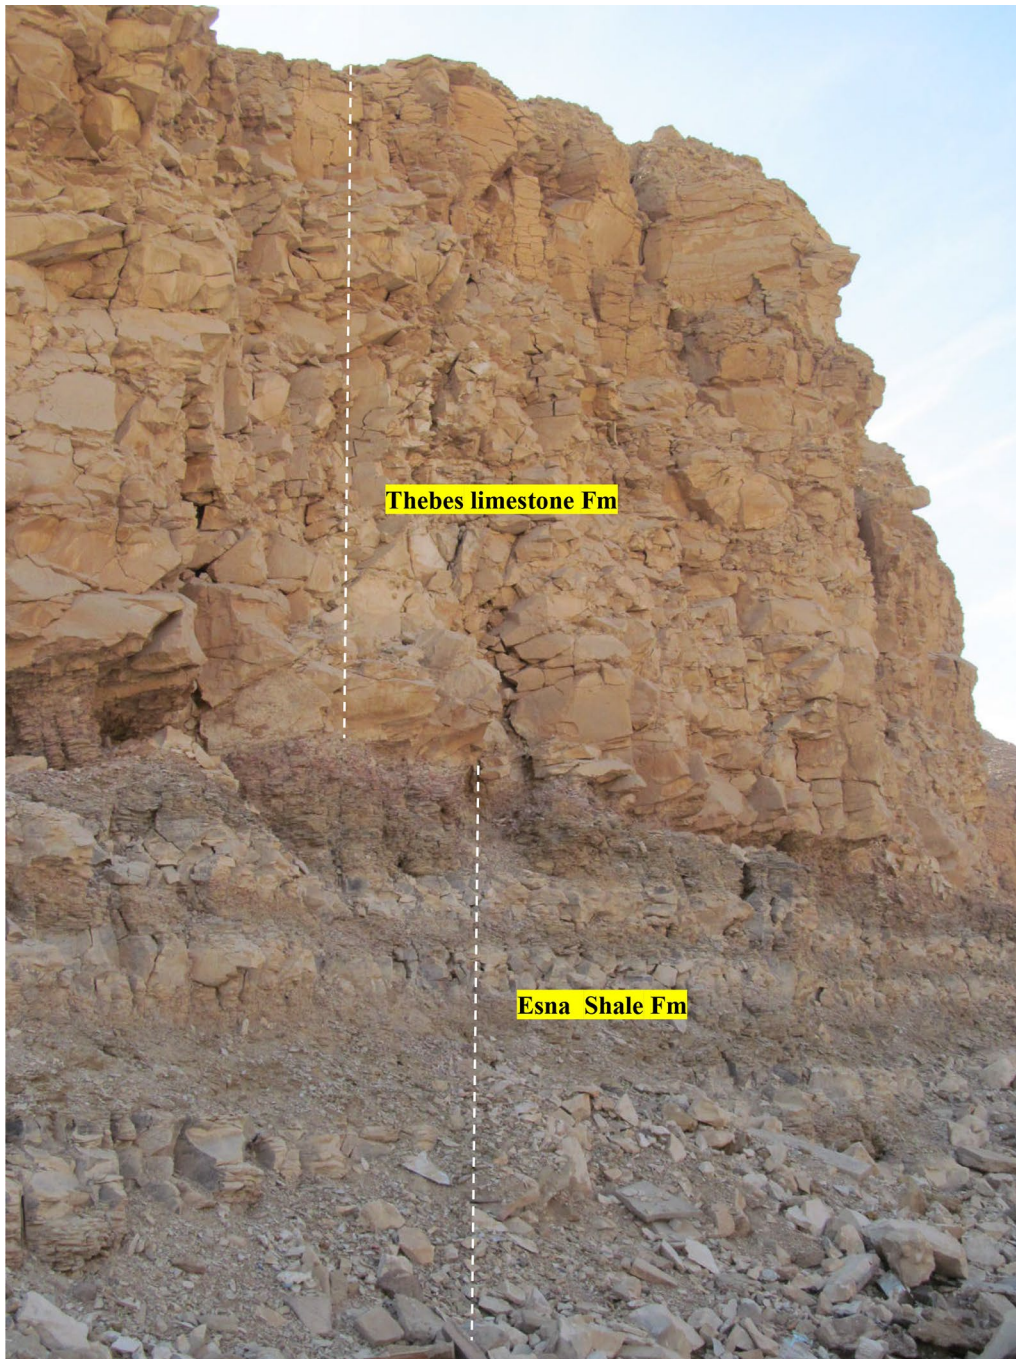
Fig. 14 Abrupt contact of the Abu Had Member of the Esna Shale Formation with lithological unit 1 of the Thebes Limestone Formation. Photo taken just above the location of the KV57

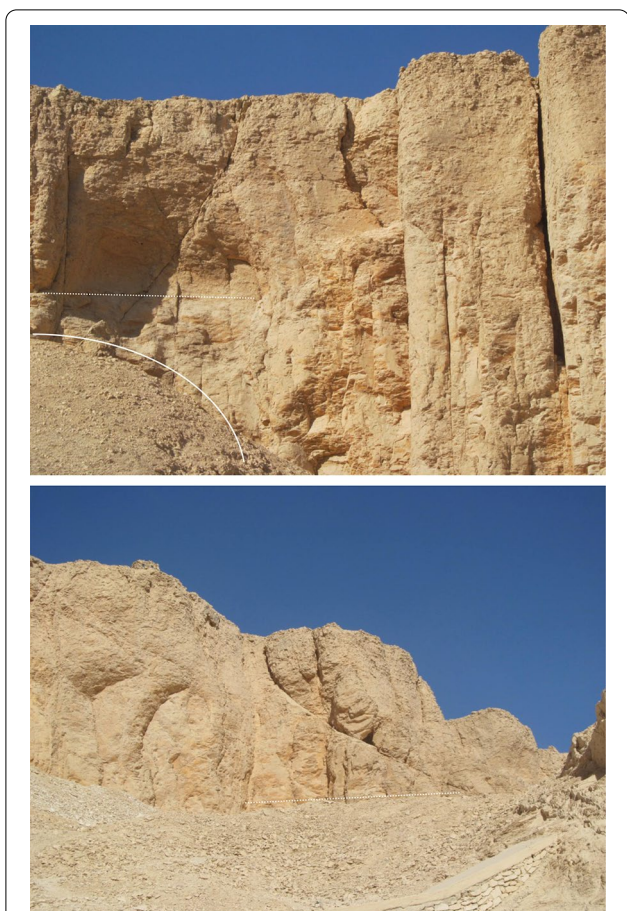
Fig. 15 Evidence of flash flood related erosion in the Esna Shale and vertical fissures in Unit 1 of the Thebes Limestone, delineation of the abandoned Excavations and its causeway. The subvertical wall-cuts were dug in the upper part of the Esna Shale Formation and at the base of the Thebes Limestone Formation. White arrows point to erosional gullies in the lower part of unit 1 of the Thebes Formation, in the Hanadi Member (Esna Shale Formation) and in the debris that cover the Esna Formation. Note that the gullies at the base of the Thebes Limestone and just below are commonly hollowed out, in particular on top and below the prominent base of Unit 1. These are probable evidence of flash floods. fallen blocks; unstable columnar block and open vertical fissures; screes. screes resulting from archeological excavations

Figure 15 is an indication of the erosion caused by the rapid flooding of the shale stratum and vertical fissures in Unit 1 of the limestone at Thebes, and the identification of abandoned excavations and its bridge. The semi-vertical wall pieces were excavated at the top of the shale formation and at the base of the limestone formation at Thebes. White arrows indicate erosion grooves at the bottom of the first unit of the Thebes Formation, in the Hanadi member (the Esna rock formation) and in the debris covering the Esna Formation. Note that the grooves in the base of the limestone at Thebes and slightly below are generally hollow, particularly at the top and bottom of the protruding base of Unit 1. These are possible signs of a flash flood. Deciduous blocks are unstable columnar mass and open columnar fractures; Degrees. Dunes resulting from archaeological excavations, [24].

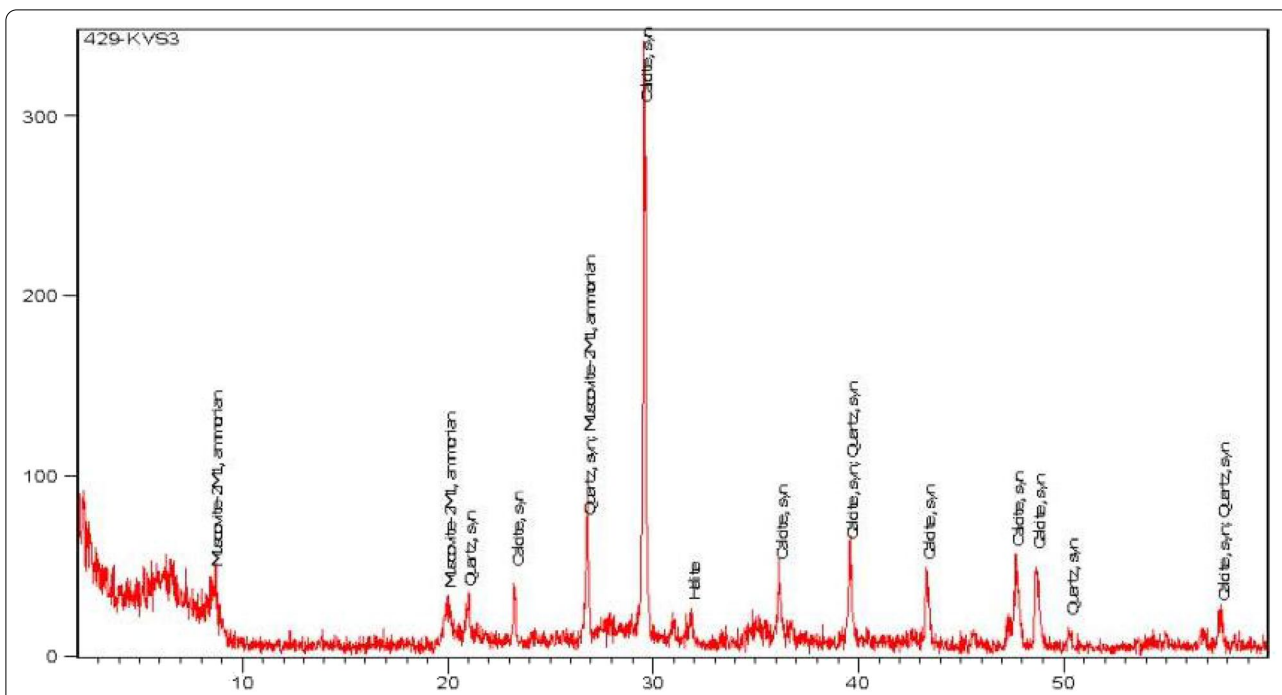
Fig. 16 X-ray Diffraction results showing the bulk Mineralogy of Marl Shale (Calcite/ Smectite) where the Horemheb tomb (KV57) is excavated

The clay minerals consist mainly of palygorskite (50–80%), kaolinite (10%) and mixed layers of Illite/smectite (10–40%). The mineral composition of shale is 5–25% calcite, 5–10% anhydrite and 70–80% clay minerals. Clay minerals consist mostly of mixed layers of lit/smectite (40–75%), yogorskite (20–50%), kaolin (less than 10%) and elite (less than 10%). The bottom unit of Esna’s composition, Esna Shale I, contains up to 20% Calcite and up to 95% phosilicate, with 3–10% anhydrite. Clay minerals consist of about 70% kaolin, 25–35% illite/smectite mixed layers and small amounts of palygorskite and elite, as shown in Fig. 16.

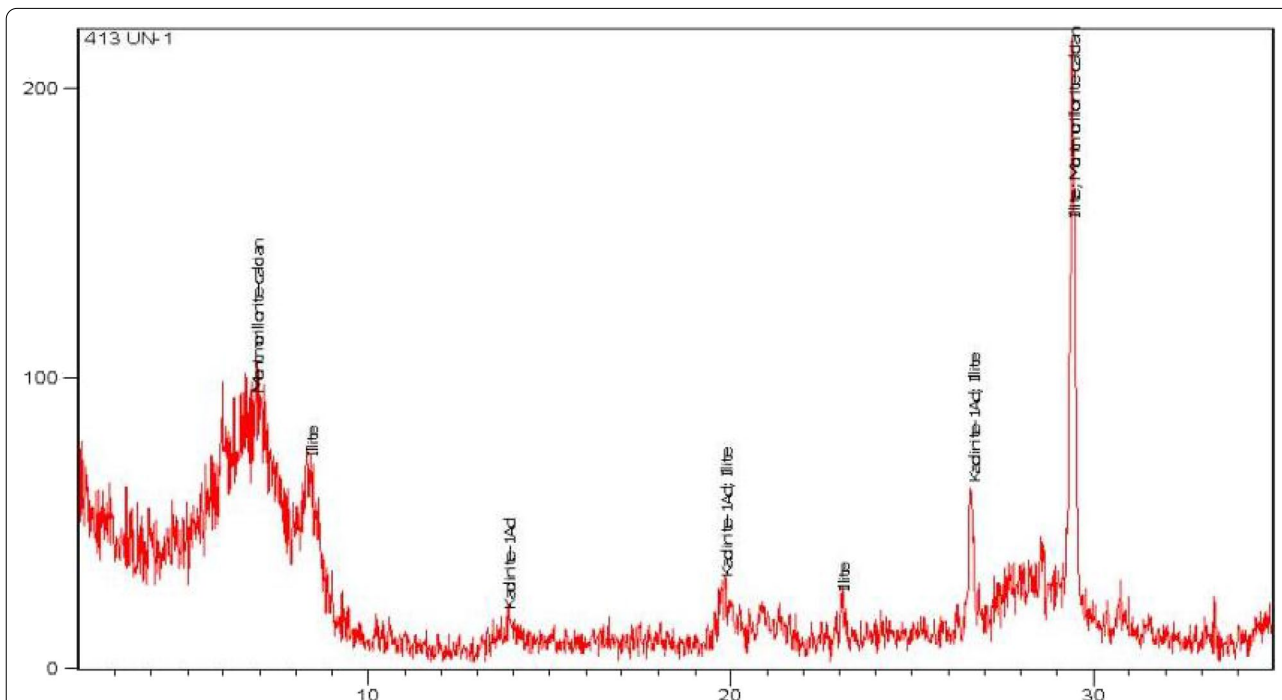
Fig. 17 X-ray Diffraction pattern showing the clay minerals of natural or air treated untreated clay fractions sample from Esna shale Member, where the Horemheb tomb (KV57) is excavated

XRD analysis indicated that the main contents of Esna shale are quartz (SiO_2) and montmorillonite ($\text{Na}_{0.2}\text{Ca}_{0.1}\text{Al}_2\text{Si}_4\text{O}_{10}(\text{OH})_2 \cdot (\text{H}_2\text{O})_{10}$), the secondary contents include kaolinite and elite with traces of calcite, such as shown in the two Tables 2 and 3 X-ray diffraction results showing natural clay minerals or with air An untreated clay fracture sample from the Esna rocky organ, where the tomb of Horemheb (KV57) was excavated and it is a 77% montorillonite, Elite 20% and kaolinite 3% as shown in the Fig. 17 and Table 4 and Table 5 summarizes X-ray

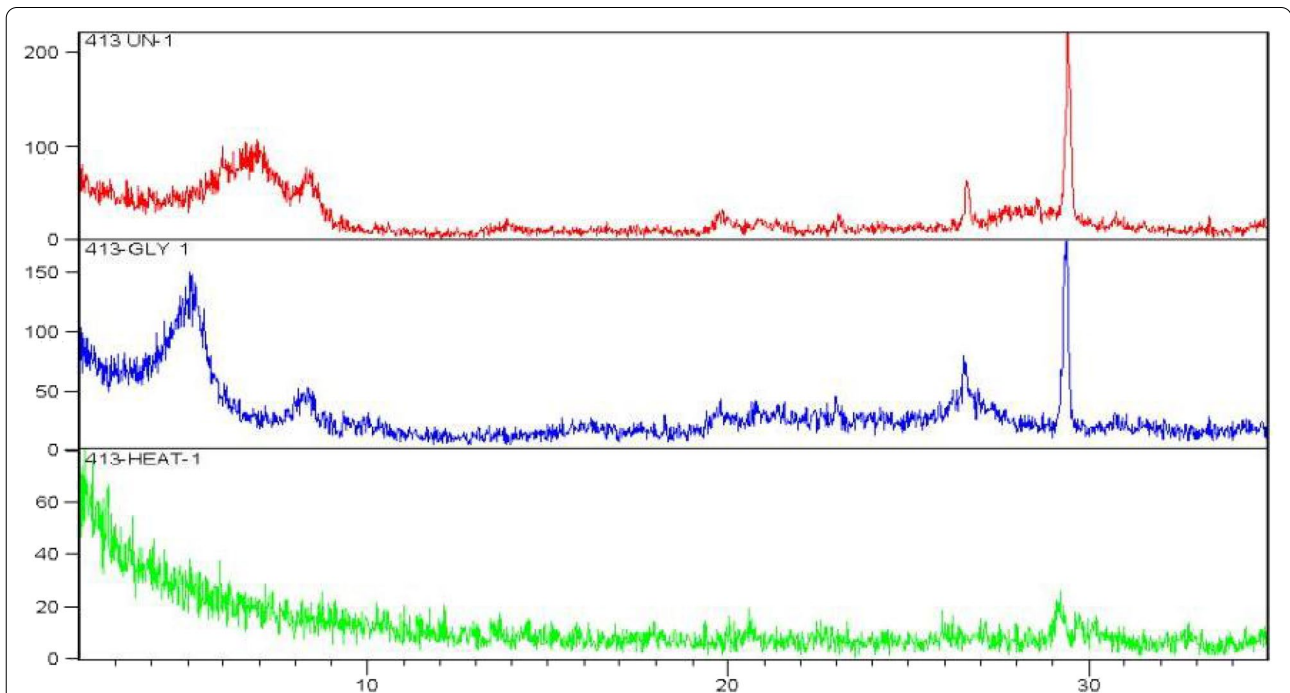
Fig. 18 XRD for the air dried, ethylene glycol treated, and heated to 550C clay fractions from samples of Esna shale, showing decrease and disappearance of peak of Illite/Smectite (I/S) and the present of the Montmorillonite

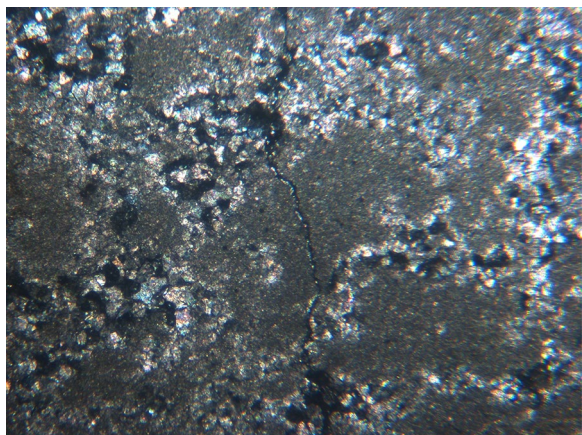
Fig. 19 C.N. Microscopic photograph shows The marl sample from Member I is very fine-grained to fine-grained. Considerable amounts of cavities and microvioletlets filling by recrystallized dolomite are observed in the micritic calcite matrix. The rock is very to fine-grained and composed mainly of calcite and dolomite as the essential components associated with minor amount of clay minerals and rare amounts of microcrystalline quartz, iron oxides and opaques. Calcite represents the matrix of the rock and occurs as very fine-grained (micrite), anhedral to subhedral interlocked crystals. Dolomite occurs as very fine to fine-grained, euhedral to subhedral crystals and filling microvioletlets and cavities. Quartz is detected as very fine-grained crystals scattered in the matrix. Some pores of irregular shapes and various sizes are observed scattered in the rock. Some parts of the sample are stained by iron oxides

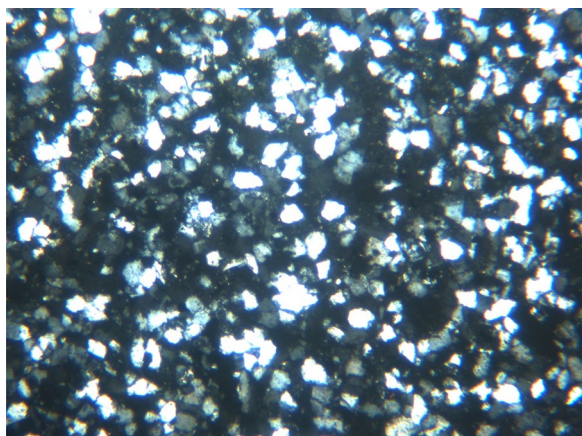
Fig. 20 C.N. Microscopic photograph shows the Esna shale sample is very fine to fine-grained (mainly sand size), well sorted that is cemented by minor amounts of iron oxides, clay minerals and carbonates. The sample is porous where pore spaces of different sizes are observed. The rock is composed mainly of quartz and feldspar grains cemented by minor amounts of iron oxides, clay minerals and calcite. Rare amounts of muscovite, biotite, hornblende and opaque minerals are observed in the sample. Quartz occurs as very fine to fine grains of subrounded to angular shape. Feldspars occur as fine grains that are observed in different parts of the sample. Opaque minerals occur as very fine to fine-grained crystals, scattered in the sample. Some parts of the sample are stained by traces of iron oxides

Eight thin sections were prepared on marl limestone and Esna shale samples where KV57 was excavated. C. The micrograph shows that the marl sample from the first organ is very fine to fine grains. Large quantities of cavities and microvioletlets filled by recrystallized dolomite were observed in micritic calcite matrix. The rocks are highly grainy and consist mainly of calcite and dolomite as basic components associated with a small amount of clay minerals and rare quantities of microcrystalline quartz, iron oxides and harsh substances. Calcite represents the matrix of the rock and occurs in the form of very fine grains (micrites), from hydration to interlocking crystals below the surface. Dolomite forms very finely into fine-grained, uhedral crystals into subsurface crystals and fills in micro-nanoparticles and cavities. The quartz is revealed as fine-grained crystals spread throughout the matrix. Some pores of irregular shapes and different sizes are observed scattered in the rock. Some parts of the sample were stained with iron oxides, as shown in Fig. 19. C. The micrograph shows that the sample Esna shale is very fine to fine grains (mainly the size of sand), and has been well screened which is stabilized with small quantities of iron oxides, clay minerals and carbonates. The sample is porous as porous areas of different sizes are observed. The rock is mainly composed of quartz and feldspar grains that have been encrusted with small quantities of iron oxides, clay minerals and calcite. Rare amounts of muscovite, biotite, hornblende, and opaque minerals were observed in the sample. Quartz occurs as very fine sub-type grains of angular shape. Feldspar occurs as fine grains that are observed in different parts of the sample. Opaque minerals appear as fine-grained crystals spread throughout the sample. Some parts of the sample were stained with traces of iron oxides, as shown in Fig. 20.

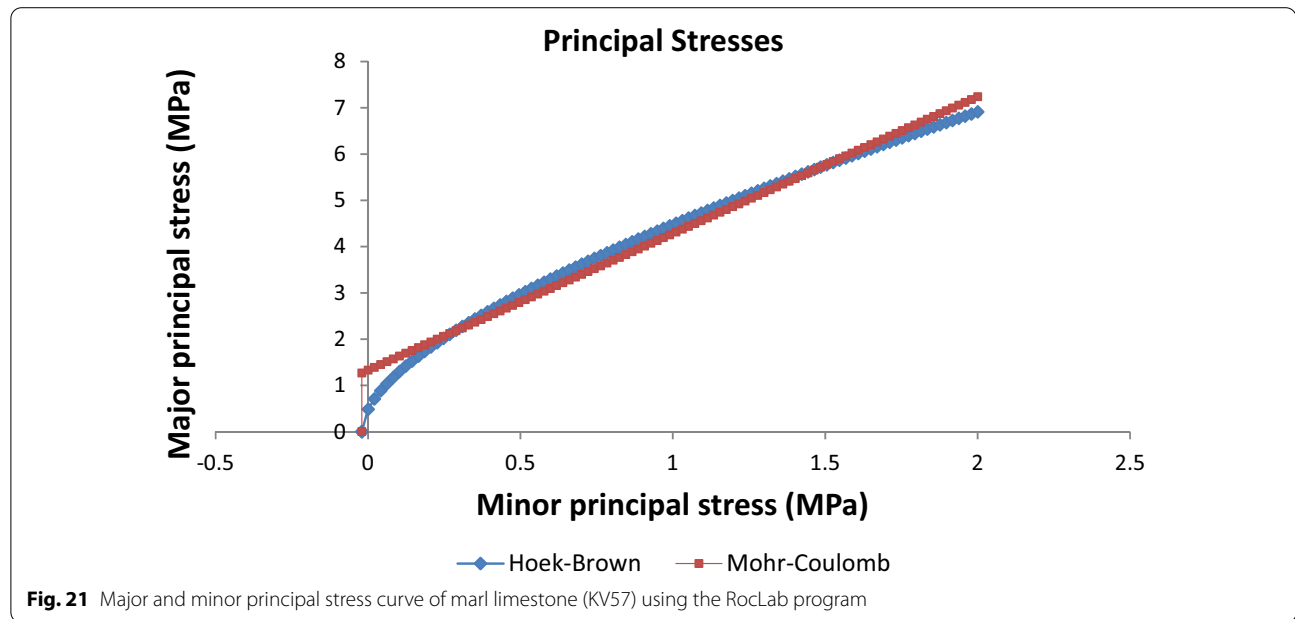
Fig. 21 Major and minor principal stress curve of marl limestone (KV57) using the RocLab program

Parameters of rock mass: tensile strength of intact rocks $\sigma_t = -0.016$ MPa, uniaxial compressive strength 800 kPa, as shown in Figs. 21 and 22. Table 9 summarizes the Hoek Brown, Hoek Brown Criterion, Failure Envelope Range, and Mohr-Coulomb Fit classification and rock mass parameters of the Marl 1 limestone member where the entrance to Horemheb's tomb (KV57) was excavated using RocLab software.

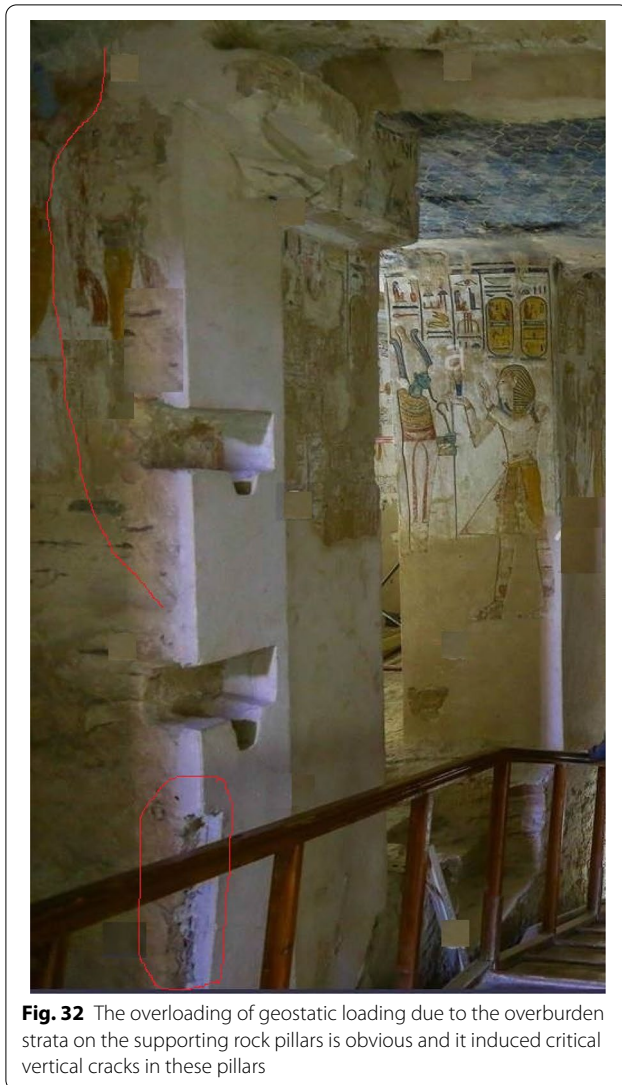
Fig. 32 The overloading of geostatic loading due to the overburden strata on the supporting rock pillars is obvious and it induced critical vertical cracks in these pillars

And the Factor of Safety $F.S = \frac{\sigma_p}{\sigma_{v^-}} = \frac{17}{17.4} = 0.97$ which very low and indicate to the dangerous and unsafe situation and losing of the structural function of these load bearing pillars. [23] quote Salamon and Munro,

Eq. 3, particularly in terms of long-term creep effects and associated strength loss or thinning-out of the effective load bearing pillars and section, [29] and [30], as shown in Fig. 32. In the original study of Salamon and Munro this occurred between safety factors of 1.3 to 1.9 with the mean being 1.6. This value was recommended for the design of production pillars in South African bord and pillar workings (Salamon and Munro, 1967), [31].
