Engineering failure analysis and design of support system for ancient Egyptian monuments in Valley of the Kings, Luxor, Egypt

Sayed Hemeda^{1,2}

Abstract

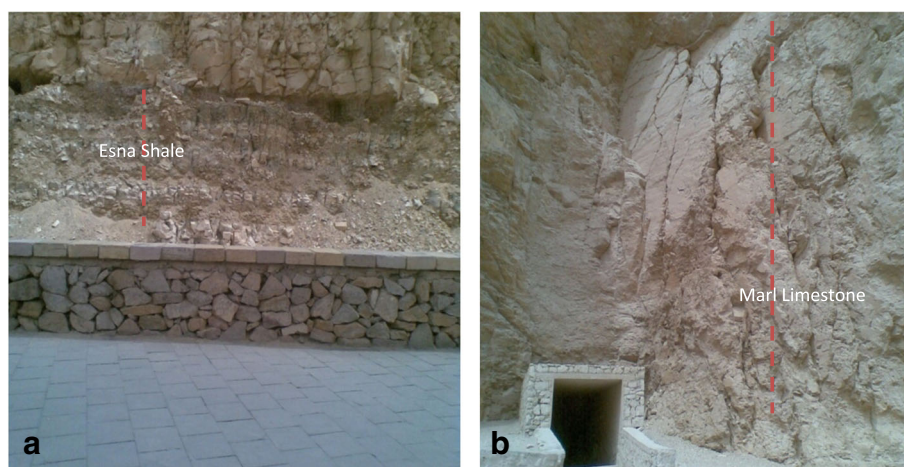
Fig. 4 a Esna Shale and **b** Marl Limestone (Member 1), Gebel El-Gurnah. The main exposed rocks in Gebel El-Gurnah are the Esna Shale (late Paleocene- Early Eocene) and the conformably overlying Thebes formation (Early Eocene)

are characteristic feature for the whole formation. The gypsum veinlets run mostly parallel to the bedding planes (Wüst and McLane 2000), as shown in Fig. 4a.

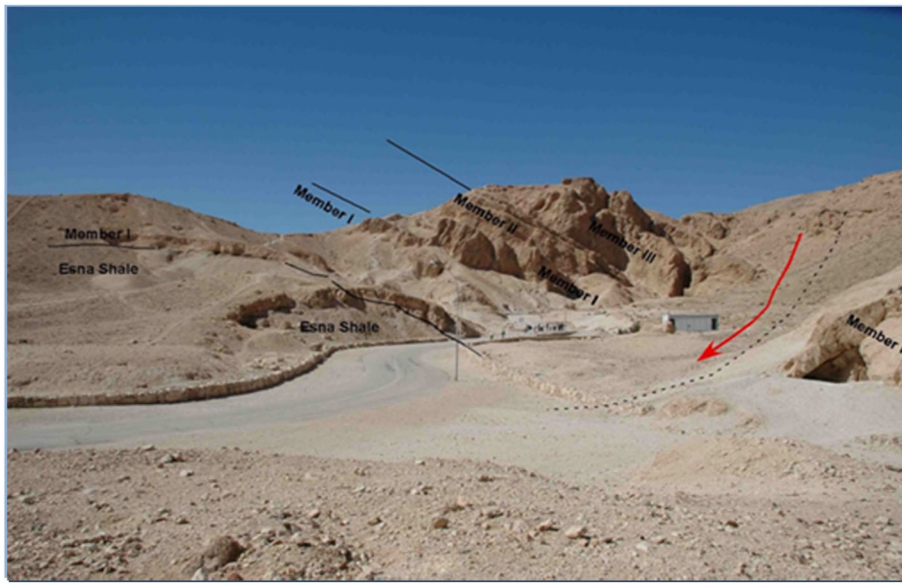
Fig. 7 Rock structures such as joints, bedding's characters of the Valley of the Kings (KV)

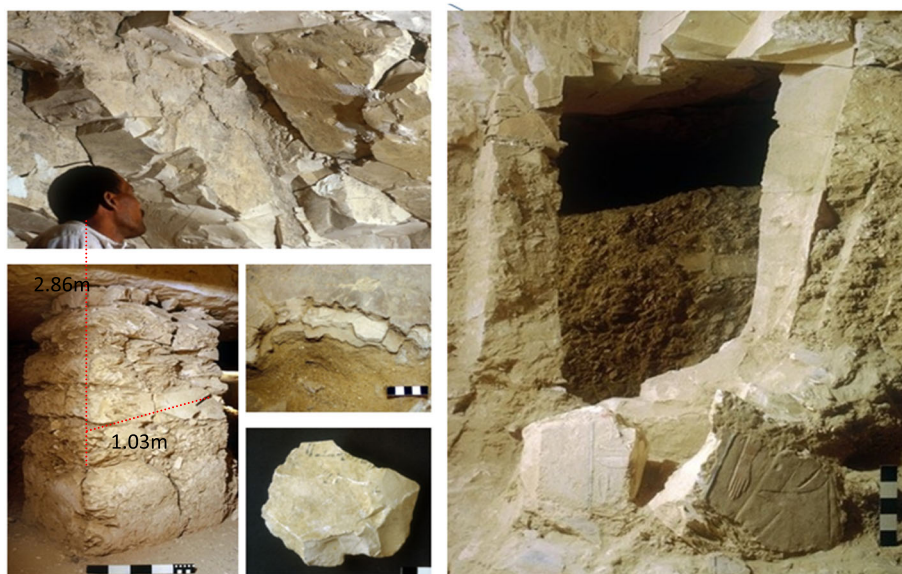
Fig. 8 Extensive structural damage in KV5. Engineering failure of the structural pillars, sidewalls and Ceiling of the Corridors and Chambers in the KV5 (<http://www.thebanmappingproject.com/>). Permission was granted by Weeks, K.R. © Theban Mapping Project 2006 to reuse this figure

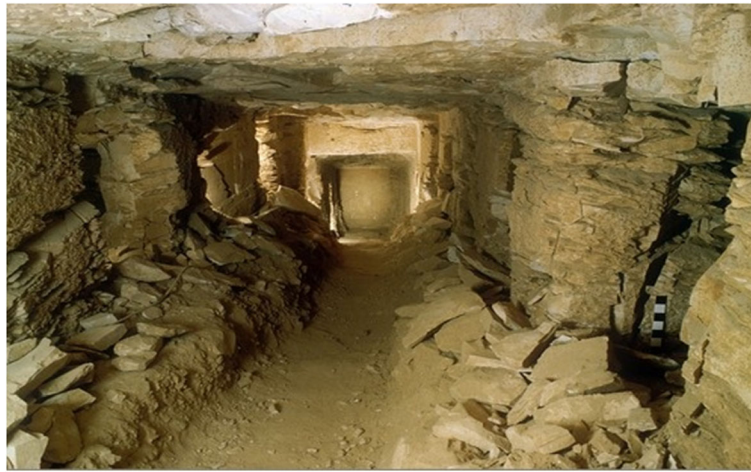
Fig. 9 Brittle rock, high stress conditions. Rockbursting (the sudden release of stored strain energy) bursts manifest themselves through sudden. (After TMP)

It is notice that In brittle rock, high stress conditions may lead to rock bursting (the sudden release of stored strain energy) bursts manifest themselves through sudden, as shown in Fig. 9.

11. Rock detachment and falls from the ceiling, as shown in Fig. 9.

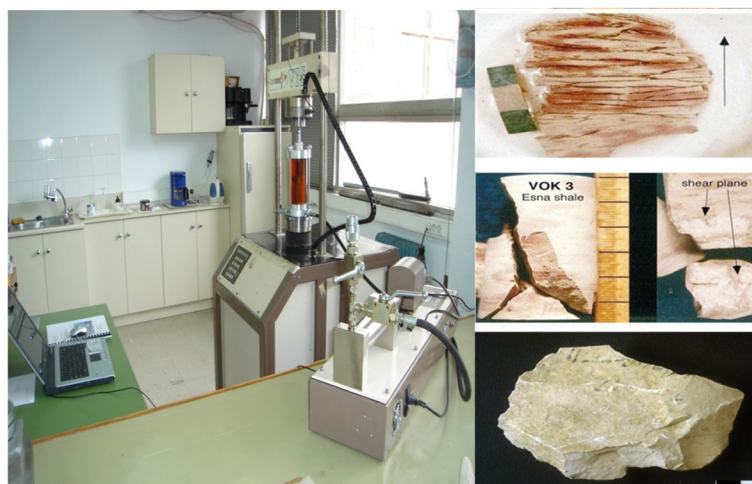
Fig. 10 Esna Shale and marl limestone samples under investigation

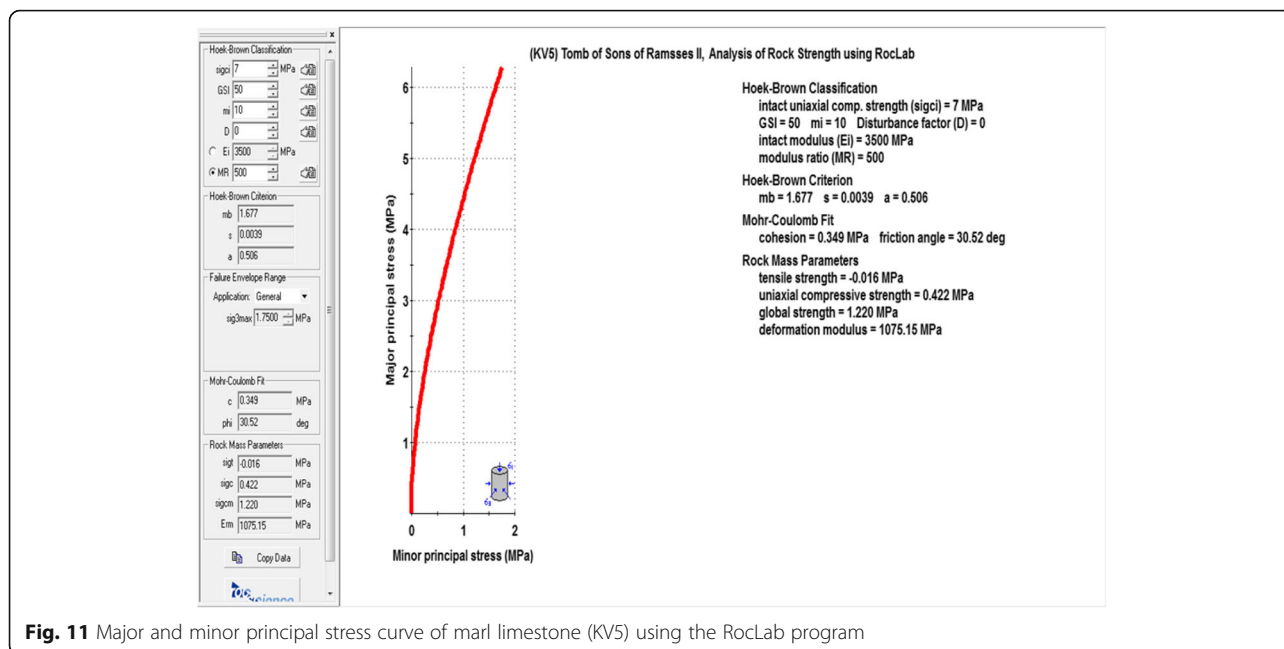
Fig. 11 Major and minor principal stress curve of marl limestone (KV5) using the RocLab program

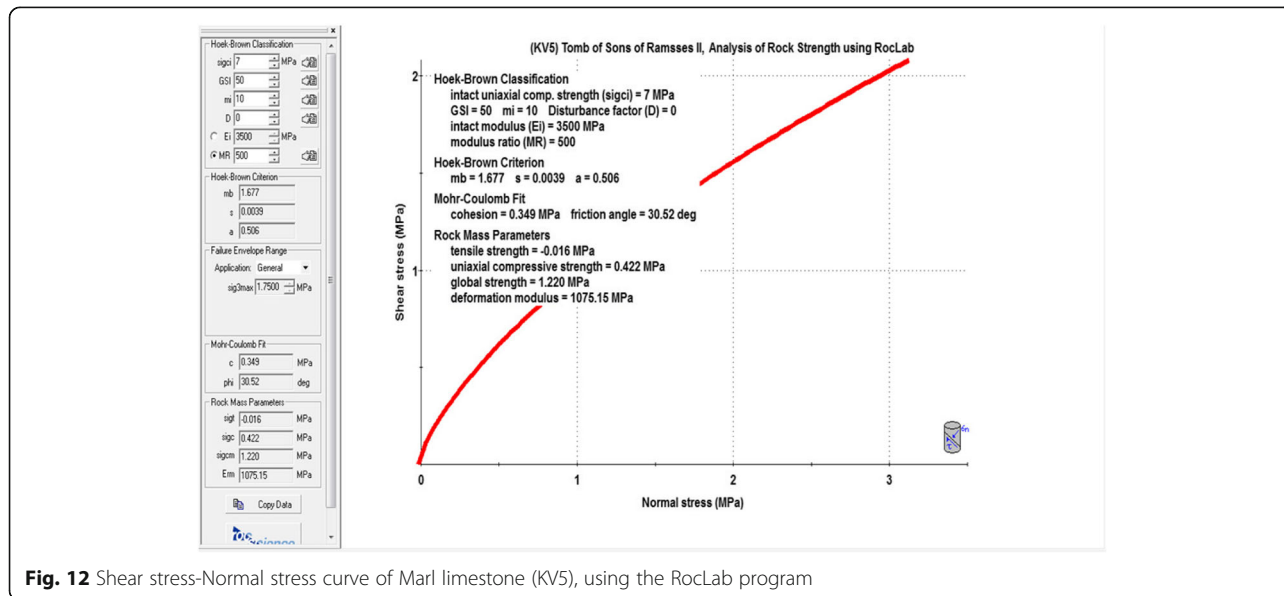
Fig. 12 Shear stress-Normal stress curve of Marl limestone (KV5), using the RocLab program

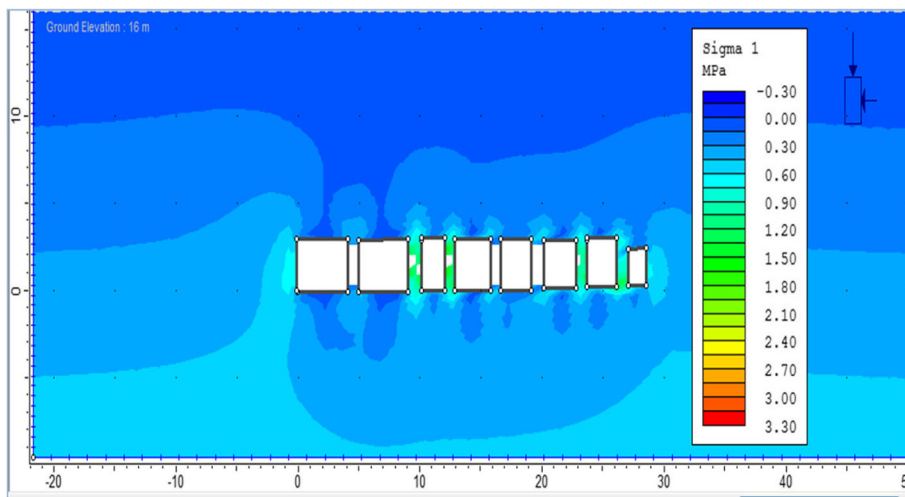
Fig. 13 Effective vertical stresses distribution through the rock pillars in Chamber 3. Examine 2D. All units of distance and depth in all figures are in meter

The results from the preliminary static analysis which are illustrated in Figs. 13, 14, 15, 16, 17, 18, 19 and 20 indicate that the maximum total displacements of the rock pillars in the large sixteen pillar chamber 3 were 1.2×10^{-4} m and the vertical

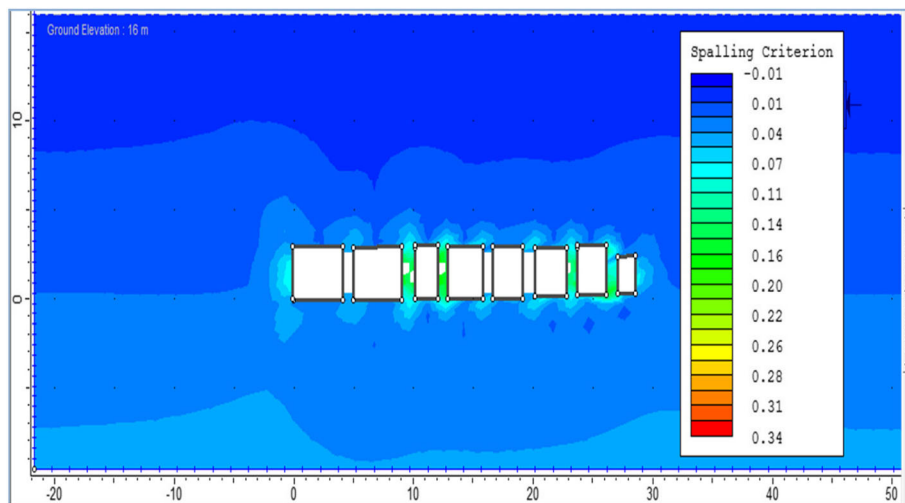
Fig. 14 Spalling Criterion through the rock pillars in Chamber 3. Examine 2D

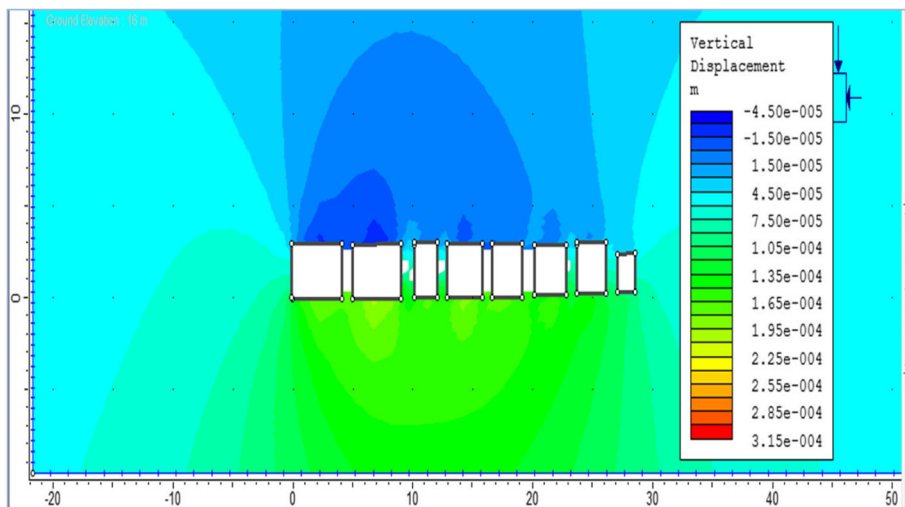
Fig. 15 Vertical displacement distribution through the rock pillars in Chamber 3. Examine 2D

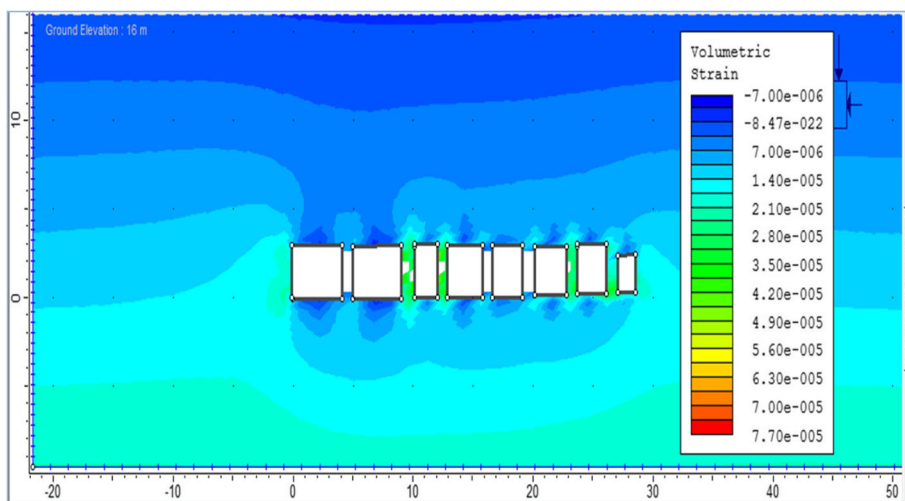
Fig. 16 Volumetric strain distribution through the rock pillars in Chamber 3. Examine 2D

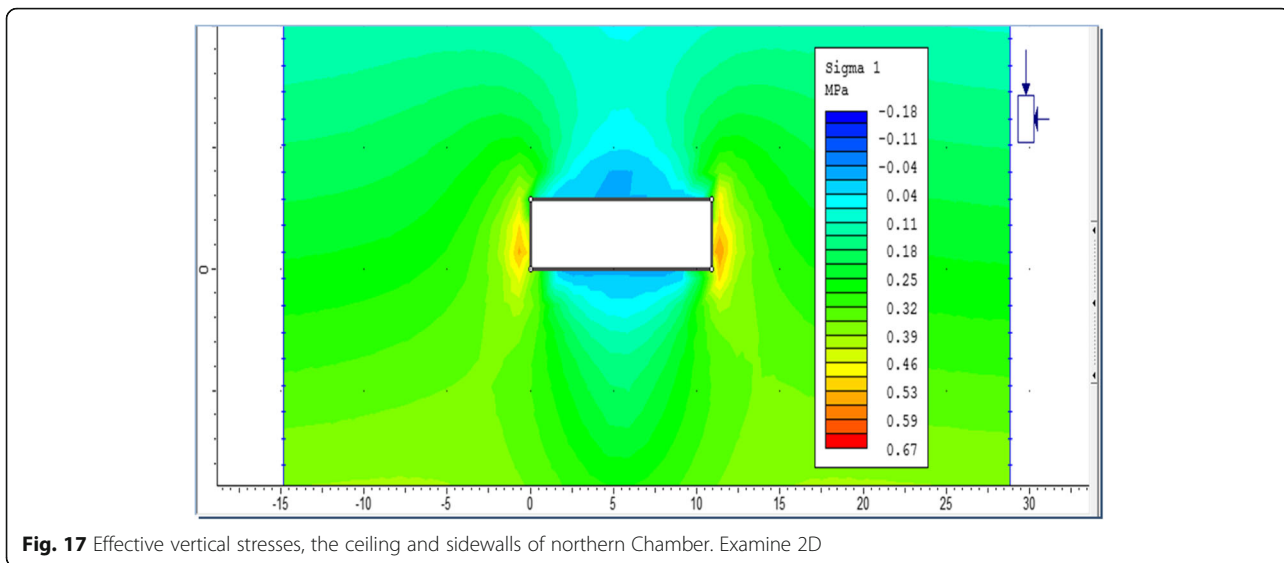
Fig. 17 Effective vertical stresses, the ceiling and sidewalls of northern Chamber. Examine 2D

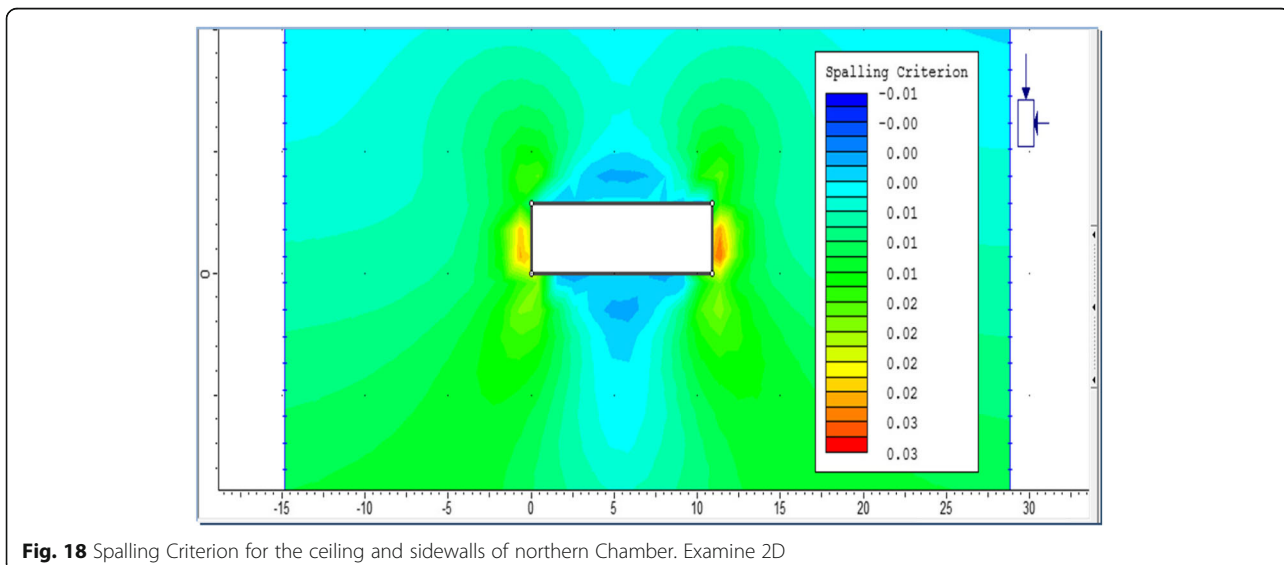
Fig. 18 Spalling Criterion for the ceiling and sidewalls of northern Chamber. Examine 2D

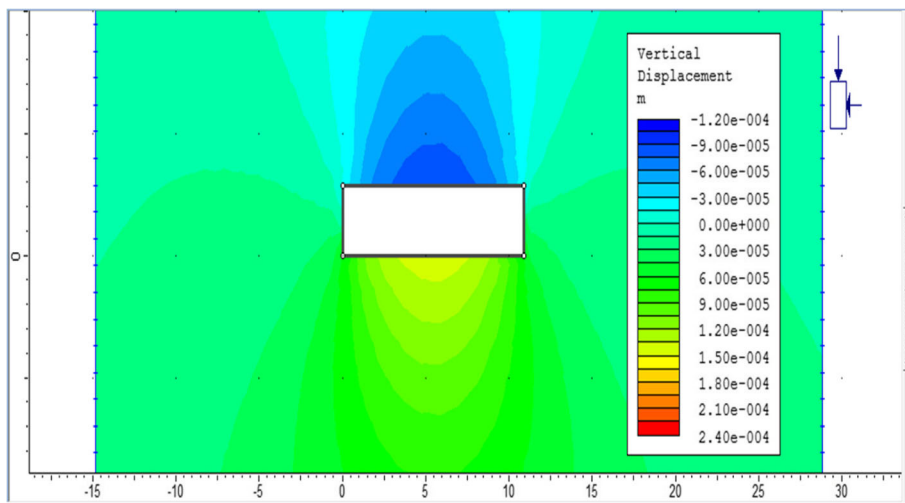
Fig. 19 Vertical displacement of the ceiling and sidewalls of northern Chamber. Examine 2D

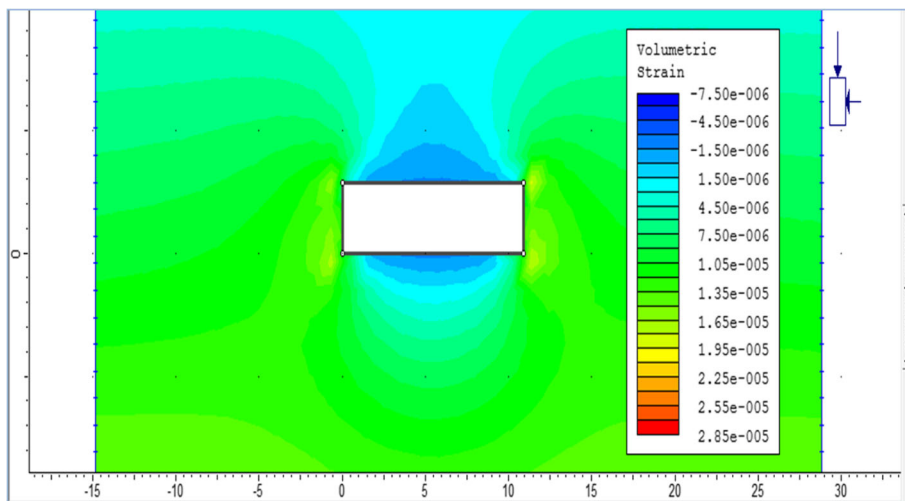
Fig. 20 Volumetric strains of the ceiling and sidewalls of northern Chamber. Examine 2D

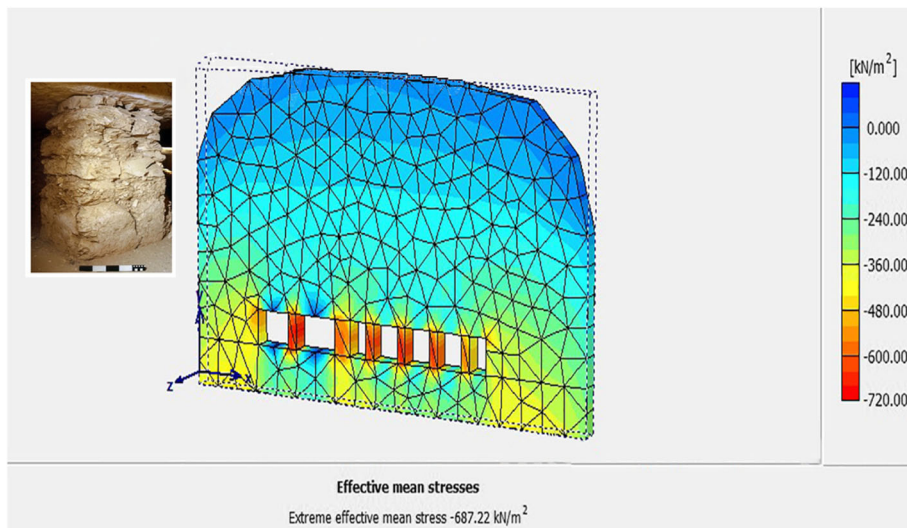
Fig. 21 Effective mean stresses distribution through the rock pillars in Chamber 3. PLAXIS 3D

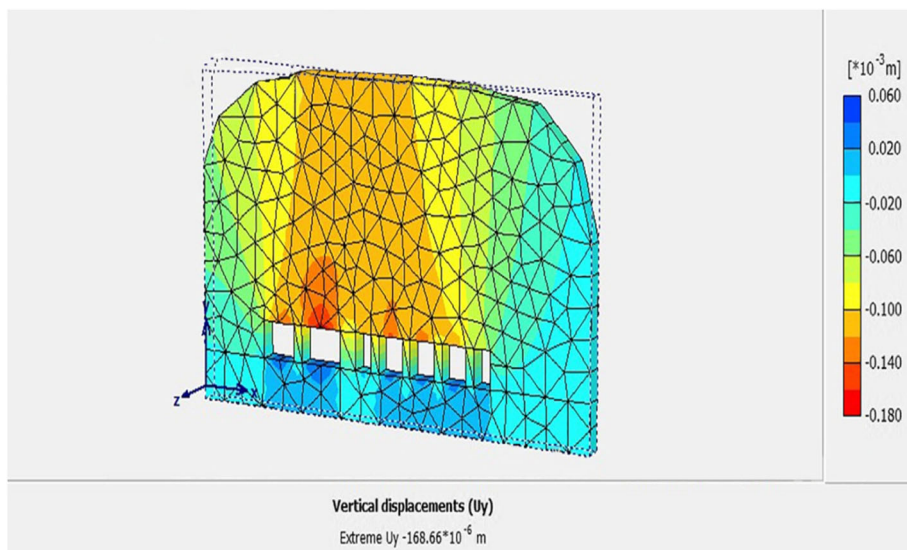
Fig. 22 Vertical displacements of the support rock pillars in Chamber 3. PLAXIS 3D

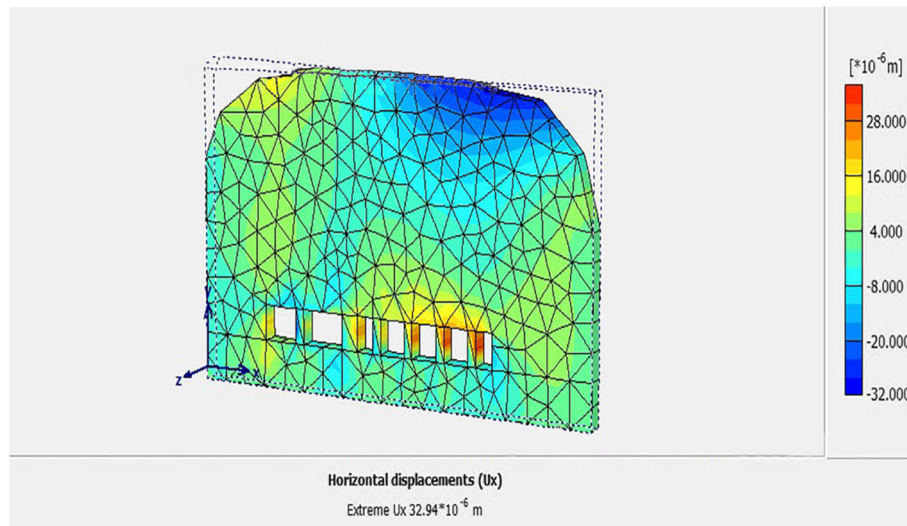
Fig. 23 Horizontal displacements of the support rock pillars in Chamber 3. PLAXIS 3D

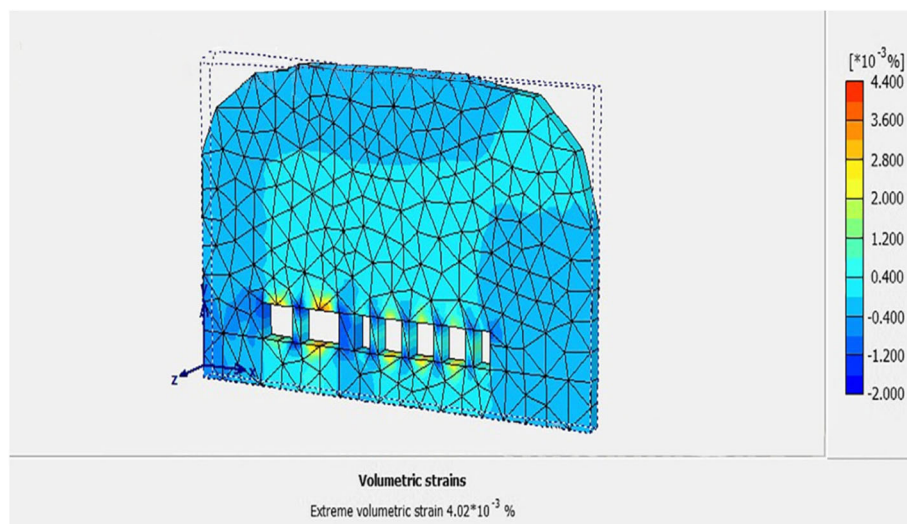
Fig. 24 Volumetric strains of the support rock pillars in Chamber 3. PLAXIS 3D

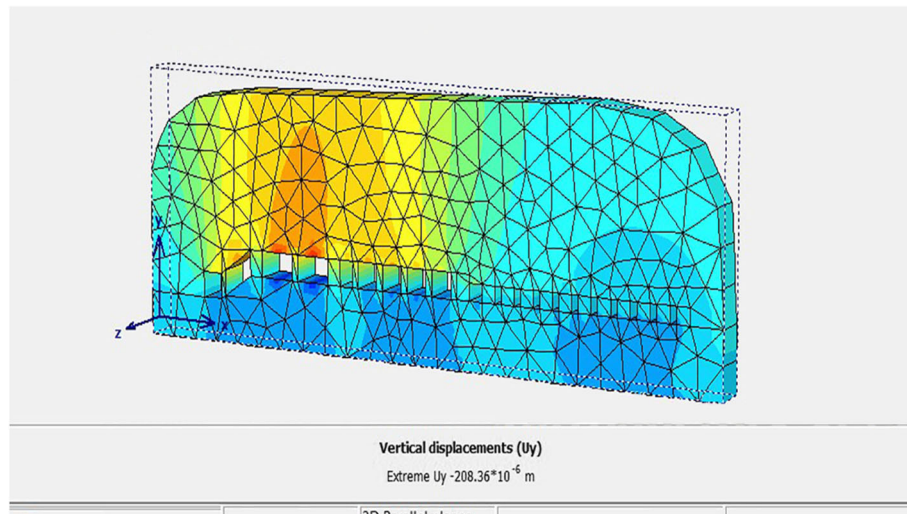
Fig. 25 Vertical displacement of rock pillars in Chamber 3 and others small burial chambers

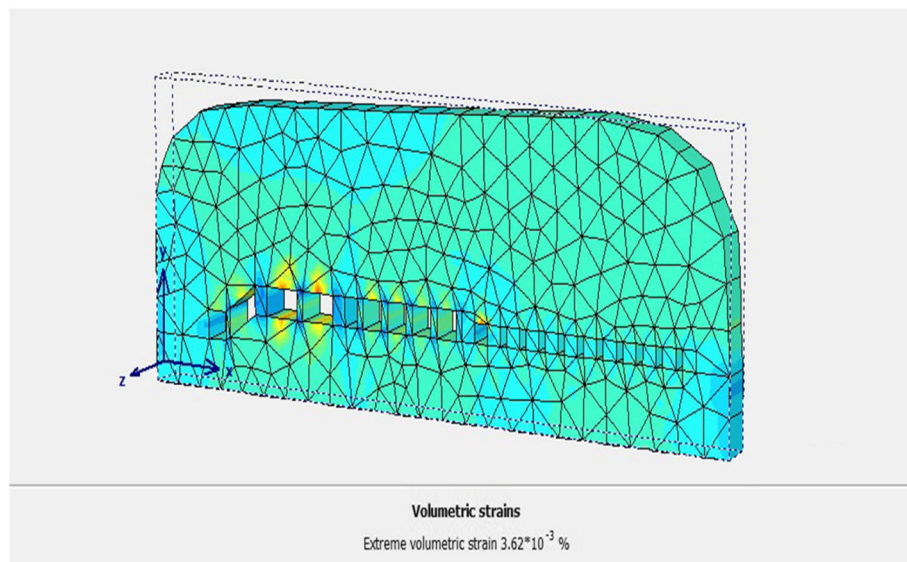
Fig. 26 Volumetric strains of rock pillars in Chamber 3 and others small burial chambers

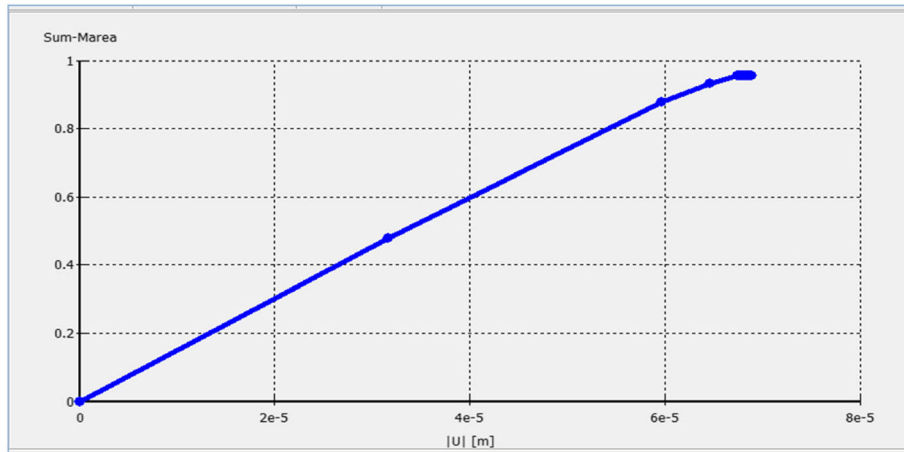
Fig. 27 Displacement progressive curve for the supported rock pillars in KV5

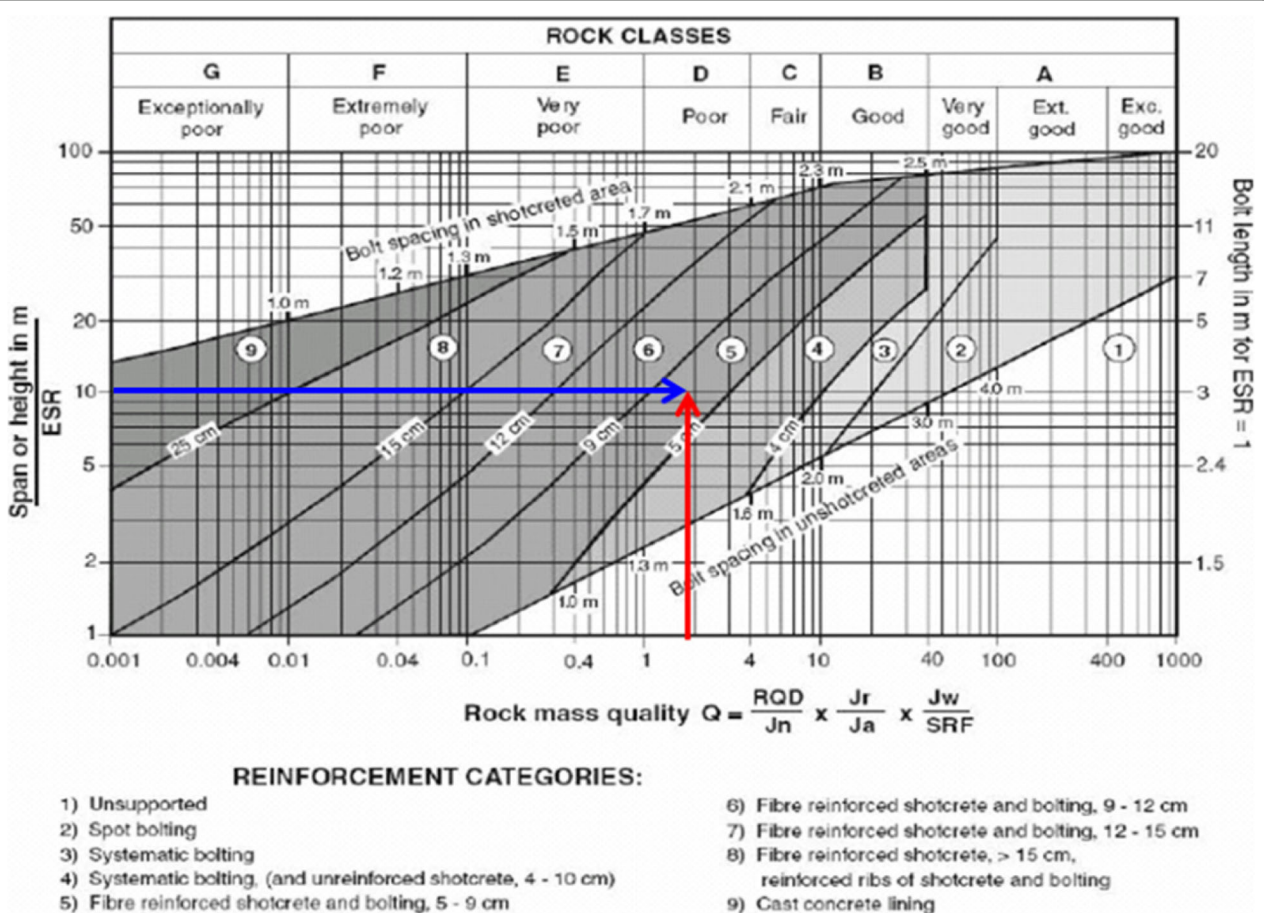
Fig. 28 Proposal support system for the (KV5) according to the Barton's Q-system

The value of De of 9.66 and value of Q of 1.87 places the tomb of sons of Ramses II in category (5) which require Fiber Reinforced Shotcrete and bolting

5–9 cm. Length of rockbolts with $L = 2+ (0.15B/ESR)$ and Maximum span (unsupported) = $2 ESR \times Q^{0.4}$ (Fig. 28). The strength properties of FRPs collectively make up one of the primary reasons for which select them in the strengthening and seismic retrofitting. A material’s strength is governed by its ability to sustain a load without excessive deformation or failure. Also it is recommended to use the Carbon FRP also nowadays we can use the advanced or Nano CFRP because of its good mechanical properties in particularly the compressive and tensile strength.

Systematic bolts with 4–5 m long, spaced 1–1.5 m in Crown and walls with wiremesh.100–150 mm in Crown and 100 mm insides with Light to medium ribs Spaced 1.5 m where required for strengthening retrofitting of the KV5. Also it is recommended to use Fiber Reinforced Shotcrete and bolting 5–9 cm. Length of rock bolts $L = 2+ (0.15B/ESR)$ and

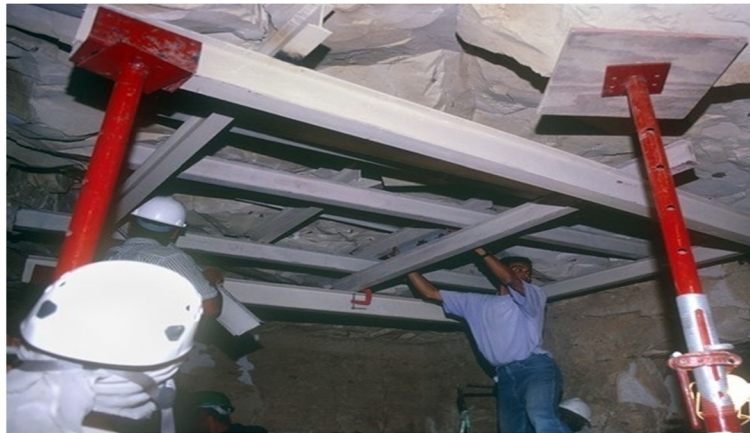
Fig. 29 Temporarily support system for the KV5, installed recently by the Theban Mapping Project. After TMP. Permission was granted by Weeks, K.R. © Theban Mapping Project 2006 to reuse this figure.

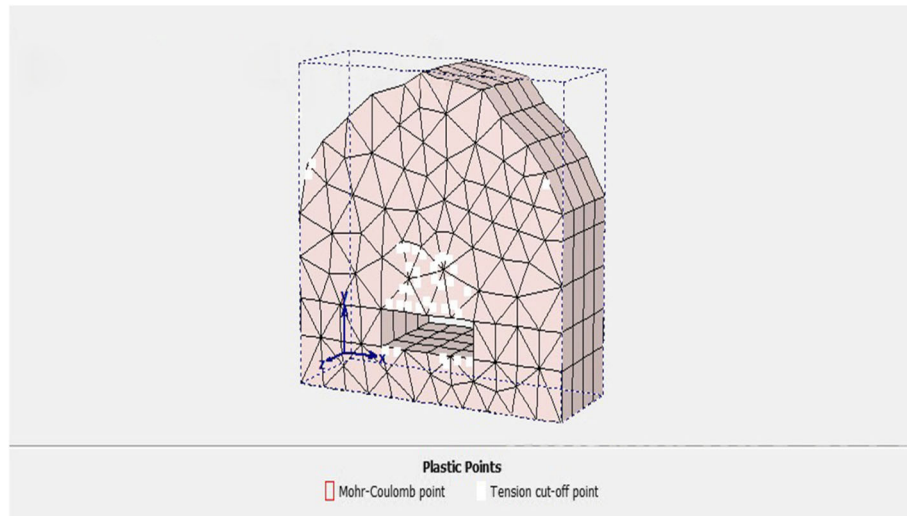
Fig. 31 Plastic Points in the ceiling and sidewalls of northern Chamber. PLAXIS 3D

and Chamber 2 reached 688 kPa, on the separate wall between them, the 2D model did not calculate it, and the maximum vertical displacement of the ceiling reached 0.18×10^{-3} m. as shown in Figs. 30, 31, 32 and 33.

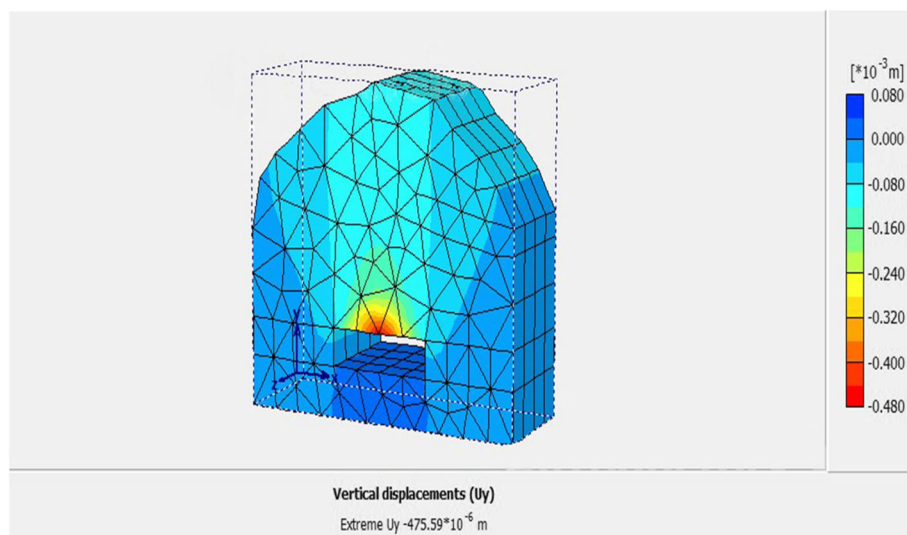
Fig. 32 Vertical displacement of the ceiling and sidewalls of northern Chamber. PLAXIS 3D

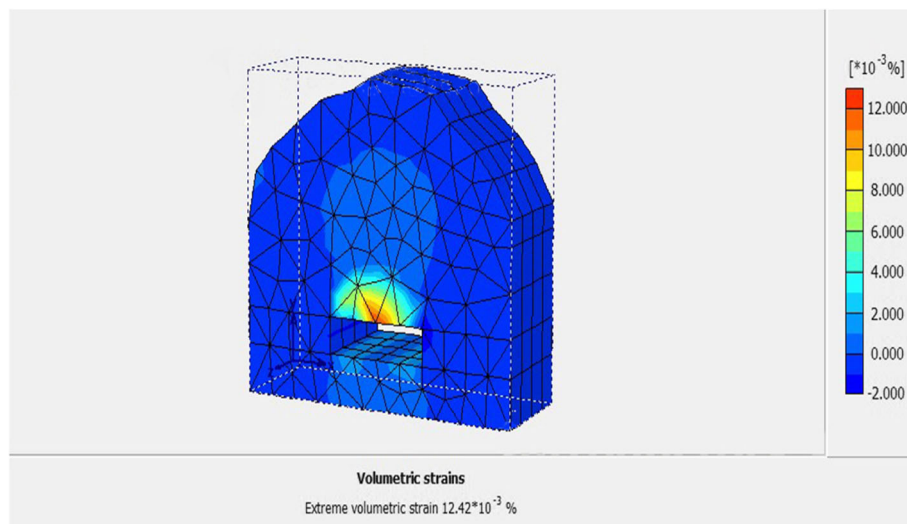
Fig. 33 Volumetric strains of the ceiling and sidewalls of northern Chamber. PLAXIS 3D

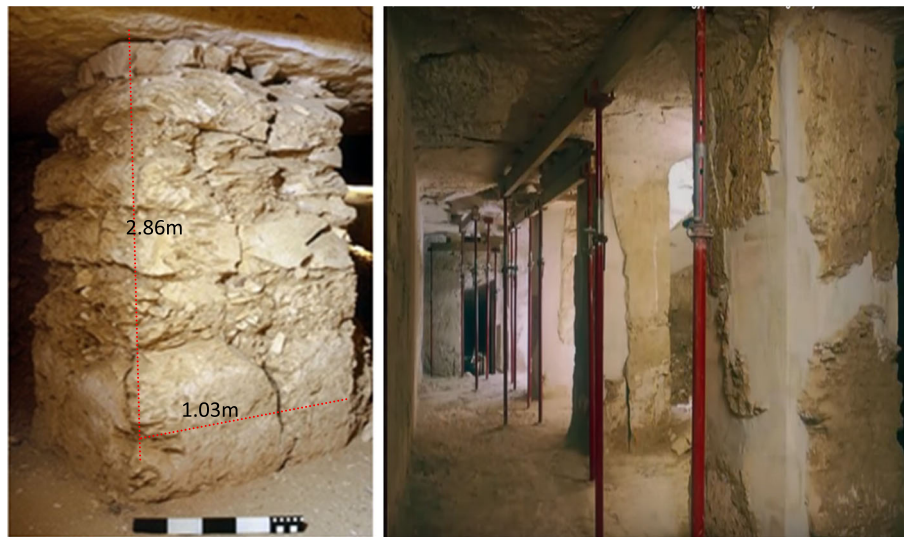
Fig. 35 Present state of the sixteen supporting rock pillars in the Chamber 3. which are structurally damaged. Vertical cracks due to the overloading and strength regression are obvious (<http://www.thebanmappingproject.com/>). Permission was granted by Weeks, K.R. © Theban Mapping Project 2006 to reuse this figure

10. The overloading of geostatic loading due to the overburden strata on the supporting rock pillars is obvious and it induced critical vertical cracks in these pillars also some sections have an overriding influence on the pillar stability, particularly in terms of long-term creep effects and associated strength loss or thinning-out of the effective load bearing pillars and section, as shown in Fig. 35.
