Experimental study on disaster mechanism of completely weathered granite landslide induced by extreme rainfall

Keywords Extreme rainfall, Completely weathered granite slope, Landslide model test

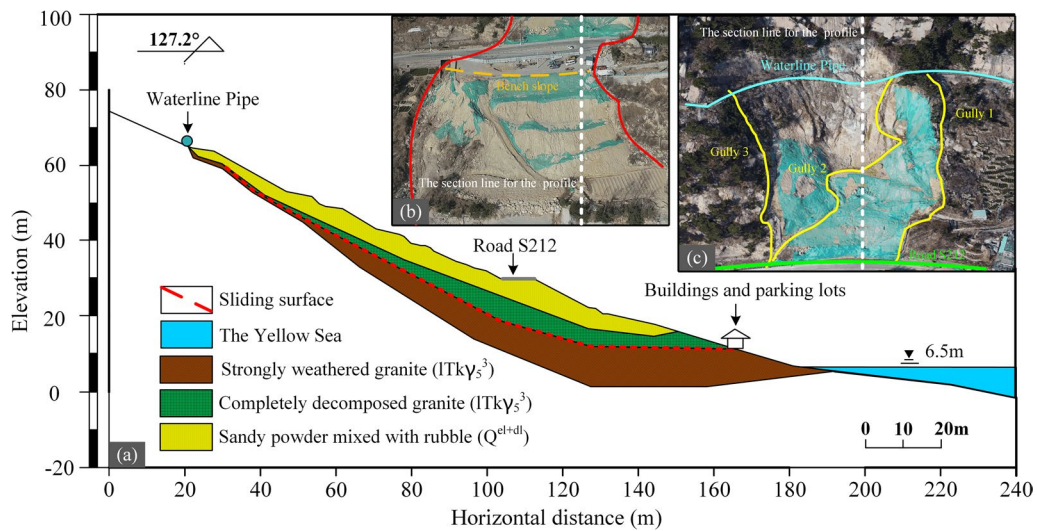
Fig. 3 a Schematic profile of landslide slope in 2020. b, c Overall view of slope

According to the field survey, the Fanling landslide is classified as a soil-like landslide, and the sliding surface is in the completely weathered granite zone (Fig. 3). With a

sliding mass covering a plane area of about $4.04 \times 10^4 \text{ m}^2$, 12 m thick on average, and about $48.48 \times 10^4 \text{ m}^3$ in volume, it is classified as a medium landslide. The front edge elevation is 3 to 5 m, 5 to 10 m from the sea surface. The rear edge elevation is 55 to 85 m, and the landslide width along the highway is 290 m. The overall slope of the landslide is steep, with an average gradient of 23° , and the slope direction and landslide direction are both 130° to 140° . The rear edge of the landslide is the boundary between bedrock and the Quaternary system, and the shear outlet is the boundary of the cataclastic deposit.

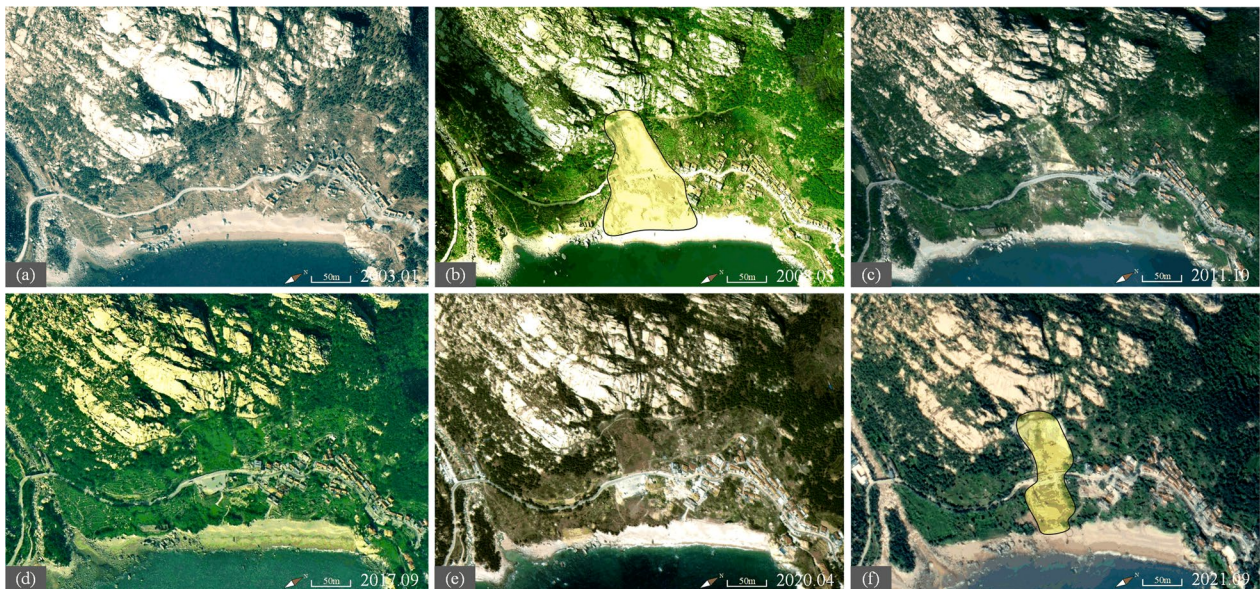
Fig. 4 Historical image map of landslide. **b** The shape of the first landslide occurred in August 2007 **f** The shape of the second landslide occurred in July 2020 (shot in September 2021). Others (**a, c, d, e**) are the historical image map of landslide in 2003, 2011, 2017 and April 2020

In August 2007, the research area was hit by a 50-year rainstorm, and the slope collapsed (Fig. 4b), causing one death and washing away nearly 150 m of road. On July 23, 2020, the landslide slipped again (Fig. 4f) during another heavy rain, burying the tourist road (S212) at the foot of the slope, destroying the parking lot on the east side of the tourist road along with three parked cars, but fortunately causing no casualty.

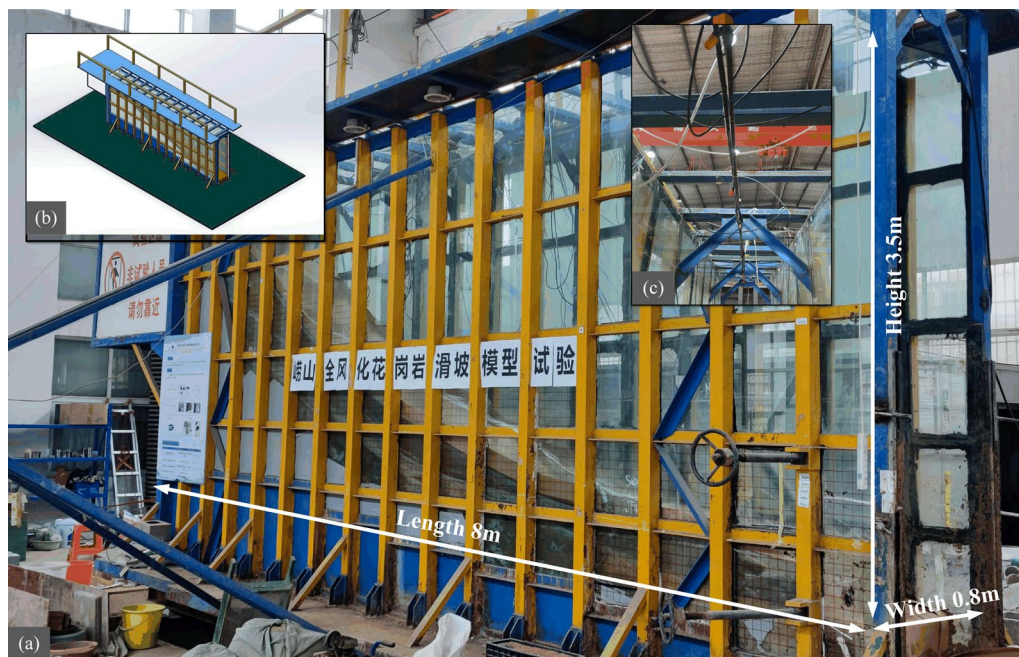
Fig. 6 **a**, **b** Model overview, **c** rainfall device

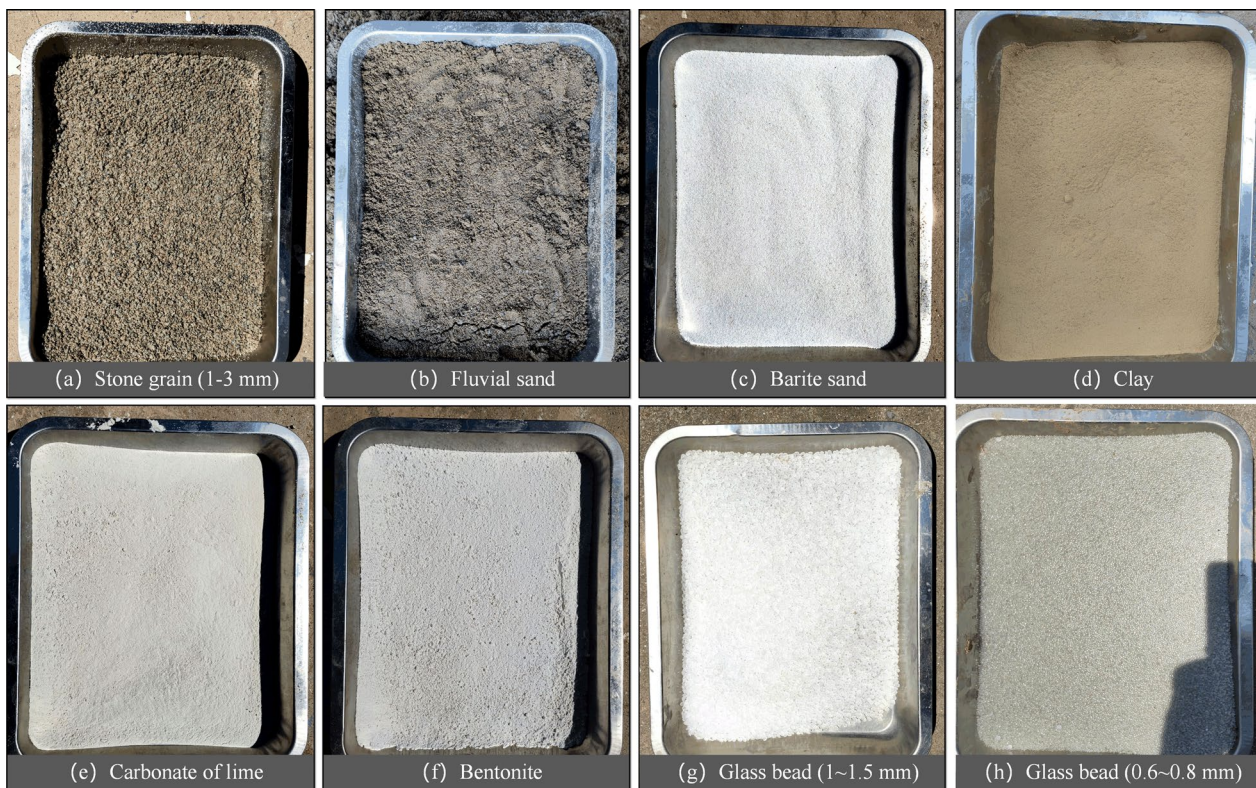
Fig.7 Landslide analogous materials

According to the field investigation and in-situ sample test, analogous materials were selected, as shown in Fig. 7. The proportions of analogous materials in the landslide physical model were determined, and the mechanical and hydraulic properties of the analogous materials were tested (Table 2).

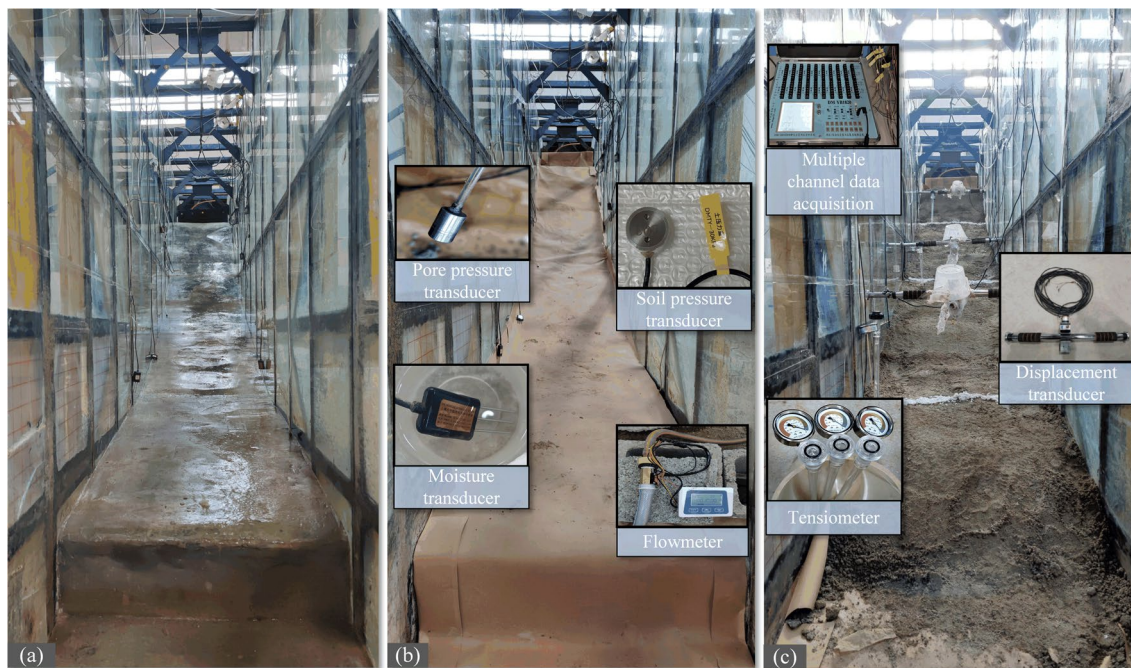
Fig. 8 Model building process **a** Sliding bed fabrication, **b** sliding surface production, **c** sliding body fabrication

After model material preparation with the benchmark mix proportion, the landslide physical model was constructed (Fig. 8).

- (1) The sliding bed was established. As the actual sliding bed was strongly weathered granite with very low permeability, C30 cement concrete was used to

build a right-angle wedge with a length of 7.84 m, a height of 2.46 m, and a slope of about 21° to simulate the impermeable strongly weathered granite layer, and the bottom layer was square bricks.

- (2) The sliding surface was laid. A layer of kraft paper ($c_m = 0.36$ kPa, $\phi_m = 26^\circ$) was first laid on the surface of the sliding bed. Then, a 1 to 2 cm soil layer of the sliding surface was laid from the rear edge of the landslide mass to the front edge in an imbricated manner. The layer was gradually thickened from the top to the toe of the slope. The thickness was determined using the grid lines on both sides of the model box, and the layer was compacted after laying.

- (3) The sliding body was established. According to the geological profile map of the main sliding surface, the thickness of the sliding mass was reduced year-on-year. The thickness of the model was determined using the grid lines on both sides of the model box. The sliding mass soil was quantitatively allocated, laid, and compacted in layers, finally forming a complete landslide model body.

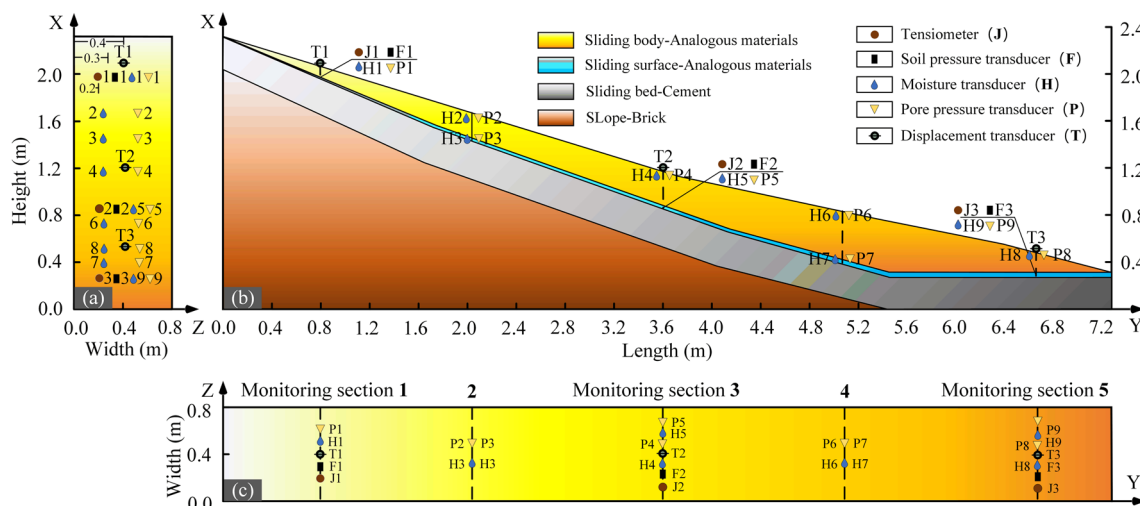
Fig. 9 Layout diagram of monitoring points

teristics of the landslide during rainfall in real-time and analyze the impact of soil and water characteristics on the landslide failure during rainfall. A variety of data acquisition instruments and automatic camera monitoring systems were adopted in the tests. Three main monitoring surfaces were arranged at the front, middle, and rear edges of the slope, and two auxiliary monitoring surfaces were arranged at the front and middle sections. Vertical displacement sensors, tensiometers, and earth pres-

sure sensors were embedded on the soil surface and soil bottom of the main monitoring surface. Pore water pressure sensors and moisture sensors were embedded on the soil surface and soil bottom of the main and auxiliary monitoring surfaces. Monitoring data were collected through automatic recorders. The arrangement is shown in Fig. 9.

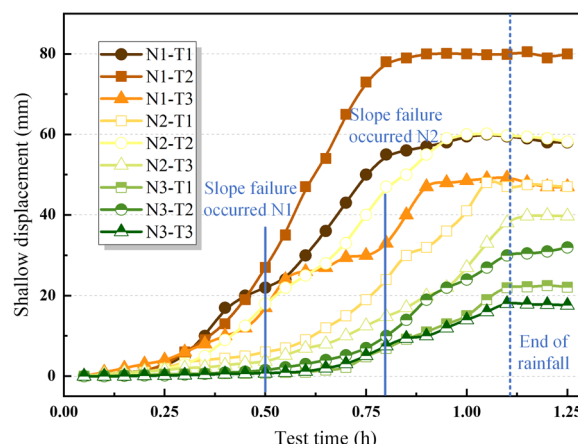
Fig. 10 Time history chart of surface displacement change under different rainfall intensity

Figure 10 shows the time history curve of each displacement monitoring point under different rainfall conditions to analyze the slope deformation during rainfall.

- (1) Under different rainfall intensities, the displacement change trend of each monitoring point was basically consistent. With the progress of rainfall, the rainwater infiltrated along the pores or microcracks, the physical strength of the landslide decreased, and the displacement began to increase. The slope underwent progressive deformation and failure. At the end of rainfall, the displacement reached the maximum and gradually stabilized. With higher rainfall intensities, the surface displacement was greater, and the time to reach the maximum was shorter. Under the 50-year rainfall (N1), the slope

was unstable at about 0.5 h, and the displacement reached the maximum for about 0.9 h. Under heavy rain (N2), the slope was unstable at about 0.8 h, and the displacement reached the maximum in 1.1 h. However, under rainstorm (N3), the slope displacement does not reach the maximum value at the end of rainfall.

- (2) Under different rainfall intensities, the surface deformation had a certain lagging effect due to the different rainfall infiltration rates. With greater rainfall intensities, the deformation lagging time was shorter. The lagging effect of working conditions 1 to 3 was 0.2 h, 0.3 h, and 0.6 h, respectively.
- (3) The spatial distribution pattern of deformation was analyzed. Under the same rainfall conditions, small deformation always appeared first at the foot of the slope before the rear and middle edges. When the slope was completely destroyed, the deformation rate of the middle edge decreased sharply, while the turning points of the deformation rates of the front and rear edges lagged behind. The middle edge (T2) had the largest deformation, followed by the trailing edge (T1), and the toe (T3) had the smallest deformation.

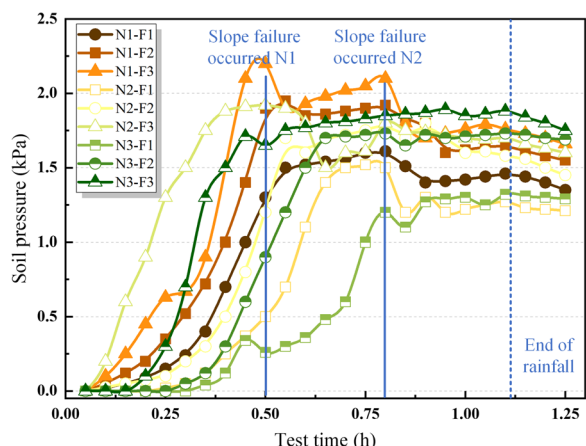
Fig. 11 Time history chart of soil pressure change under different rainfall intensity

Figure 11 shows the time history curves at each soil pressure monitoring point under different rainfall conditions to analyze the response process of soil pressure to rainfall infiltration.

- (1) The trends of soil pressure variation curves at each measuring point under different rainfall intensities were basically consistent and had good correspondence with the development of slope deformation and the change of pore water pressure. During rainfall, the soil mass was gradually saturated, the weight of the soil above the soil pressure sensors increased, and the soil pressure increased accordingly. Meanwhile, the slope surface expanded and shrunk, forming tension cracks acting as the dominant flow channels of rainwater infiltration, and further strengthening the seepage effect. After the rainfall, the water in the slope was discharged along the seepage channels, the soil weight decreased, and the soil pressure decreased slowly.

- (2) According to slope deformation pattern analysis, gradual failures occurred, and the stress redistribution led to sudden stress changes. With the appearance of local and overall failures, vertical tensile failures occurred in the soil mass, and the earth pressure dropped suddenly. The sudden earth pressure drops appeared at the foot of the slope first, and the vertical earth pressure at the middle and rear parts began to decrease immediately afterward.

- (3) Under greater rainfall intensities, the soil pressure changed faster due to water infiltration, and the trends were more apparent.

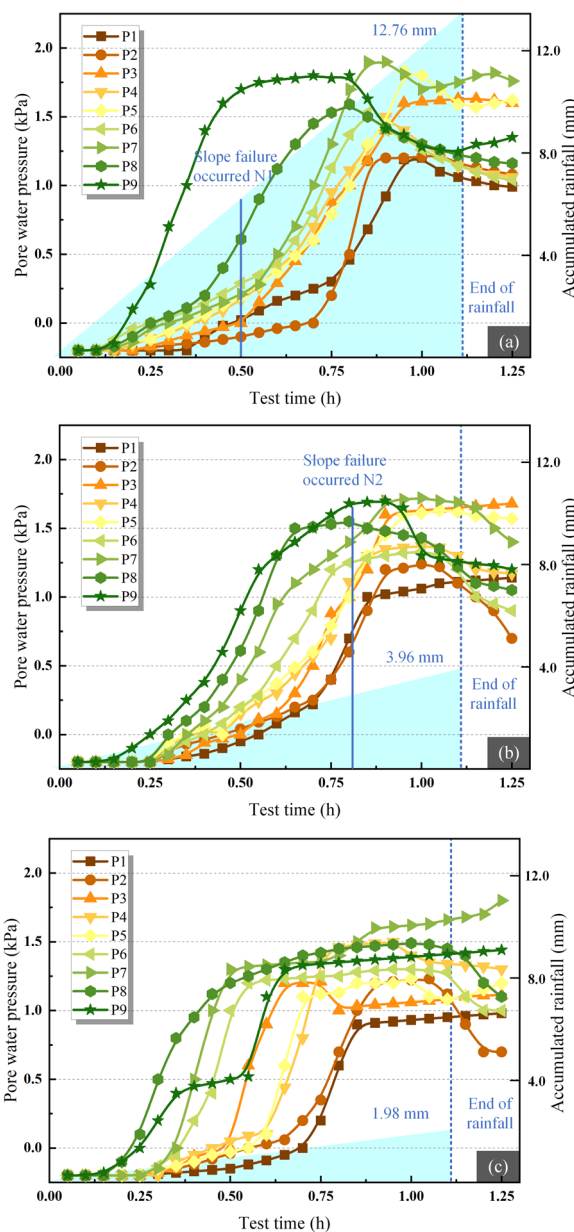
Fig. 12 Time history chart of pore water pressure change under different rainfall intensity **a** N1, **b** N2, **c** N3

Rainfall infiltration caused local saturation in the slope, changing the pore water pressure. Figure 12 shows the time history curves at each pore water pressure monitoring point under different rainfall conditions to analyze the response process of pore water pressure to rainfall infiltration.

- (1) The changes in pore water pressure trends at each measuring point under different rainfall intensities

are basically consistent, with slow increases first, rapid increases next, and rapid decreases at last. At the beginning of the test, the pore pressure at some measuring points was negative. To explain this phenomenon, the pore water pressure sensor was pumped saturated (24 h) before the test, and the pore pressure was set to 0 under the condition of saturation and no water pressure. At the beginning of the test, the liquid–air interface between soil particles in unsaturated soil is a curved surface, and there is matrix suction. The theoretical expression of matrix suction is

- (2) In terms of spatial pattern, the pore water pressure changes in different parts of the landslide at the same depth were different. The response time of the front edge (P8, P9) and middle part (P4, P5, P6, P7) of the landslide were short as the rainwater accumulated in the front and middle of the landslide, forming the groundwater level, and the pore pressure accumulated first.
- (3) At the same monitoring profile, the variation of pore water pressure at different depths was also different. The variation history of water pressure in the shallow soil mass of the slope was closely related to the water seepage in the vertical cracks. The pore pressure variation range of the slope surface (P2,

P4, P6, P8) was greater than that of the internal (P1, P3, P5, P7, P9). After the rainfall, the surface pore pressure decreased rapidly while the internal pore pressure continued to rise, with a hysteresis effect.

- (4) In addition, higher rainfall intensities led to higher infiltration rates, greater seepage effects, and shorter soil saturation time, shortening the pore pressure response time and increasing the change rate.

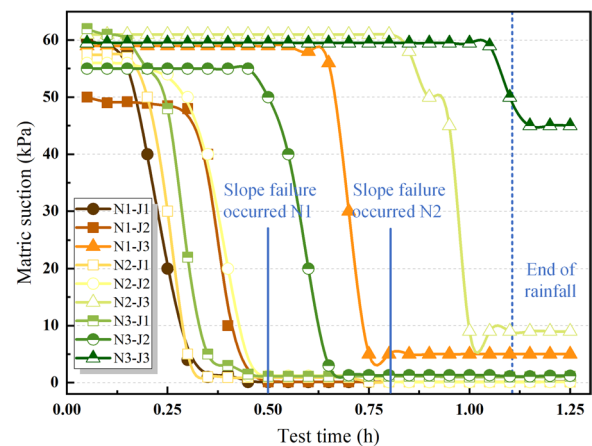
Fig. 14 Time history chart of matric suction change under different rainfall intensity

Figure 14 shows the time history curves of each water content monitoring point under different rainfall conditions. The response pattern of matrix suction to rainfall infiltration was similar to that of water content.

- (1) The matric suction changed from stable to decreasing and then stabilizing with the rainfall. The response time of matrix suction and volume water content at the measuring point was relatively consistent, showing a negative correlation, i.e., the matrix suction decreased with the increase of volume water content. As the volume water content at the measuring point reached saturation, the matrix suction dissipated to 0 kPa.
- (2) The matric suction at the top of the slope showed the fastest changes, followed by the middle of the slope, and the bottom responded the slowest. The matrix suction change rate increased with the increase in rainfall intensity.

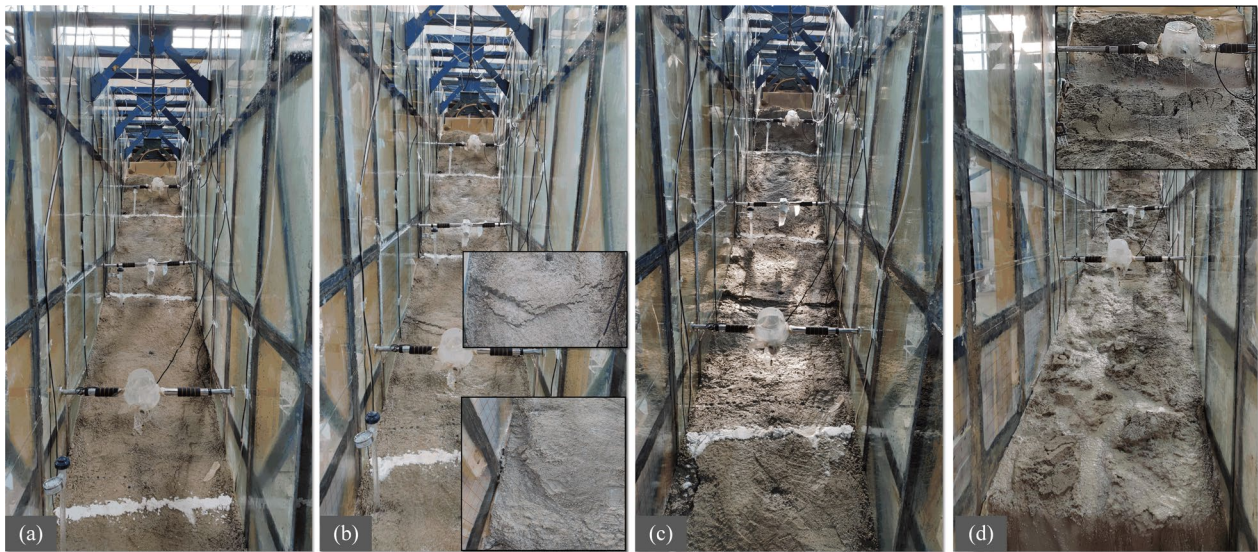
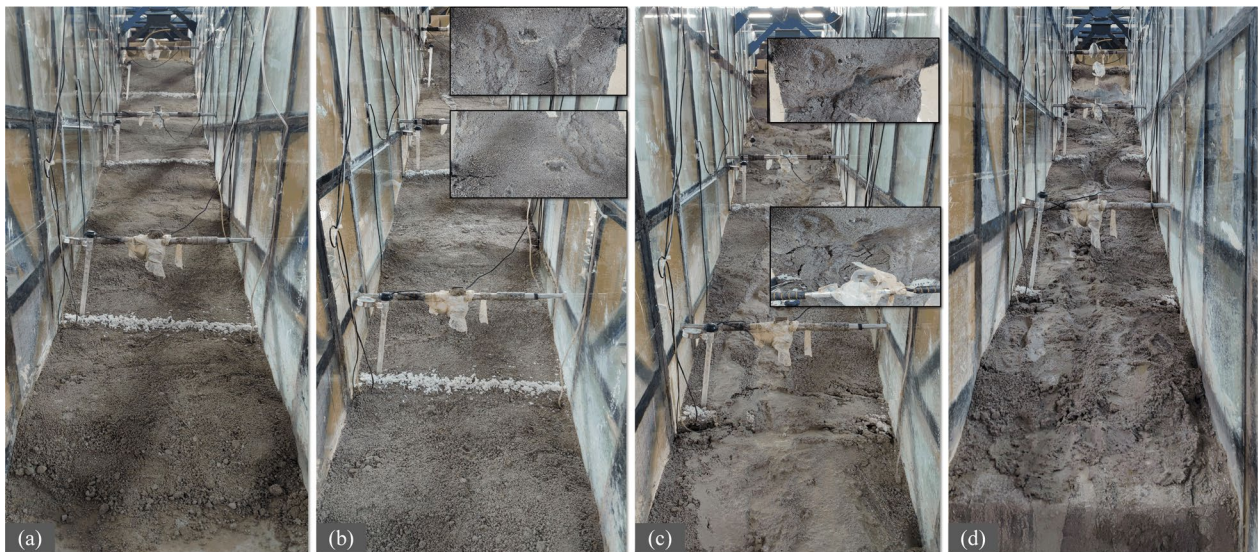
Fig. 15 Landslide deformation process under condition N1 **a** 0.1 h, **b** 0.3 h, **c** 0.5 h, **d** 0.9 h

Fig. 16 Landslide deformation process under condition N2 **a** 0.1 h, **b** 0.3 h, **c** 0.9 h, **d** 1.1 h

Figures 15 and 16 show the landslide deformation processes under conditions N1 and N2, respectively. According to the model test results and the responses of each parameter to rainfall infiltration, the failure process of completely weathered granite induced by rainfall can be divided into four stages shown in Fig. 17.
