The use of transverse connectors as reinforcement of multi-leaf walls

Marco Corradi · Antonio Borri · Elena Poverello · Giulio Castori

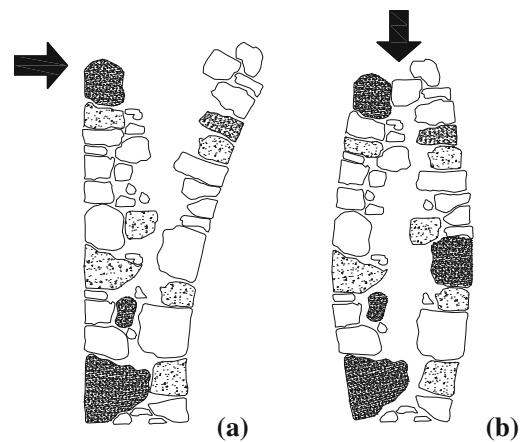
Fig. 1 **a** Failure mechanism of a double-leaf wall panel subjected to a *horizontal load*. **b** Failure mechanism of a panel subjected to a *compression vertical load*

Since the out-of-plane behavior of masonry structures is mainly governed by simple boundary conditions and rotational equilibrium equations, previous research on the analysis of the mechanical properties of the masonry material supplemented by numerical models and laboratory studies, has limited relevance: masonry mechanical parameters (shear and compressive strengths, elastic moduli) do not govern the overall out-of-plane behavior of a slender masonry wall panel. For example the application of a vertical compressive load may have a positive effect on the out-of-plane behavior since it stabilizes the wall. For a multi-leaf wall, the out-of-plane mechanism often involves the external (outdoor) unconfined masonry leaf being vulnerable to horizontal actions (Fig. 1).

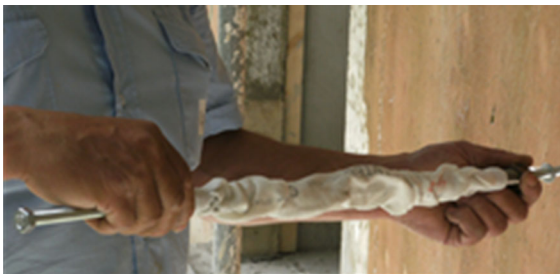
Fig. 2 The steel rod connector with fabric sleeve before grout injection

The strengthening system consisted in a SAE 304 (or AISI 304) stainless steel rod inserted in a fabric sleeve (Fig. 2). Wall panels were drilled from one side only with full-thickness holes. A diamond core drill bit was used to remove a cylinder of existing masonry material. Connectors were made of a solid stainless steel rod, with a diameter of 12, 16 or 20 mm, encased in a fabric sleeve injected with a cement-based grout. The choice of rod diameter depended on many factors like the magnitudes of the acting loads, the wall's thickness and on the quality of the masonry material.

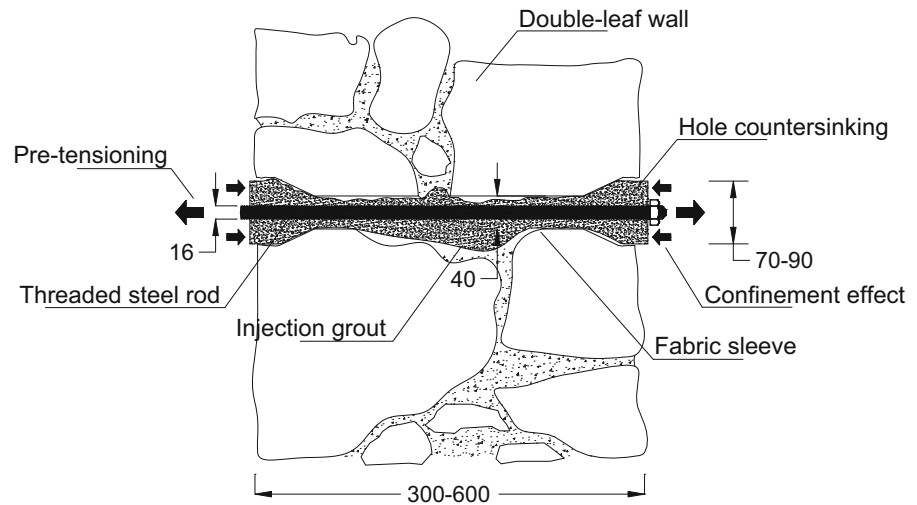
Fig. 3 Detail of the 16 mm-diameter connector (dimensions in mm)

90% greater than the diameter of the hole. Installation of the rod into the core-drilled hole (Fig. 3) was also followed by a pre-tensioning operation up to 10–20% of the rod yielding strength. Finally, the fabric sleeve was injected in pressure (2.5–5 atm, depending on the quality of the masonry material) using a high-strength ready-to-use cement-based grout. The effect of pre-tensioning and countersinking produced a confinement of the masonry material and increased the level of connection between wall leaves (Fig. 3). The fabric sleeve avoided unexpected scattering and wastefulness of the grout between the masonry. Thanks to its flexibility, it could expand, moulding itself into the shape and voids within the walls, providing mechanical bond. Although the use of cement is generally detrimental in heritage structures due to its scarce compatibility with historic masonry, the cement-based grout provided by the producer was still used here for the tests. In fact, the fabric sleeve encasing the anchor did not allow the cement-based grout to spread freely within the masonry, thus largely limiting the used quantity. The grout's mechanical and thixotropic properties and its low porosity also guaranteed the needed characteristics for the transmission of the loads between the masonry leaves.

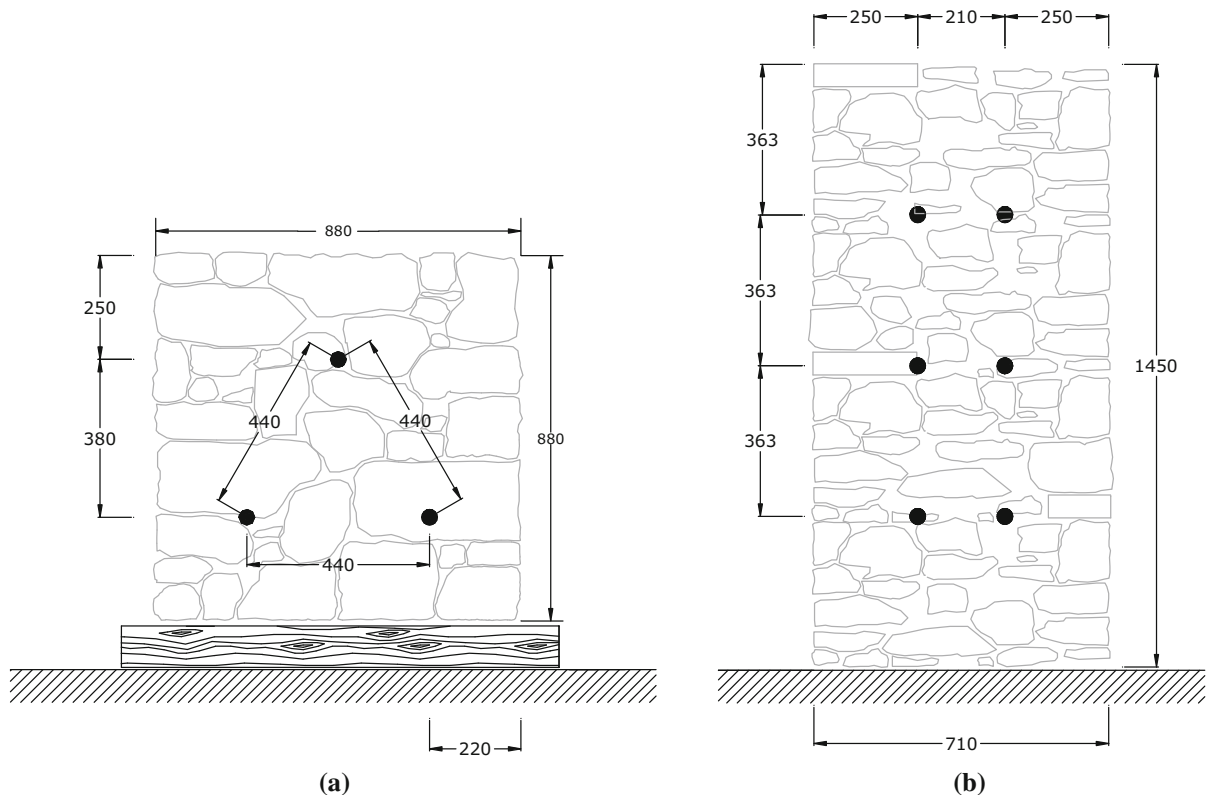
Fig. 5 Arrangement of connectors: **a** shear test. **b** Compression test (dimensions in mm)

reinforced according to the same arrangement used to repair Panel No. 3 (Fig. 5b).

The application of three transverse connectors (Fig. 5a) produced an interesting effect both in terms of load and deformation capacity: Panel 2Rf has been tested after being retrofitted and a compressive maximum load P_{\max} of 109.43 kN was recorded (Table 3). This is an increment of 3.21 compared to the load capacity of the unreinforced panel (Panel 1Un). The leaf response in terms of vertical and horizontal deflections was more symmetric and the difference between leaf deflections at failure was approx. only 15%.

Panel 3 was also repaired by the application of 6 traverse connectors and tested again (Panel 3Rp) (Fig. 5b). The capacity of the panel increased to 91.1 kN and a compression stress of 0.583 MPa was

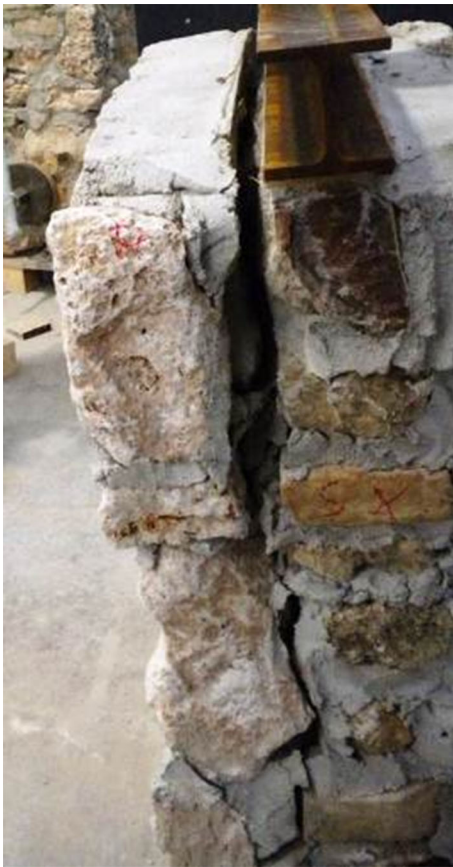
**Fig. 7** Failure mode (unreinforced panel)

Results of unreinforced Panel 1Un clearly demonstrated that the vertical planes between masonry leaves were critical for the overall behavior of a triple-leaf wall. Mechanical interlocking was not able to prevent the separation between masonry leaves. A maximum compression load P_{\max} of 34.11 kN was recorded (Table 3). Failure was by splitting of the inner rubble core from one of the two external wall leaves. The failure occurred progressively in a non-brittle manner: a vertical crack opened near the point of application of the load and propagated toward the wall base (Fig. 7).

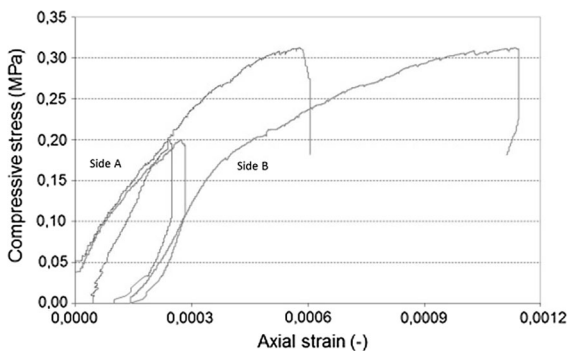
Fig. 9 Stress versus axial strain of masonry leaves for unreinforced panel 3Un

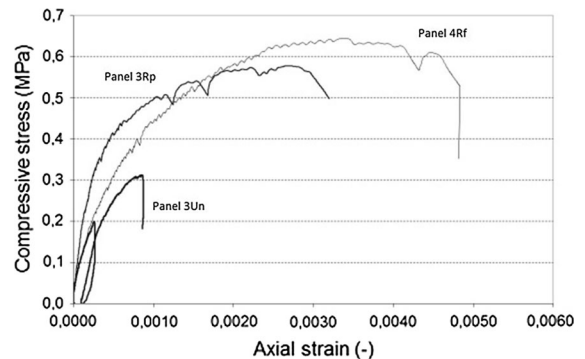
Fig. 10 Stress versus axial strain: comparison between the three compression tests

calculated (Fig. 10). For this second test, vertical cracks mainly appeared on the leaf’s surface highlighting a more-likely compressive failure. Scattering of vertical strains between wall leaves highly reduced indicating a monolithic behavior of the wall.

in terms of compressive stress) was reached (Fig. 10). This was more than 108% greater compared to the control unreinforced wall panel. Again the failure occurred for the formation of vertical cracks on the leaf’s surface. The analysis of the vertical deformations clearly showed the similar behavior between the two masonry leaves. For test on Panel 3Rp the magnitudes of the vertical strain at maximum load were 0.0030 and 0.0023, for side A and B, respectively (with a ratio between the strain values of 1.3). For test on Panel 4Rf this ratio was only 1.03.

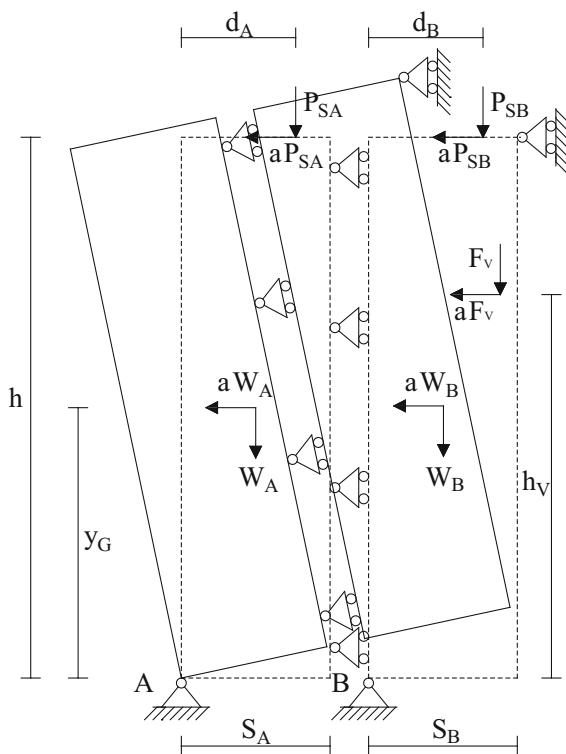
Fig. 11 Behavior of an unreinforced double-leaf wall

For a double-leaf wall (Fig. 11), by assuming a frictionless surface between adjacent masonry leaves (no mechanical interlocking or chemical bonding), the lower bound of the collapse-load factor a is:
