## Erratum to: Meso-scale analysis on shear failure characteristics of asphalt–aggregate interface

**Erratum to: Materials and Structures (2017) 50:209**  
**DOI 10.1617/s11527-017-1075-x**

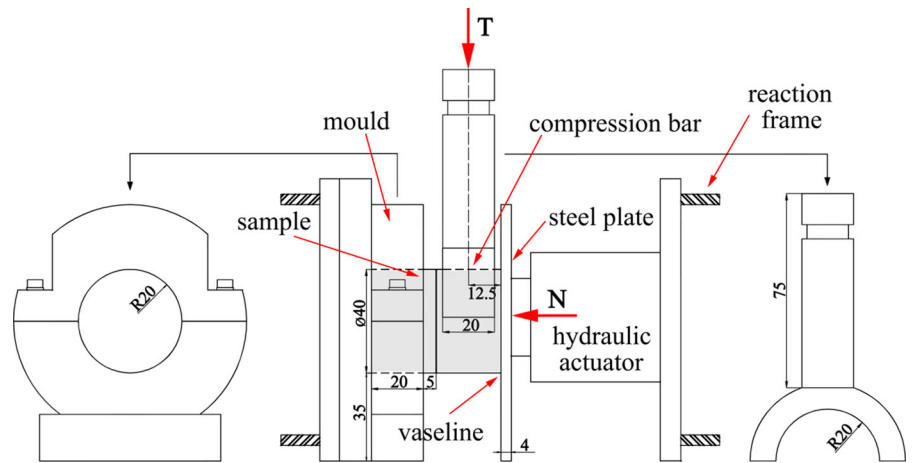
**Fig. 3** Direct shear test apparatus (dimensions in mm)

Due to an unfortunate turn of events, this article was published with an erroneous version of Fig. 3. The

thickness of the steel plate should be 4 (mm) instead of 40 (mm). Please find in this erratum the correct version of Fig. 3 that should be regarded as final version by the reader.
