# In-plane cyclic tests of strengthened rubble stone masonry

M. Ponte · A. Penna · R. Bento

**Keywords** Rubble stone masonry · Quasi-static cyclic tests · Seismic strengthening · FRM · Mortar injection

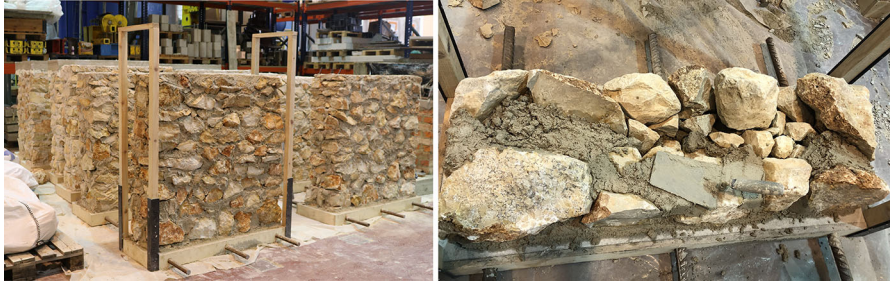
**Fig. 1** Construction of the masonry specimens at LERM, IST

The specimens were built to reproduce the current condition of ancient masonry in Portuguese monuments and existing buildings. Thus, to represent the mortar's ageing effect, during the specimens' construction the interior core of the walls was left with several voids and only after a minimum period of 4 months after their construction they were tested, guaranteeing the mortar's curing. Moreover, the specimens were composed of two leaves of stone with occasional interlocking through the thickness, as shown in Fig. 1. The masonry units were irregularly shaped, with various dimensions, presenting an irregular texture typical of the ancient masonry buildings and monuments in the centre-south region of Portugal.

The specimens were built directly on reinforced concrete footings with dimensions  $0.5 \times 1.25 \times 0.10 \text{ m}^3$ . A reinforced concrete beam with  $0.5 \times 1.25 \times 0.10 \text{ m}^3$  was built on top of each specimen to distribute the loads applied during the experimental tests.

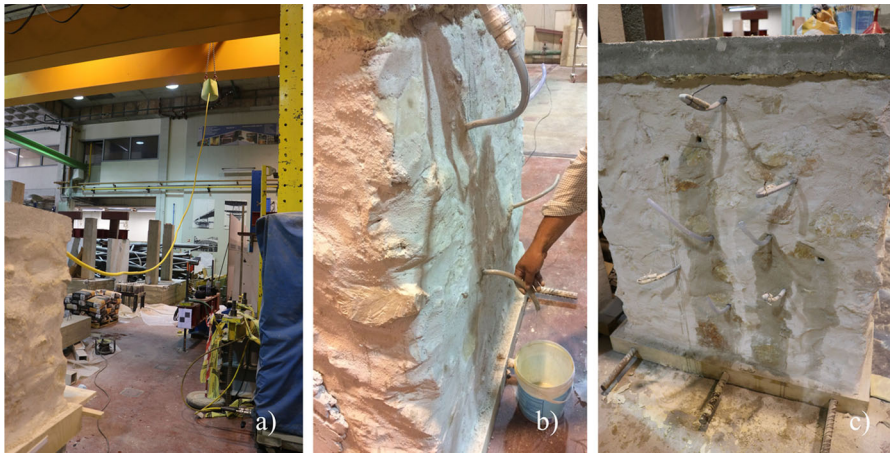
**Fig. 2** Injection of specimen: **a** bucket and hose with mortar during injection, placed at 5 m height, **b** I 2 (pouring mortar from one of the lower tubes), and **c** I 1 (with several injection holes)

The injection technique was applied through gravity as recommended for ancient deteriorated walls. The mortar was injected from a height of approximately 5 m higher than the specimens to obtain the necessary pressure (Fig. 2a), using an average of 3.7 bags of 18 kg of premixed mortar per panel. Four to five injection holes spaced approximately 50 cm apart with a light downward inclination were made on one side of each specimen. The injection holes were first filled with small quantities of water to clean the tubes and holes of small sediments and dust. Twenty-eight days after sealing the surface voids, the mortar was injected into the plastic tubes until it started to come out either from the same or other tubes, which were then closed (Fig. 2b). In the case of specimen I 1, as the tubes became filled with very little mortar injected, a total of 10 holes in different positions were made (Fig. 2c). However, even so, only a small quantity of mortar was injected, meaning the wall presented one of the lowest quantities of voids (3%). The percentage of voids was calculated and ranged between approximately 2% and 8%, with an average value of 5%.

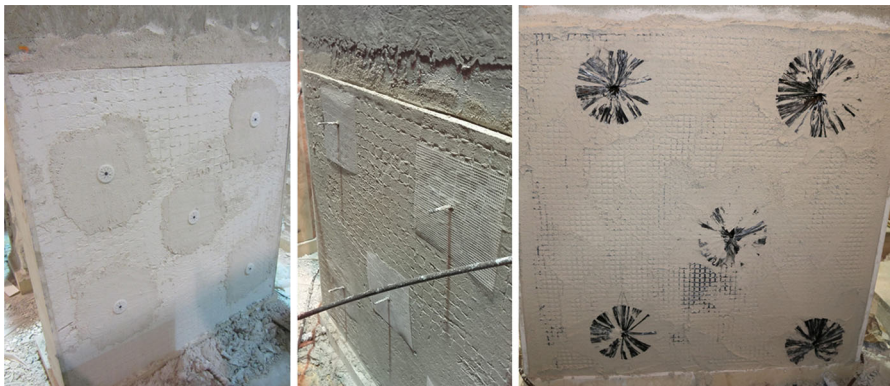
**Fig. 3** Connectors applied to glass (left) and carbon (right) FRCM systems

The application of the FRCM systems (see Fig. 3), including its anchoring system, was applied following the CNR-DT 215/2018 guidelines [20] and the studies of Gattesco et al. [36]. Only one layer of mesh was applied and just on one side of the masonry specimens. The connectors for the glass mesh system, made of polypropylene and with an interior nail of glass-fibre reinforced polyamide, were applied by pressure, together with a further localised second layer of denser glass mesh (openings— $5 \times 5 \text{ mm}$ ) at the intersection of each connector with the Glass-FRP (GFRP) mesh, that helps to distribute the concentrated stresses generated around the connectors. Whereas the connectors used with the Carbon-FRP (CFRP) mesh already present a shape that allows a suitable distribution for peak stress. Both devices present a 10–15 cm anchorage length, which means they do not connect the two leaves of stone. Five connectors per wall were applied in 10 mm diameter holes drilled in the stones, with approximately 50 cm distance in between. No mechanical devices were applied to fix the ends of the FRP meshes to the concrete footing or top beam. The lack of continuity of the FRCM system at the ends of the masonry structural element is not in accordance with the good practices for the proper installation of the retrofitting technique that ensure the behaviour of the strengthening solution is fully exploited.

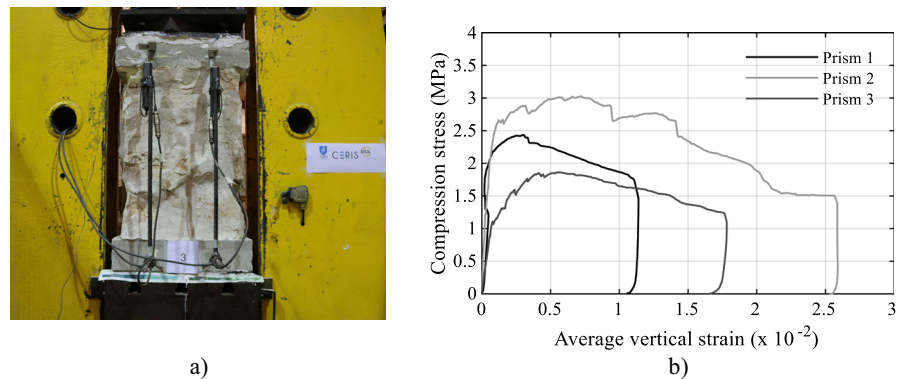
**Fig. 4** Compression tests to masonry prisms: **a** test set-up, **b** capacity curves

Compression tests were also carried out in three small masonry prisms with dimensions of 0.4 × 0.4 × 0.6 m<sup>3</sup>, as presented in Fig. 4a. The capacity curves of each prism during compression tests are presented in Fig. 4b in terms of vertical force and average vertical displacement (measured in four points, from the base footing to the top beam). Moreover, the test was performed under displacement control.

The average compressive strength obtained with the compression tests was 2.44 MPa from values between [1.86, 3.03] MPa. Moreover, due to the scatter of results of Young’s modulus, different ranges of points were considered for the calculation of the secant stiffness. Considering 0.1\**F*<sub>max</sub> and 0.33\**F*<sub>max</sub>, the best fit resulted in an average value of Young’s modulus of 3.2 GPa from a range of [1.40, 4.80] GPa.

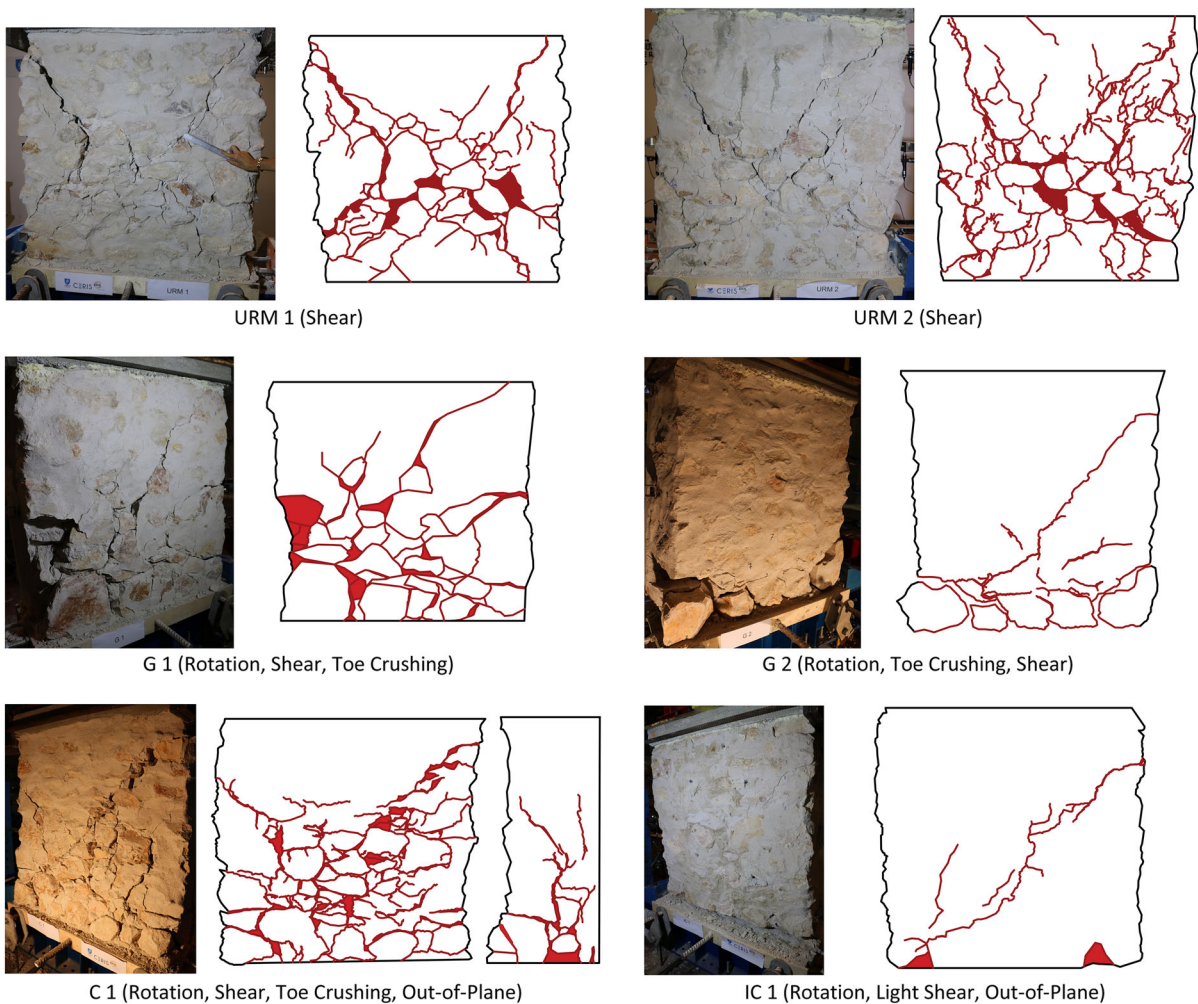
**Fig. 7** Damage distribution and failure modes at the end of the tests for the damaged specimens (pictures and drawings of front and side facades)

Regarding the specimens that presented visible damage at the end of the tests, besides a rigid body rotation, the damage distribution in one of the facades is presented in Fig. 7. For specimen C 1, as the separation of the two leaves of stone occurred, a view of the side facade is also shown. Failure was defined as the point when the specimen achieved a decay of 20% of the horizontal peak load, or when the panel presented such a high level of damage that was on the verge of collapse.

There is a clear distinction in the existing damage in strengthened specimens with mortar injection and without. The specimens with mortar injection presented almost no damage besides the detachment of the panel from the concrete base (Fig. 9), behaving as a rigid body, while the specimens without injection tended to present more damage on the masonry panel, whether it was diagonal cracking, toe crushing, or a combination of both. The cracking was visible only on the facade without the FRCM and the sides except for specimen G 1, the only presenting a crack on the plastered face. Moreover, this difference in behaviour due to the mortar injection is represented in lower energy dissipation of the hysteretic cycles. It is also worth noting, that specimen C 2, presented a rocking behaviour without visible damage, as for the specimens with mortar injection technique. This can be explained by the heterogeneity of the walls, due to the material and manual construction. Moreover, no detachment of the FRP mesh from the masonry panel was noted in any of the specimens.

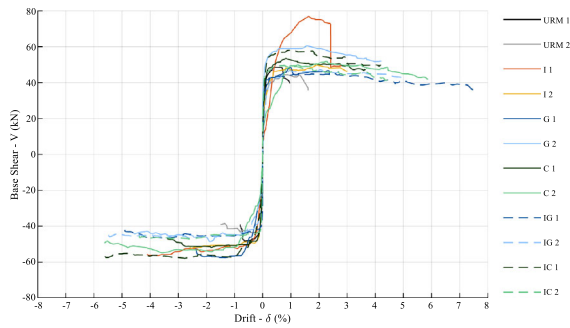
**Fig. 8** Envelope curves until the ultimate drift

From the envelope curves in Fig. 8, it is possible to immediately identify a significant positive impact of the retrofitting solutions on the deformation capacity of masonry walls. On the other side, in terms of shear strength, the retrofitting did not cause a significant enhancement since the lateral strength is limited by the rigid body rocking mechanism. It is worth mentioning that the strength experimentally obtained also depends on the contact surface. For these experimental tests, it was used a concrete footing, although in real buildings that should not be the case. Nevertheless, for the specimens in which sliding occurred (I 1, I 2, C 2, IC 1), a range of the maximum value of the friction coefficient was obtained between [0.40, 0.57].

The values obtained from the envelope curves in terms of peak load ( $V_{max}$ ), ultimate drift ( $\delta_u$ ), and effective stiffness, together with the average values for each type of tested strengthening solution are presented in Table 4. The maximum horizontal force limit given by the horizontal force of a rigid body rocking mechanism ( $V_{rigid}$ ), which was calculated by the equilibrium of forces and considering the weight of the specimen at its centre of mass, is also presented. In Fig. 10, it is possible to observe the increase in peak load and ultimate drift capacity of the strengthening solutions compared to the unstrengthened specimens. The ultimate drift of each specimen is considered the minimum value between the positive (push) and negative (pull) direction of the horizontal load for which one of the conditions of failure occurred. The effective stiffness was calculated as indicated in

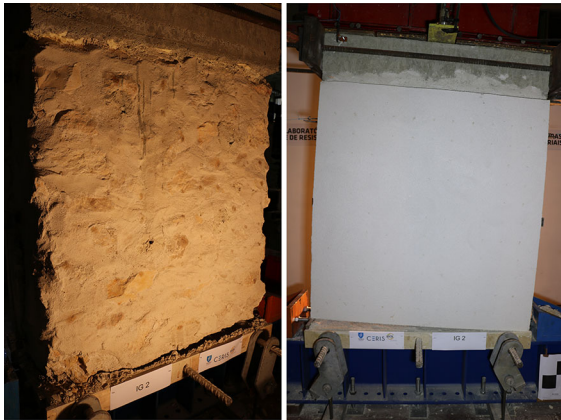
**Fig. 9** Rigid body behaviour of a wall strengthened with injection and G-FRCM system (IG 2), both sides view

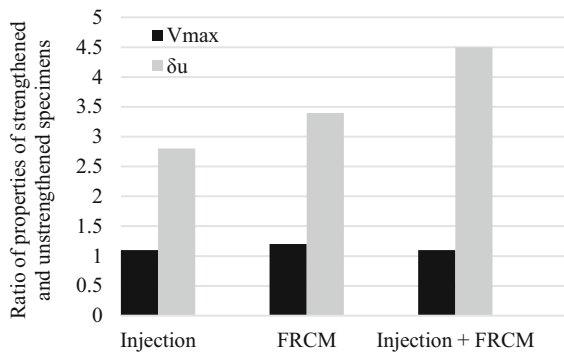
**Fig. 10** Ratio of properties of strengthened to unstrengthened specimens

Even though the FRCM solution was only applied on one side of the specimens, not providing confinement to the masonry, it already presents a significant improvement of the ultimate drift, related to the change of failure mode from shear to rocking. It is also worth noting that, the deformation capacity results obtained for the mortar injection technique are not considered representative of this technique and should be considered as a minor of the real behaviour. The ultimate displacement of specimen I 2 was conditioned by out-of-plane collapse, not due to extensive damage or strength decay, and for specimen I 1 the decay of strength was caused by alterations in the boundary conditions, as already explained before.

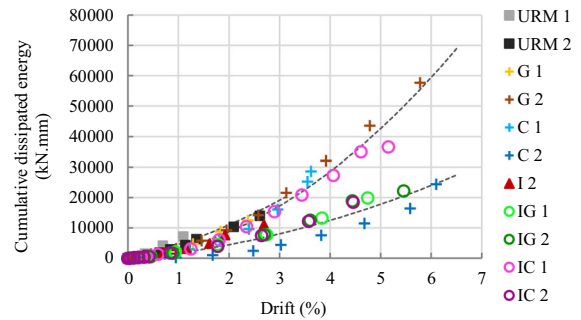
**Fig. 11** Cumulative dissipated energy (kN mm)

The cumulative dissipated hysteretic energy was calculated for each cycle and compared with the corresponding maximum absolute value of drift, presented in Fig. 11. It is possible to observe the correlation between the dissipated energy and the type of failure mode of the specimens. Three parabolic trends are identified. URM 1, with a shear collapse, is the specimen that presents the highest dissipated energy when comparing equal values of drift. The specimens that presented rotation followed by diagonal cracks due to shear and toe crushing (G 1, G 2, C 1, I 2, IC 1) present a similar trend of dissipated energy, lower than the URM 1 that was completely damaged by shear. Finally, specimens like IG 1, IG 2, IC 2, and C 2, with mostly only rocking behaviour and no visible

damage, present a trend of low dissipated energy, as it is common in this type of failure mode.
