Interfacial bond strength and failure modes of traditional and modern repair materials for historic fibrous plaster

Barrie Dams · Naveen Kumar · Rajnish Kurchania · John Stewart ·
Martin Ansell · Marion Harney · Richard J. Ball

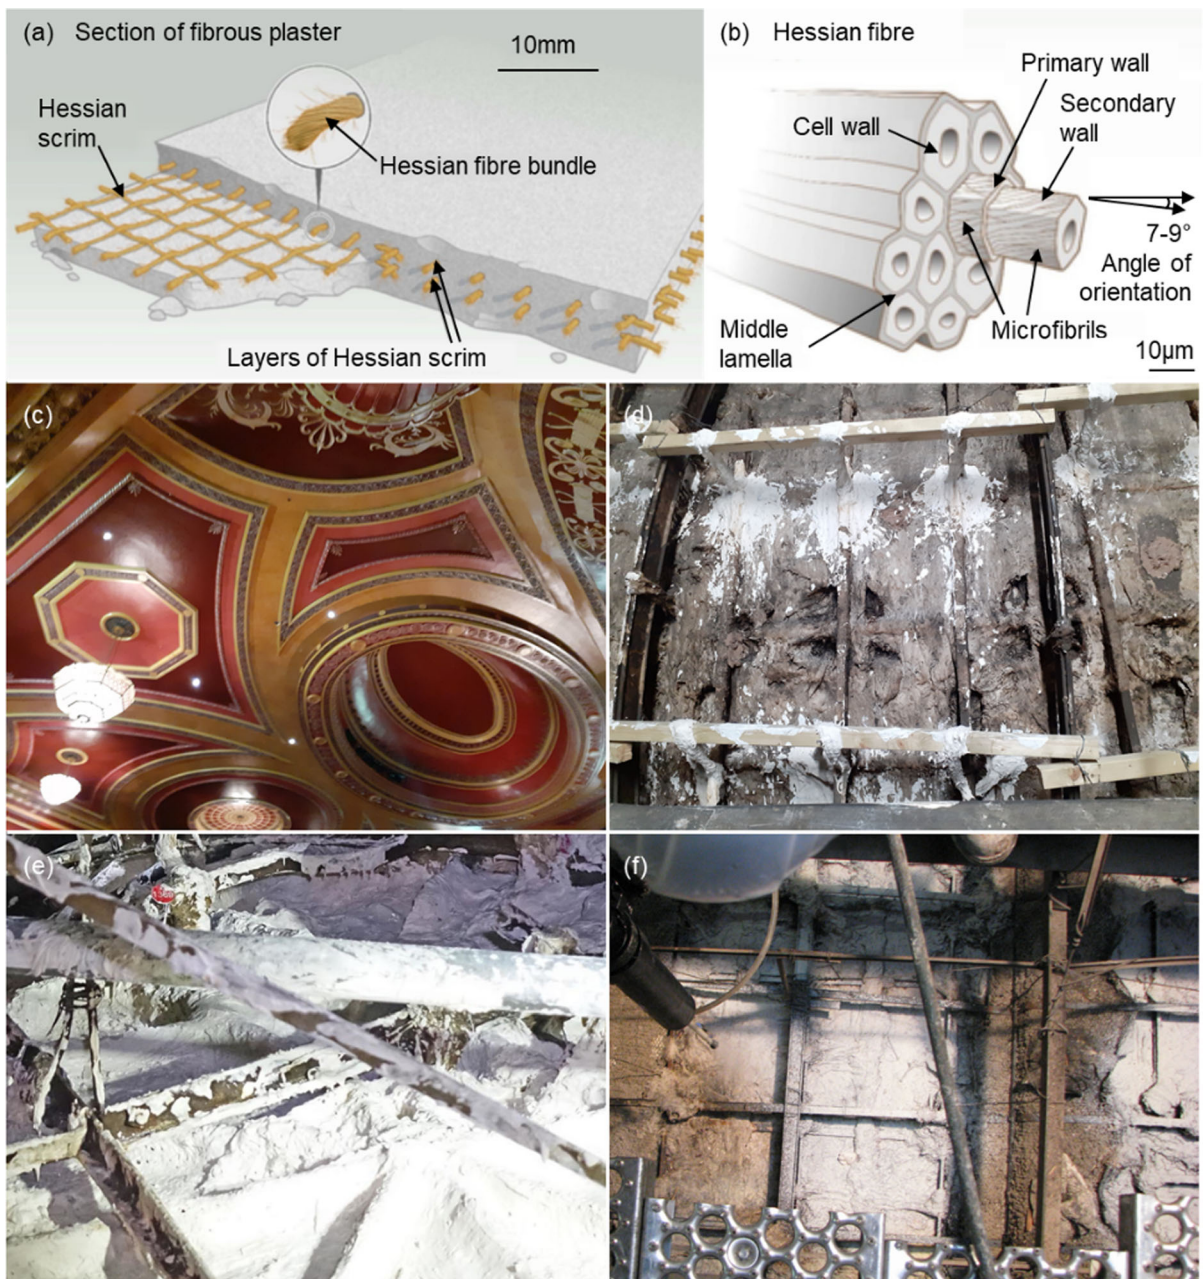
Fig. 1 Historic fibrous plaster ceiling structure and examples of modern repair methods. **a, b** Axonometric drawing of fibrous plaster element with hessian scrim and illustration of hessian fibre structure (Source: [15]). **c** A theatre's fibrous plaster ceiling underside showing decoration and ornate features (Source: Author). **d** An example of newly applied fibrous plaster

composite wads (Source: Author). **e** Laminations of an acrylic modified plaster with alkali-resistant quadaxial fibreglass reinforcement on the topside of a ceiling (Source: [12]). **f** The application by spraying of a thin lamination of HPCP RE Aramid Gel™ on to a ceiling topside (Source: [18])

Figure 1 contains images of a section through a fibrous plaster element and hessian fibre along with in-situ fibrous plaster ceilings and illustrations of the different repair applications. Figure 1a illustrates a section through a fibrous plaster element showing layers of hessian scrim, with Fig. 1b showing a close-up drawing of a hessian fibre structure [15]. Figure 1c shows the decorated underside of a fibrous plaster ceiling.

Figure 1d-f images show ceiling topside images showing the different repair methods. Figure 1d shows newly applied wads consisting of gypsum plaster, hessian fibres and galvanised steel draped over structural supporting timber beams and affixed to the topside of a historic ceiling, with new plaster in contact with aged plaster. The topside of a historic ceiling may be well over a century old and be covered in accumulated layers of mould and dirt. This may have a significant influence of the mechanical integrity of the interface between any newly applied repair material and the topside of the in-situ ceiling panel element. In modern practice, it is typical to vacuum the topside of historic fibrous plaster ceilings to remove the layers of mould and dirt which have built up over the years and providing it is safe to do so by inspection,

carefully inscribe lines to form a mechanical 'key' to roughen the topside surface to aid adhesion of a newly applied material and promote bonding. Figure 1e illustrates the application of a lamination consisting of a fibrous scrim with quadaxial glass fibres as a replacement for traditional hessian, soaked in an acrylic-modified plaster and placed upon in-situ historic material. Figure 1f features a gel material which has been sprayed onto the topside of a historic ceiling to a thickness of 1.35 mm.

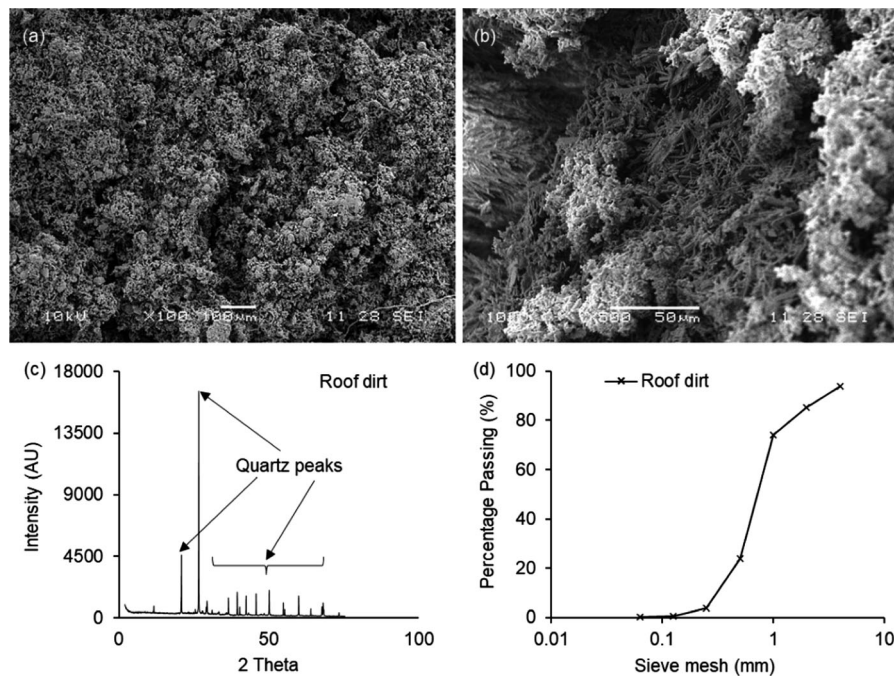
Fig. 2 a, b SEM images at $\times 100$ and $\times 500$ respectively of in-situ dirt on a fibrous plaster element (Source: Authors). c XRD spectrum of the roof dirt, revealing it is predominantly

comprised of quartz. (d) Particle size distribution of the roof dirt showing the range of sizes

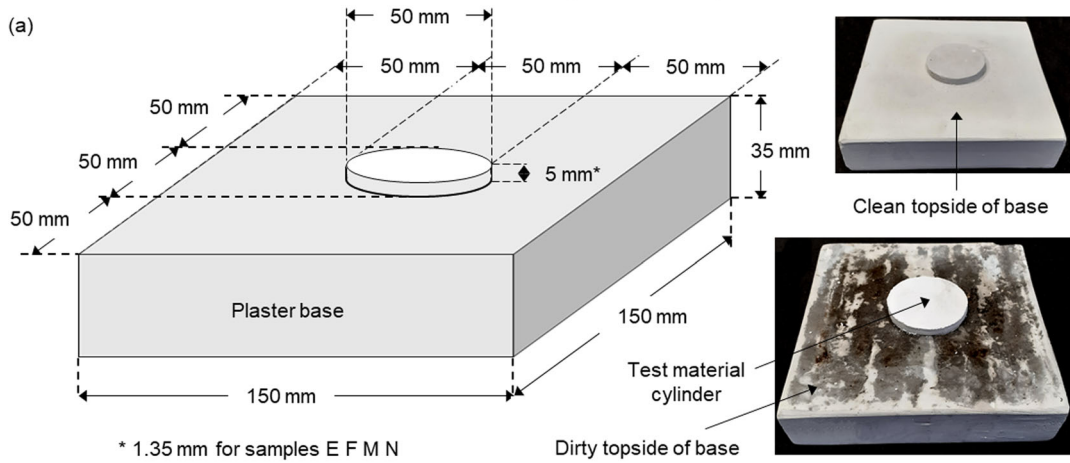
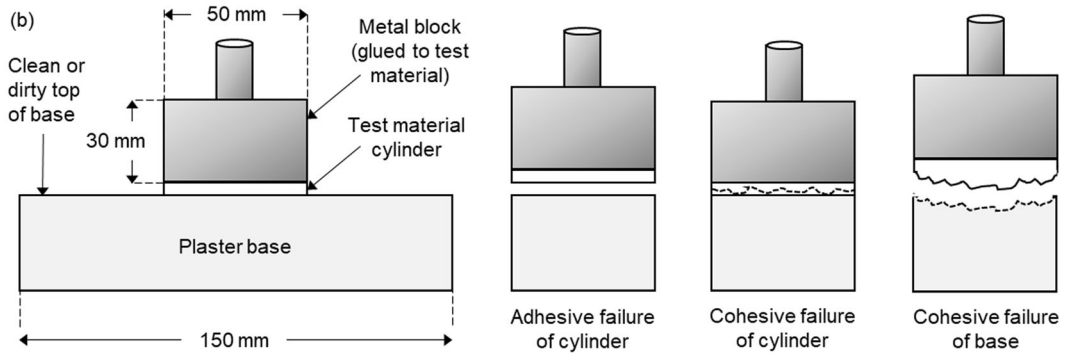
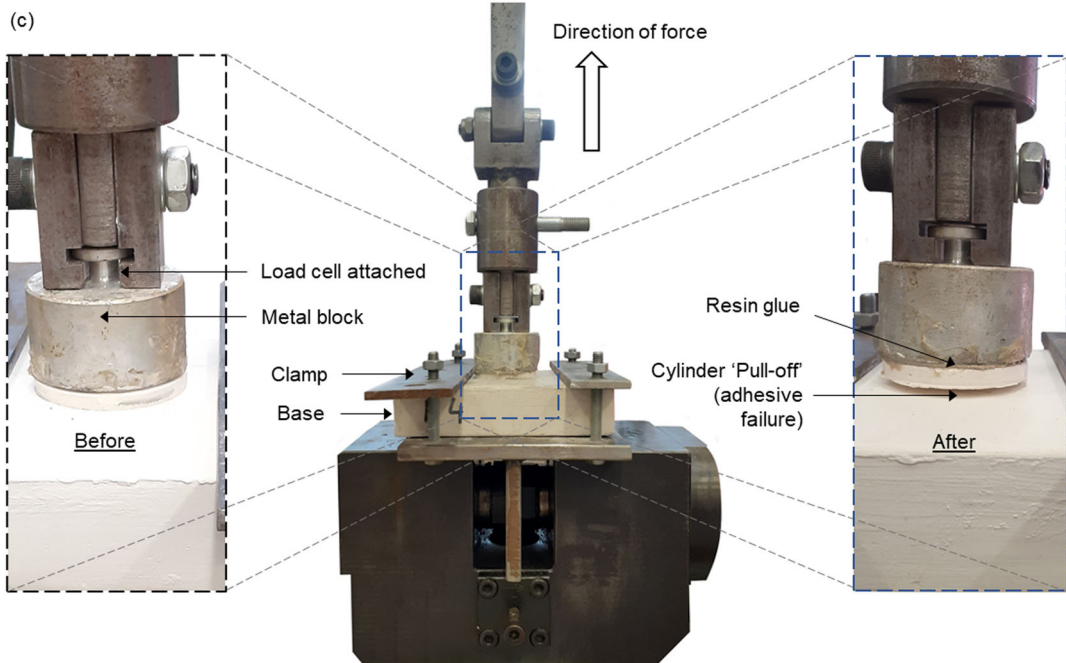
◀ **Fig. 3 a** Isometric view with dimensions of the pull off test sample along with images of both clean and dirty topsides of the plaster base, **b** Modes of failure possible with the metal block secured to the cylinder of testing material with a resin and **(c)** The tensile test rig comprising the adhesion of an aluminium metal block to the sample group specimen and load cell and application of tensile load

Figure 3a illustrates the tensile ‘pull-off’ test specimen design and dimensions, which consisted of a 150 mm × 150 mm × 35 mm beta gypsum plaster base, on to which a cylinder of 50 mm Ø and up to 5 mm thickness of each test material was applied.

Figure 3b and c illustrate the potential failure modes and the details of the tensile test rig for the pull-off tests. The tensile test rig was based upon BS 1881–207:1992 pull-off test methodology and Fig. 1c [20]. A 50 mm Ø aluminium metal block was mounted centrally on to the cylinders affixed to the base plates using a two component Sikadur -31 epoxy building adhesive (stronger than the cylinder-base bond to ensure that failure did not occur at the metal block—cylinder interface). The aluminium metal block was inserted into a custom-built testing rig. Displacement-controlled tests were carried out using a Dartec Universal Testing machine with a 100 kN load cell and executed at a crosshead speed of 0.2 mm/min until failure occurred. A small pre-load (0.03 kN ± 0.01 kN) was applied after samples were manoeuvred into position to test correct alignment prior to full loading. Failure type (FT), as illustrated in Fig. 3b, was to be classed as either adhesive failure at the cylinder-base interface, cohesive failure within the applied cylinder (resulting in a partial or total fracture within the cylinder material itself and cylinder material being left on the base) or cohesive failure within the base plate (resulting in material being pulled out of the base plate and being attached to the cylinder material).

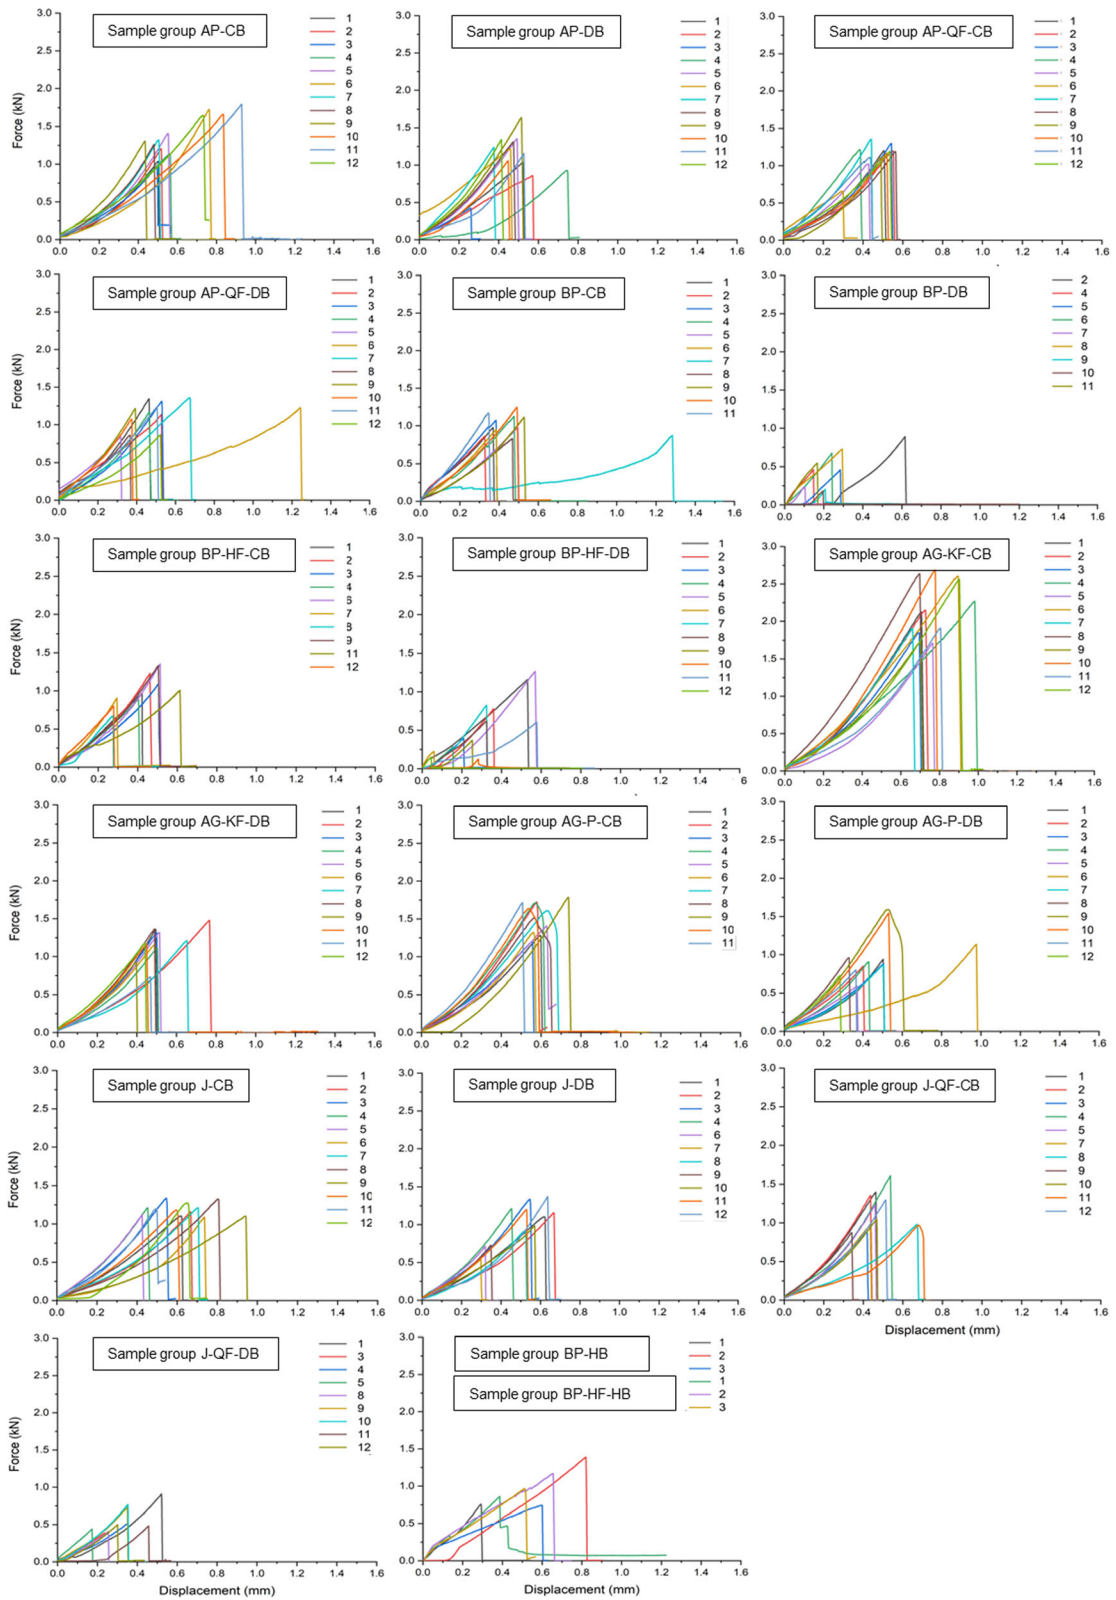
◀ **Fig. 4** Matrix of force versus displacement curves for all tested specimens of each sample group

Figure 7 integrates the area under the force—displacement curves shown in Fig. 4 to measure the work done in loading the specimens to failure, expressed in terms of energy (in Joules) for the sample groups, with the standard deviation and coefficient of variation also represented as per Fig. 5 and Fig. 6.

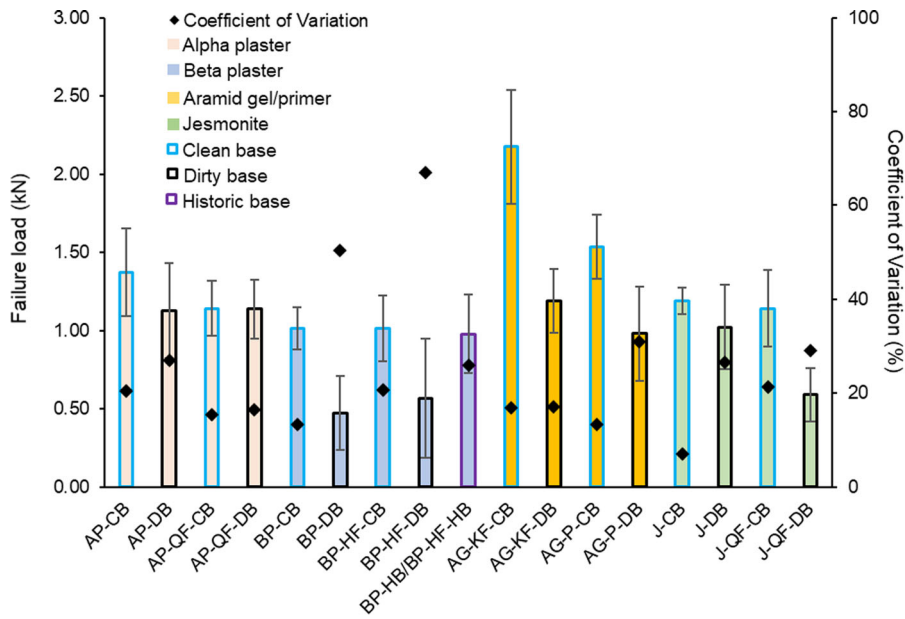
Fig. 5 Mean maximum failure load (force required) of specimens in each sample group, with error bars denoting standard deviation and “black diamond” representing the coefficient of variation

While it may be tempting to look at Fig. 5 and Fig. 6 and note that this sample group has values which are not as ‘high’ as some others, one has to consider the differences in application and fibrous plaster material loading scenarios. This pull-off test in this particular sample group is representing a vertical hessian wad being draped over existing in-situ material, a quite different application to placing soaked scrim or spraying a thin, wide-area covering of repair material directly on to an existing ceiling element. The loading provided by a fibrous plaster ceiling element should also be considered; taking a density value of 800 kg/m³ to represent both traditional Beta fibrous plaster and timber laths, a square metre ceiling element of typical 6 mm thickness would weigh in the region of 5 kg. Considering that in historical practice, four wads are applied per square metre, this study has determined that one new wad, under vertical dead loading, is more than adequate to support the square metre of ceiling, at what is potentially the weakest point of the wad—the interface between the applied wad and the existing ceiling. Therefore, assuming that four wads per square metre are affixed in practice, there is a very large safety factor and redundancy in the fibrous plaster structure with vertical dead loading. Hence, the use of traditional Beta plaster hessian wads as a ‘like for like’ repair method is appropriate and effective at the wad-ceiling interface. (Note that although heavy decorative features weigh significantly more than typical ceiling elements, other methods of restraint such as wire restraints and steel washers are used for those exceptional elements).

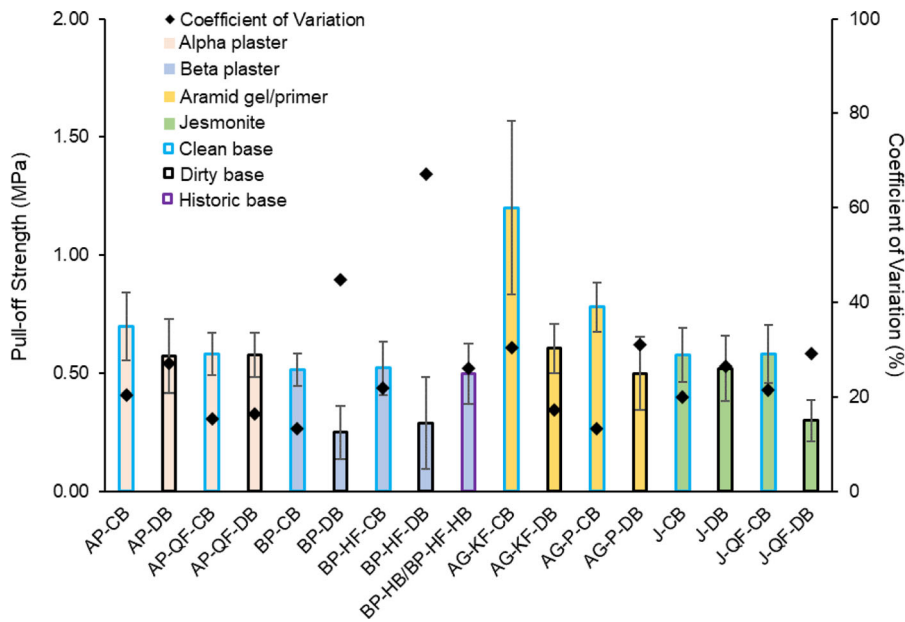
Fig. 6 Mean pull-off strength values of specimens in each sample group, with error bars denoting standard deviation and “black diamond” representing the coefficient of variation

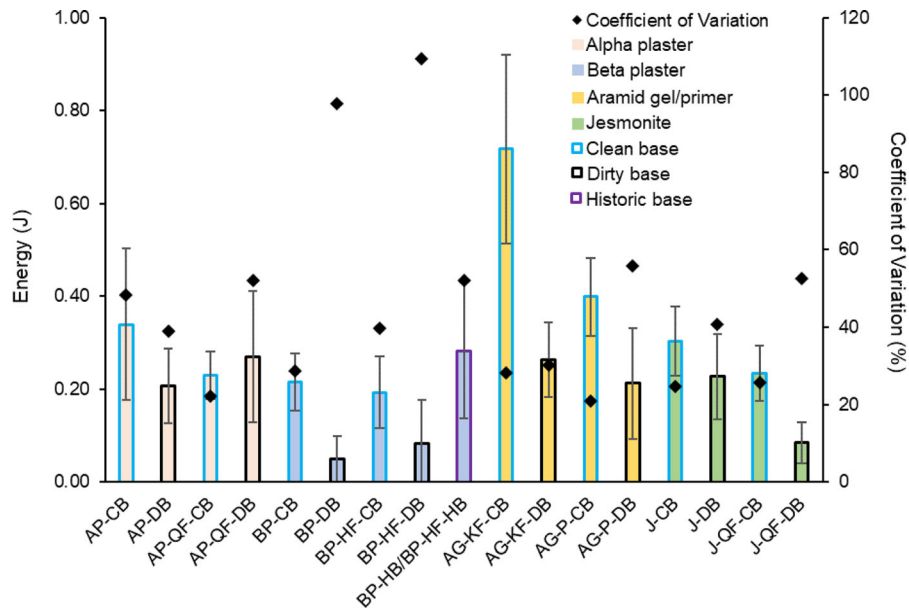
Fig. 7 Mean values of the work done, expressed in energy, of specimens in each sample group, with error bars denoting standard deviation and “black diamond” representing the coefficient of variation

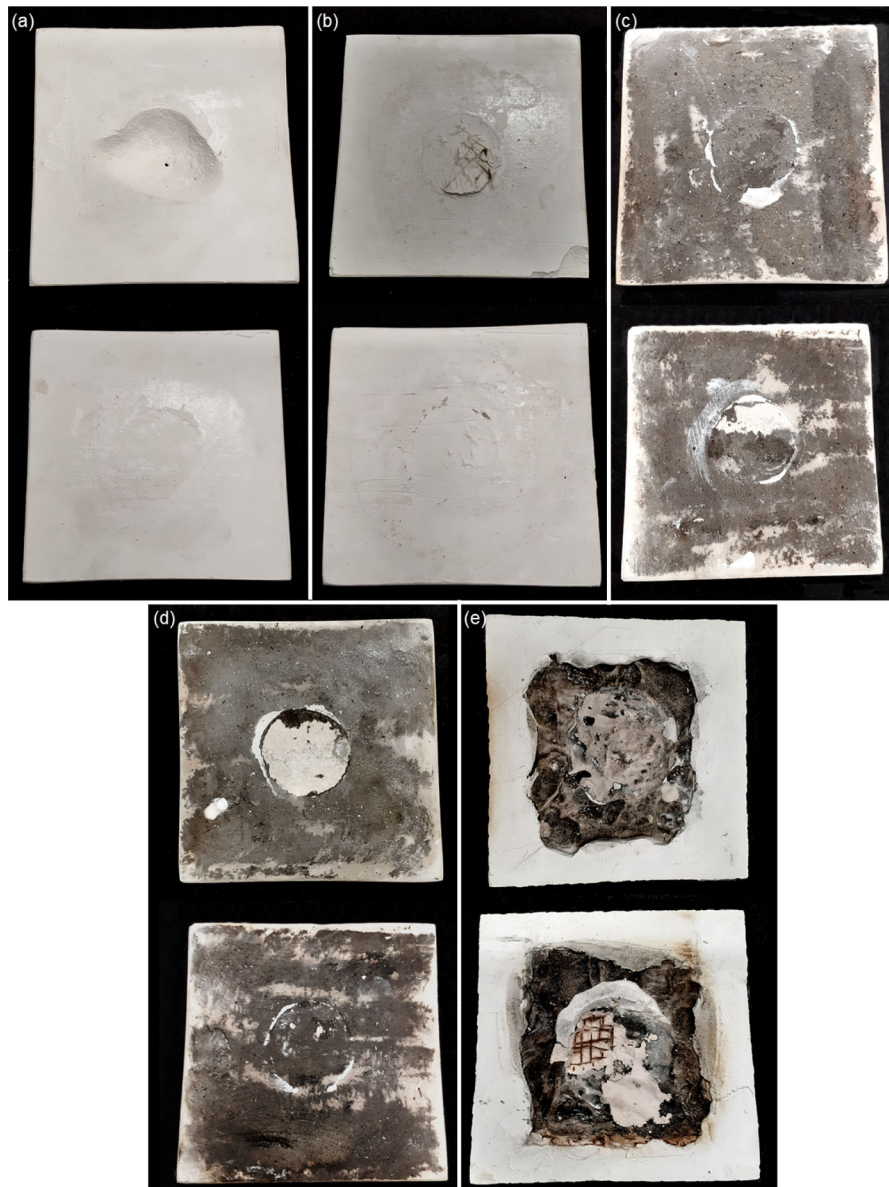
Fig. 8 Tested bases (dimensions 150 mm × 150 mm) from groups BP-CB, BP-HF-CB, BP-DB, BP-HF-DB and BP-HB/BP-HF-HB. **a** Group BP-CB; failure ranged from cohesive in the base material (top) and adhesive (lower). **b** Group BP-HF-CB, partial cohesive failure of the applied cylinder (top) and adhesive failure (lower). **c** Group BP-DB featured adhesive

failure at the cylinder-base interface (top) and partial cohesive failure of base material (lower). **d** Group BP-HF-DB failed in an adhesive manner (bottom) and partial cohesive failure of base material (top). **e** Group BP-HB/BP-HF-HB, adhesive failure (top) and partial cohesive failure of the base exposing hessian fibres (lower)

Figure 8 depicts selected images illustrating the range of failure types from sample groups BP-CB, BP-HF-CB, BP-DB, BP-HF-DB and BP-HB, BP-HF-HB featuring Beta plaster and hessian fibres (note: metal block images with cylinders attached were not available for these sample groups). Figure 8a shows specimens from sample group BP-CB which consisted of beta plaster cylinders on clean bases. Failure types ranged from cohesive failure in the base, where the metal block pulled off a small chunk out of the base (shown in the top image) to adhesive failure in the cylinder-base interface (example in the bottom image) which was the most typical occurrence in group BP-CB. Figure 8b shows specimens from sample group BP-HF-CB, consisting of beta plaster cylinders with hessian fibres on clean bases. This was the one sample group which showed evidence of cohesive failure in the applied cylinder rather than the base, with the top image showing plaster and hessian fibre from the cylinder on the top of the plaster base circular area. Specimens also featured adhesive failure at the cylinder-base interface as shown in the bottom image, with only one specimen in this sample group showing partial cohesive failure with a small quantity of base material being pulled off.

Figure 8c illustrates specimens from sample group BP-DB, Beta plaster on dirty bases. All specimens featured adhesive failure at the cylinder-base interface as shown in the top image, with only two exceptions which showed a small degree of cohesive failure in the base material, with an example shown in the bottom image of base material being pulled off. Figure 8d shows specimens from sample group BP-HF-DB, consisting of beta plaster with hessian fibres on dirty bases; specimens in this sample group all exhibited adhesive failure at the cylinder-base interface (an example of which is shown in the top image), with coverage of dirt remaining in the circle on the base. There were two examples of partial cohesive failure in the base with a small quantity of base material pulled off (bottom image). Figure 8e illustrates specimens from sample group BP-HB, BP-HF-HB both without hessian fibres (above image) and with fibres (below

image) with adhesive failure shown in the top image and partial cohesive failure in the bottom image, with an area of the historic base material having been pulled off exposing the historic hessian fibres within.

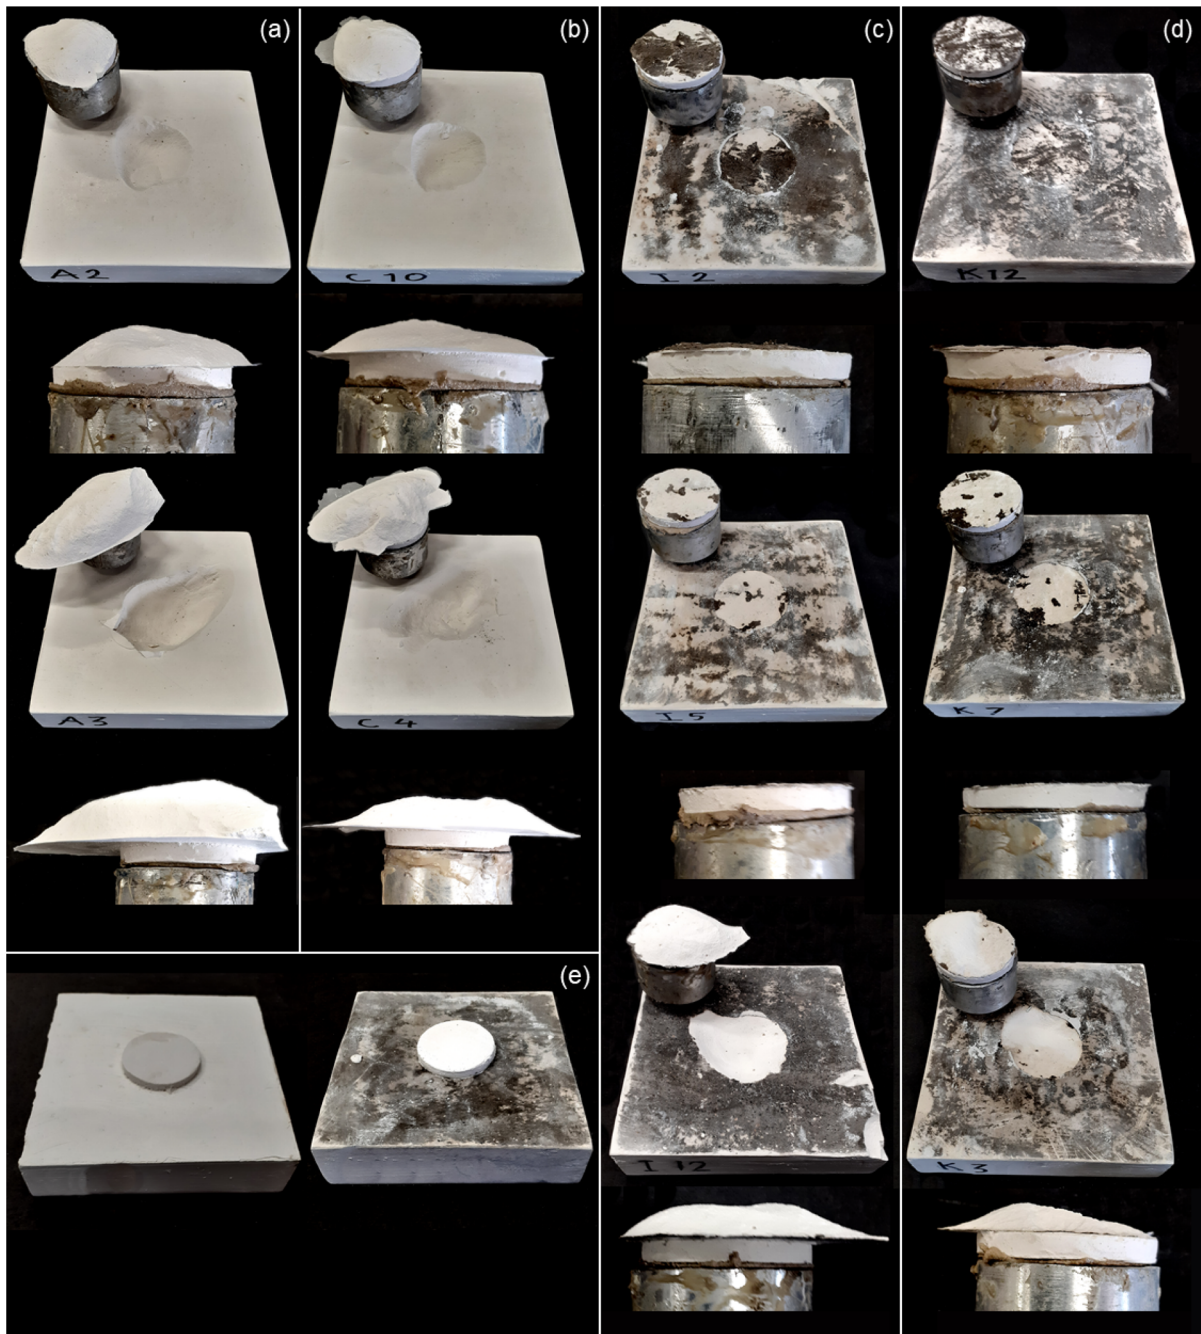
Fig. 9 Tested specimens from groups AP-CB, AP-QF-CB, AP-DB, and AP-QF-DB. **a** Group AP-CB, cohesive failure of base material. **b** Group AP-QF-CB, cohesive failure in bases. **c** Group AP-DB, partial cohesive failure of base material (top, middle) and cohesive failure (bottom images). **d** Group AP-QF-DB,

partial cohesive failure of base material (top, middle) and cohesive failure of base material (bottom). **e** Clean based (left) and dirty (right) specimens. Cylinders 50 mm \varnothing and base dimensions 150 mm \times 150 mm

range of failure types are presented in Figure 9. Figure 9a depicts specimens from sample group AP-CB, which featured Alpha plaster on clean bases and showed cohesive failure of the base with varying extents of material pulled out of the base with the least amount pulled out in the top image and the most in the bottom image. Figure 9b shows specimens from sample group AP-QF-CB, which used Alpha plaster with quadaxial fibres on clean bases; again these all showed cohesive failure with varying extents of material pulled out of bases, the least in the top image and most in the bottom image; the set primer applied to the bases prior to the cylinders being affixed can also be seen on the material around the circular area on the metal block in both the top and bottom specimen images.

Figure 9c illustrates specimens from sample group AP-DB, which used Alpha plaster on dirty bases. Group AP-DB largely showed partial cohesive failure in the base, with small quantities of base material being removed, the least amount in the top image, the most in the middle image and in the bottom image is the one instance of cohesive failure in the sample group with a bulk quantity of material pulled from the base; this may be due to less dirt being present in the circular area on this specimen. Figure 9d depicts specimens from sample group AP-QF-DB, with Alpha

plaster and quadaxial fibres on dirty bases. Specimens showed partial cohesive failure with small quantities of base material being removed as shown in the top and middle image; again there was one exception as shown in the bottom image which can be classed as cohesive failure and a bulk quantity of base material pulled off. Figure 9e shows specimens from groups AP-CB (clean base) and AP-DB (dirty base) with the applied cylinders prior to testing.

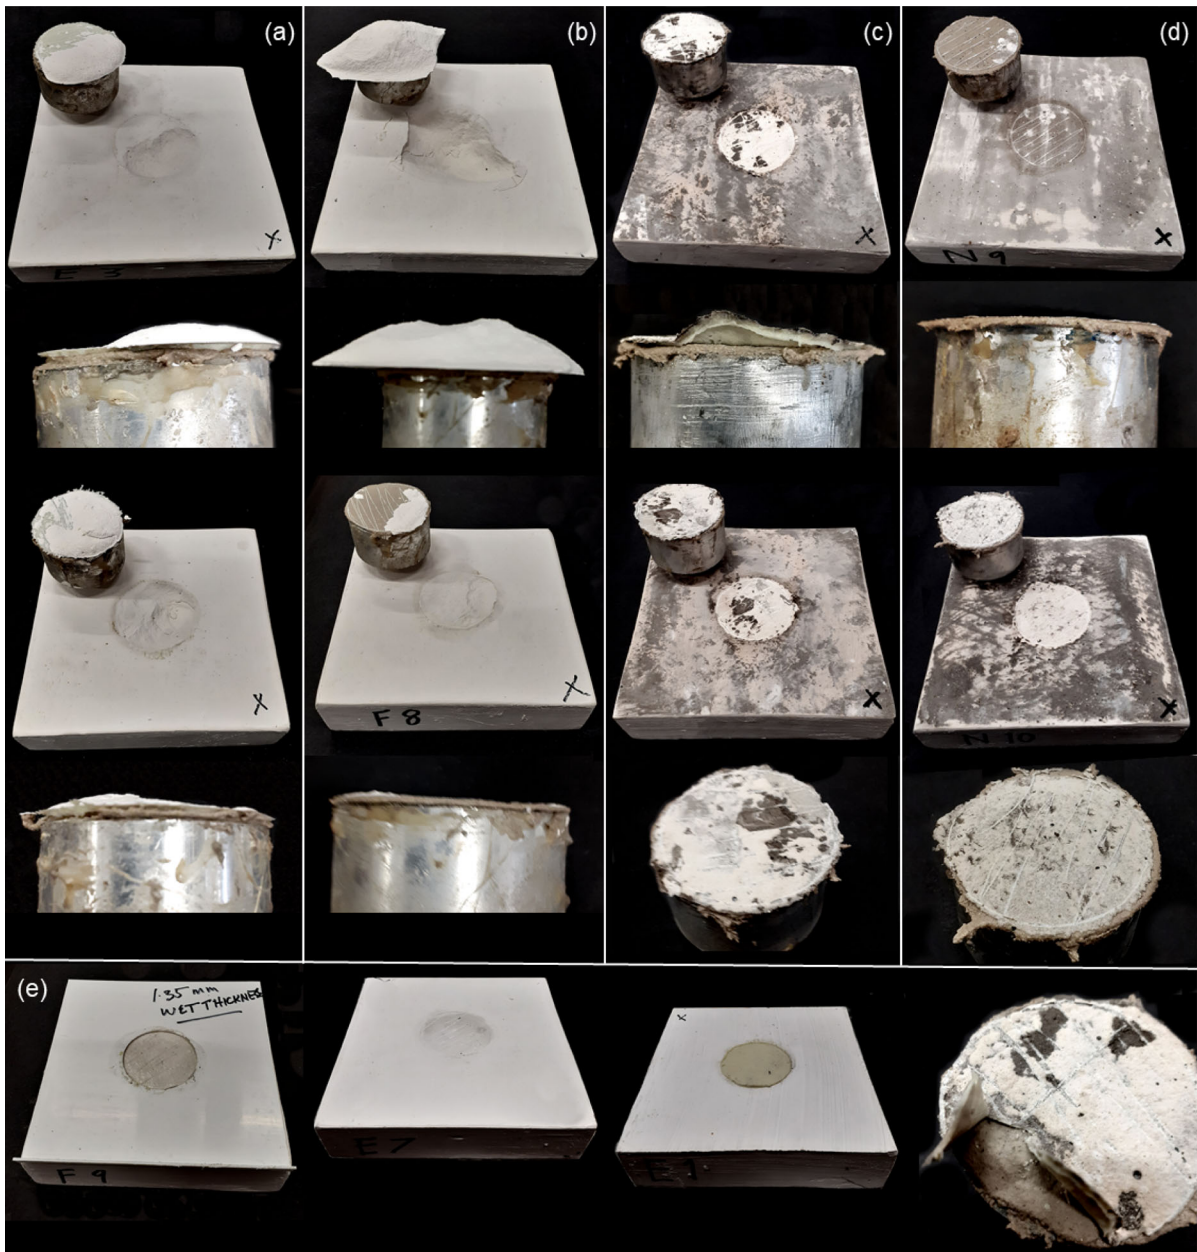
Fig. 10 Tested specimens from groups AG-KF-CB, AG-P-CB, AG-KF-DB, and AG-P-DB. **a** Group AG-KF-CB, adhesive and cohesive failure with partial cohesive failure of base material. **b** Group AG-P-CB, cohesive failure with base material removed (top) and partial cohesive failure of base material (lower). **c** Group AG-KF-DB, partial cohesive failure of base

material. **d** Group AG-P-DB, partial cohesive failure with base material evident on cylinders. **e** Left to right: template with aperture on a base, a clean base specimen with just primer, a clean base specimen with gel/fibres/primer and a close-up illustrating the ductility of cured HPCP RE Aramid GelTM. Cylinders 50 mm Ø, base dimensions 150 mm × 150 mm

Selected images showing the range of failure types from sample groups AG-KF-CB, AG-KF-DB, AG-P-CB and AG-P-DB are shown in Figure 10. Figure 10a illustrates specimens from sample group AG-KF-CB with HPCP RE Aramid GelTM (including DuPontTM Kevlar® fibres) and HPCP CO S-20TM primer on a clean base; this group exhibited both elements of adhesive and cohesive failure to varying extents as shown in both specimen images. Figure 10b shows specimens from sample group AG-P-CB, which featured just primer on a clean base; this sample group ranged from fully cohesive failure (shown in the top image) to partial cohesive failure (lower image).

Figure 10c shows specimens from sample group AG-KF-DB, which featured gel/fibres and primer on a dirty base. Specimens in this group all showed partial cohesive failure with varying extent of base material evident on the cylinders as shown in the top and bottom images; it can be seen in the close-up on the metal block of the top image specimen that the cured product is pliable rather than stiff.

Figure 10d shows specimens from sample group AG-P-DB, with just primer on dirty bases. This group also showed partial cohesive failure on all specimens with base plate material evident on the pulled-off cylinders to varying extents (as shown on both example specimen images). The Sika glue on the metal block is clearly visible in the top specimen image. Figure 10e shows from left to right, the template with aperture on the top of a base, a clean base specimen with just primer, a clean base specimen with gel/fibres/primer and a close-up further illustrating the ductility of the cured gel product, which can be manoeuvred by hand and is not rigid. This ductility allows movement in in-situ applications as building

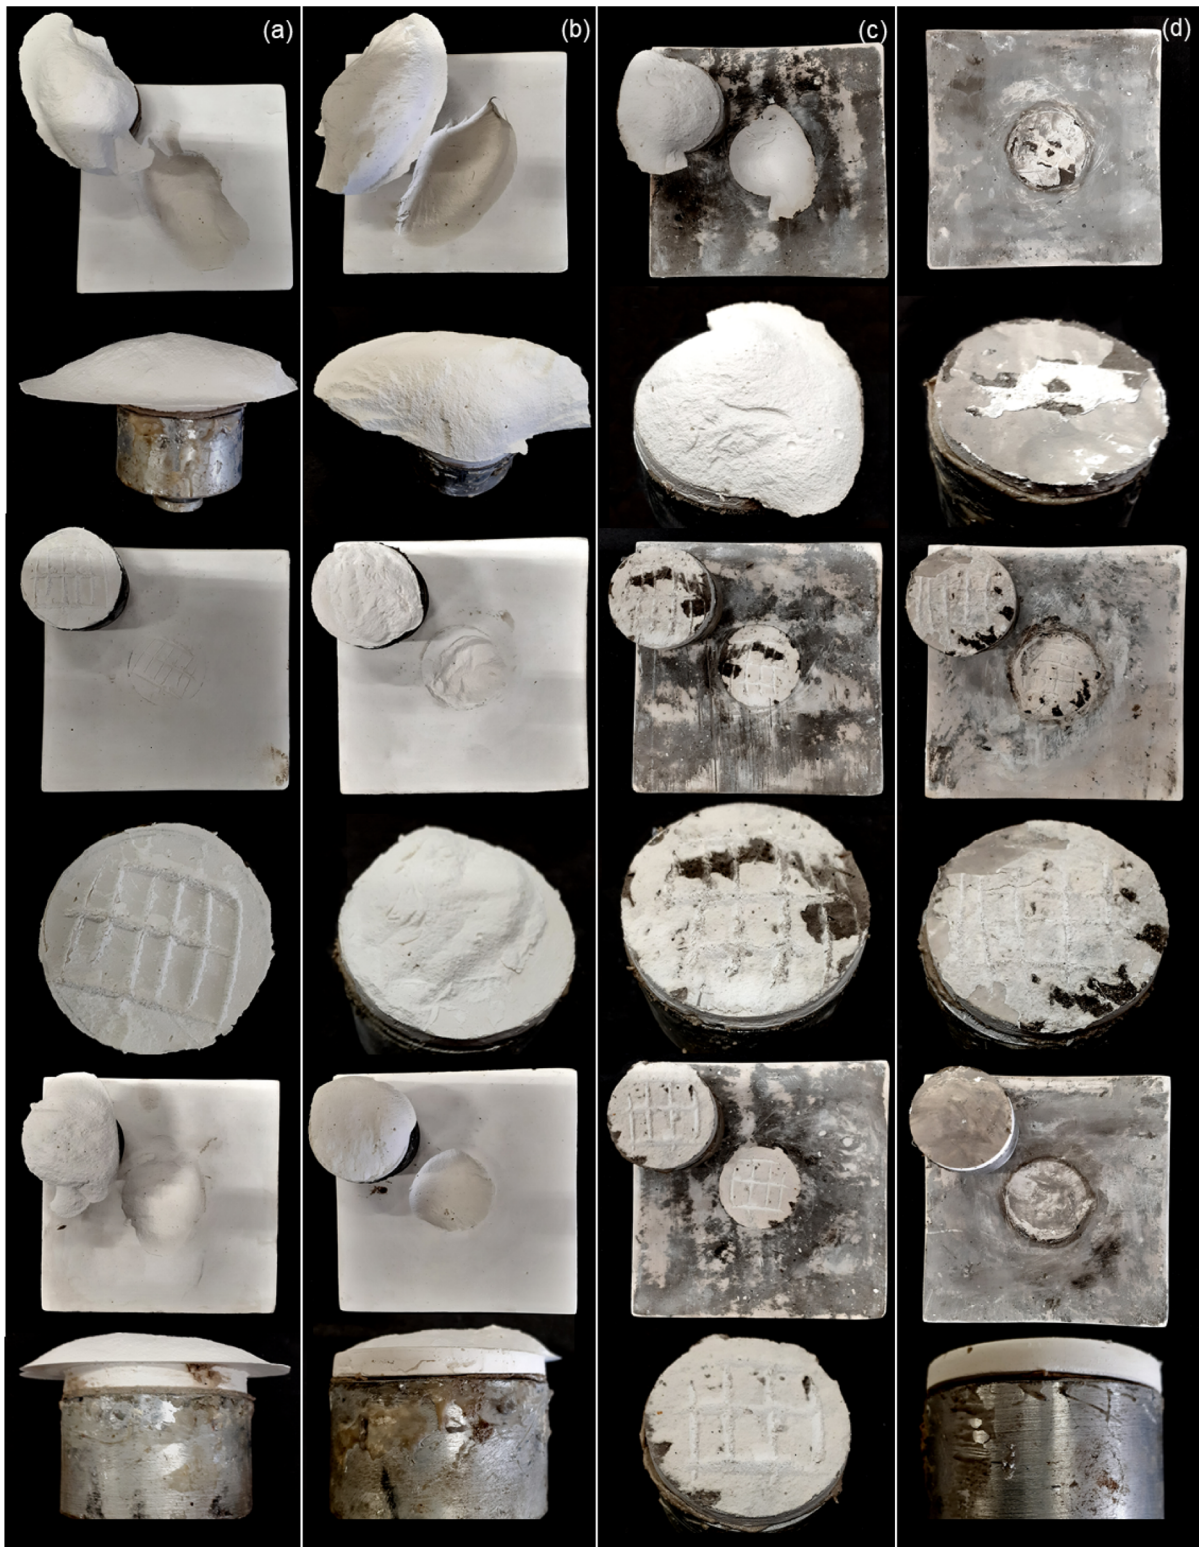
◀ **Fig. 11** Tested specimens from groups J-CB, J-QF-CB, J-DB, and J-QF-DB. **a** Group J-CB, cohesive failure in the base (top and lower) with one exception of largely adhesive failure where ‘keying’ is evident (middle). **b** Group J-QF-CB, cohesive failure in base material. **c** Group J-DB, cohesive failure (top) and partial cohesive failure of base (middle, lower). **d** Group J-QF-DB, partial cohesive failure of base material (top, middle), adhesive failure (lower). Cylinders 50 mm Ø, base dimensions 150 mm × 150 mm

Selected images showing the range of failure types from sample groups J-CB, J-QF-CB, J-DB and J-QF-DB are shown in Figure 11. The ‘criss-cross’ keying to aid bonding between the plaster base and cylinder is particularly visible in these images. Figure 11a illustrates specimens from group J-CB, featuring Jesmonite on a clean base. All specimens in this sample group failed in a cohesive manner with varying quantities of bulk material pulled out of the plaster base (as shown in the top and bottom specimens), with one exception which featured largely adhesive failure, with approximately 80% of the circular area being smooth material and 20% of the circular area was partial cohesive failure with a thin layer of material was pulled off the base plate (as shown in the middle specimen image). A strong ‘key’ applied to the base

Figure 11b depicts specimens from group J-QF-CB, featuring Jesmonite and quadaxial fibres on a clean

plaster base. Specimens in this group exhibited cohesive failure with a range of bulk quantities of material pulled out of the base shown in the upper and lower example specimens depicted; the middle image shows the one example within the group of partial cohesive failure with a small quantity of base plate material in evidence attached to the cylinder and metal block.

Figure 11c illustrates specimens from group J-DB, featuring Jesmonite on a dirty base. Group J-DB specimens largely exhibited partial cohesive failure of the base material with the circular area of base material largely being removed (middle and bottom images). The middle image shows an example of cohesive failure with a bulk quantity of base material being removed, this may again be due to less dirt applied to the central circular area on this specimen.

Figure 11d depicts specimens from group J-QF-DB, with Jesmonite and quadaxial fibres applied to a dirty base. This group featured a mix of adhesive failure and partial cohesive failure of the base material, with a small thin quantity of base material evident in the top and middle example specimen images and adhesive failure shown in the bottom example specimen images. It can be observed that there is a varying level of keying being applied ranging from very evident (middle specimen) to not in evidence (top specimen images and the adhesive failure in the bottom specimen images).

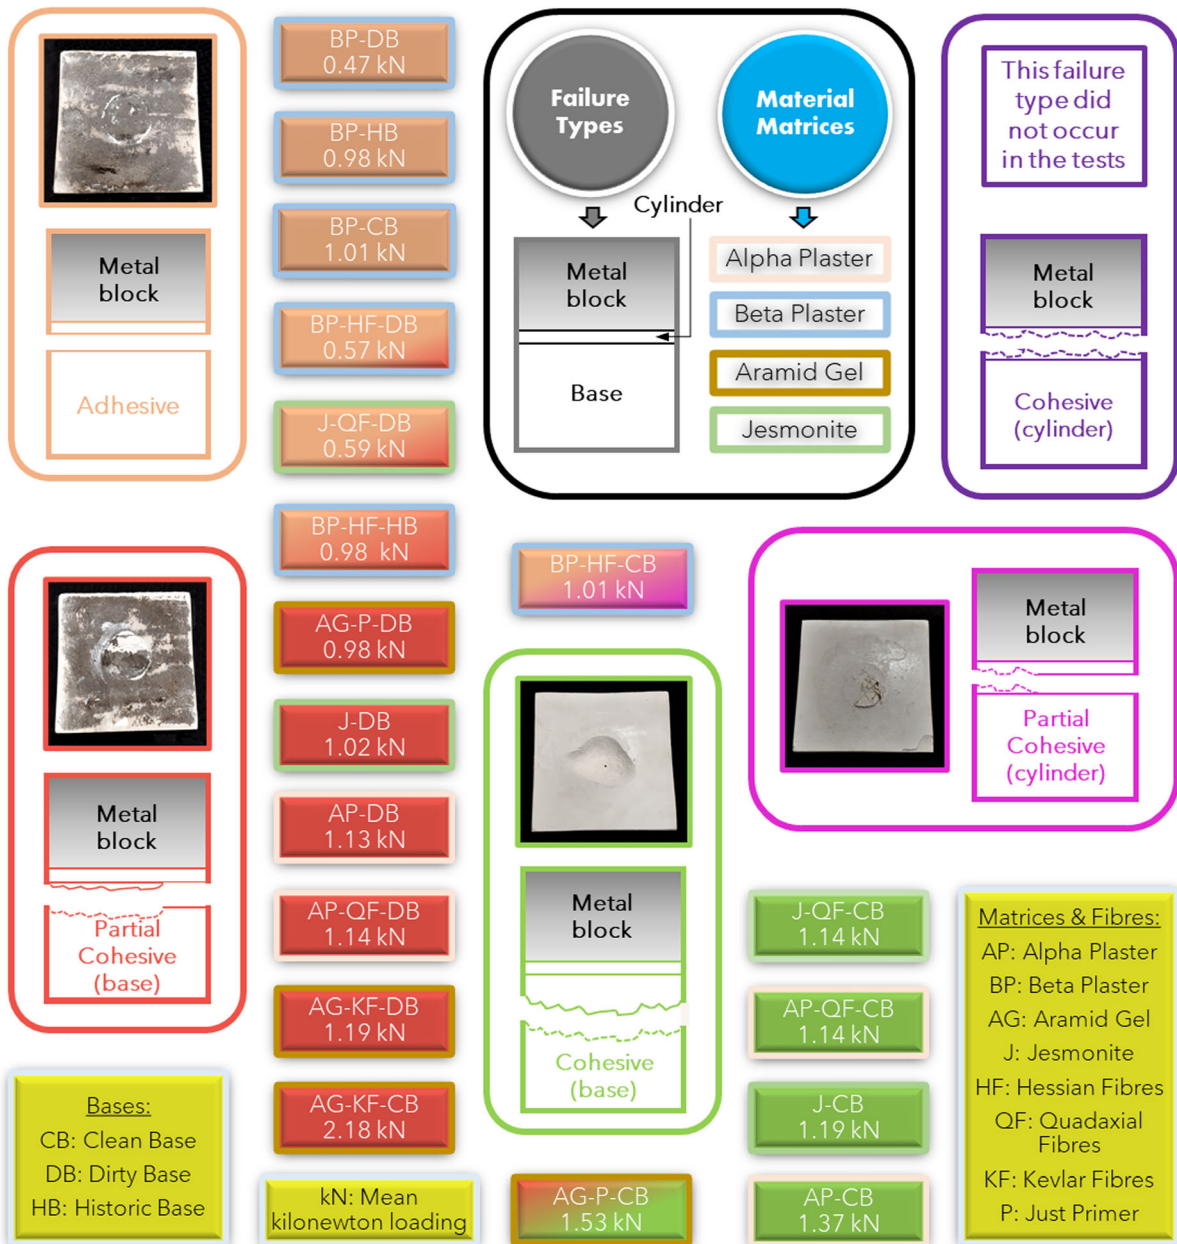
Fig. 12 Visual summary of the predominant failure types for each sample group. Sample group name boxes are fill-coloured to indicate failure type and border-coloured to indicate matrix

material. Sample group boxes also contain the group mean loading required to pull the cylinder off from the base.

Figure 12 contains a visual summation of the failure types of all sample groups which were listed in detail for each specimen in Table 4. The colour coding fill within the sample boxes represents the colour coding of the predominant type of failure within the group, with the box containing a gradient colour fill if two failure types featured significantly within a sample

group. Sample group boxes are border-coloured in accordance with the matrix material, with colours matching those used in the bar colour-fills in Figure 5, Figure 6 and Figure 7. Sample group boxes also contain the mean loading in kN for hat group required to pull-off the applied cylinder from the base. A key for matrices, fibres and bases is contained in the yellow boxes. Full cohesive failure within applied cylinder material did not occur throughout the tests.
