# Monitoring corrosion-induced concrete cracking adjacent to the steel-concrete interface

Andreas Alhede · Jelke Dijkstra · Karin Lundgren

**Abstract** Substantial research effort has been devoted on linking corrosion-induced cracking of concrete with the internal corrosion damage level. Still, numerical models of the corrosion and cracking process require internal parameters, that cannot be directly evaluated from experimental data. Therefore, this study provides a novel experimental method for monitoring the effects of steel corrosion adjacent to the steel-concrete interface. This non-destructive method is suited for small-scale laboratory-made specimen, and was designed to provide missing information required for subsequent calibration of numerical models. Hollow steel bars were cast into concrete and subjected to accelerated corrosion using the impressed current technique. The deformations of the hollow steel bars were measured using distributed strain sensing in an optical fibre, attached to the inner surface of the hollow steel bars. After the corrosion period, X-ray Computed Tomography scans were performed to evaluate concrete cracking and corrosion

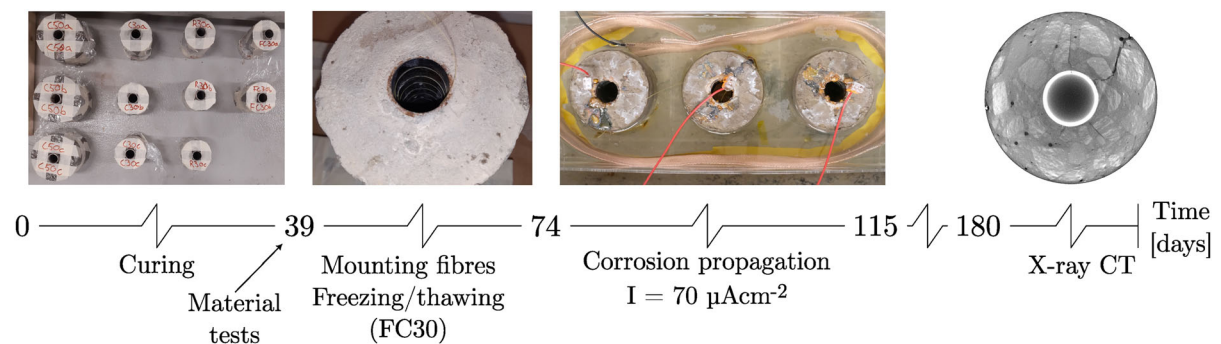
**Fig. 1** Timeline of the experiments. Material tests took place 39 days after casting. The corrosion propagation period started 74 days after casting and lasted for 41 days. Specimens of types

C30, FC30 and R30 were scanned using XCT approximately 180 days after casting

corrosion period, most of the specimens were scanned using XCT, from which cracking and corrosion level were evaluated. A timeline of the test procedure is shown in Fig. 1. In the following, the experimental programme, material and methods are elaborated.

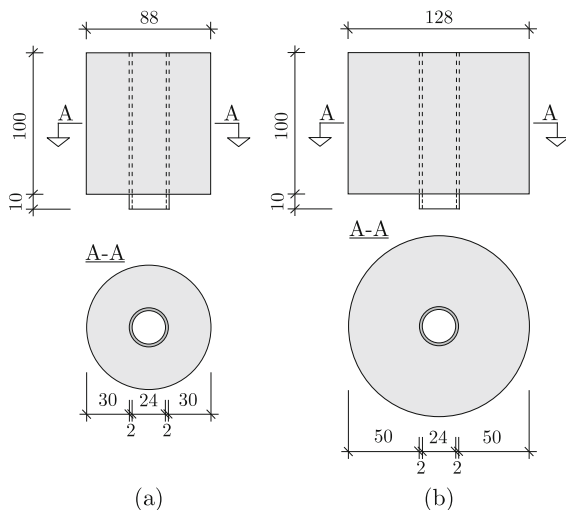
**Fig. 2** Geometry of specimens in series **a** C30, FC30, R30 and **b** C50**Table 2** Concrete mix proportions and mechanical properties measured 28 days after curing

The experimental programme consisted of four different test conditions as listed in Table 1. In addition to the reference tests without accelerated corrosion, the impact of concrete cover thickness and prior freezing damage on the steel corrosion was investigated in additional test types. In total, eleven specimens were included in the experimental programme. The dimensions of the specimens were chosen to ensure a concrete cover thickness of reasonable size compared to the ones used in real structures, while simultaneously achieving a sufficiently high resolution in the XCT scans. Further, the wall thickness and the inner radius of the hollow steel bar were chosen to ensure that the strain on the inside was measurable [19]. All specimens were 100 mm long. The cross-sectional diameter varied from 88 mm for series C30, FC30 and R30, to 128 mm for series C50. A hollow steel bar with outer diameter 28 mm and a wall thickness of 2 mm was cast in the centre of each specimen. The steel bar protruded 10 mm from the bottom surface, see Fig. 2.

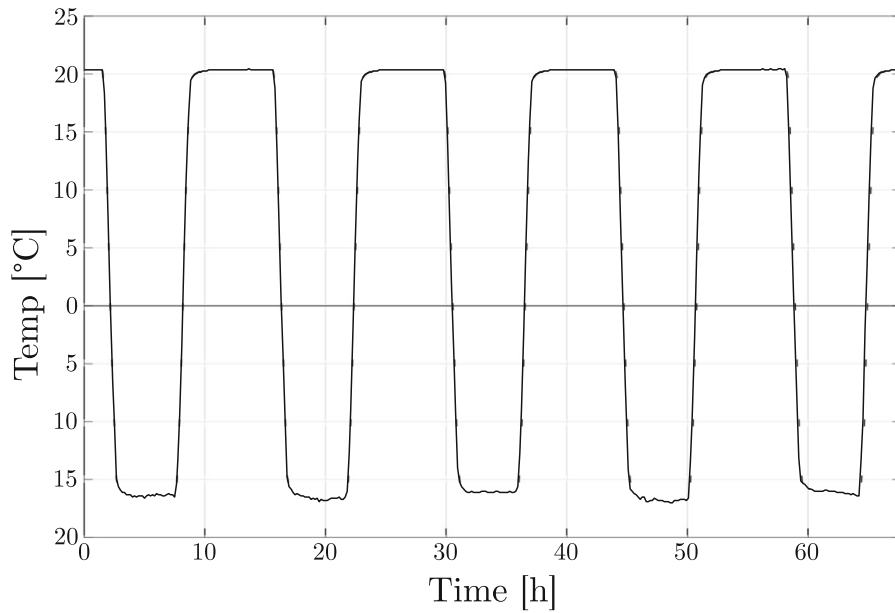
**Fig. 3** Ambient air temperature during the freezing and thawing cycles applied to FC30

Prior to accelerated corrosion, the specimens of type FC30 were subjected to freezing and thawing cycles. The specimens were immersed in water for a short time and thereafter wrapped in plastic film to prevent drying and subsequently placed in a climate chamber. The samples were subjected to five temperature cycles between a maximum and minimum temperature of 20 °C and -16 °C, as shown in Fig. 3. The period of each cycle was 14 h.

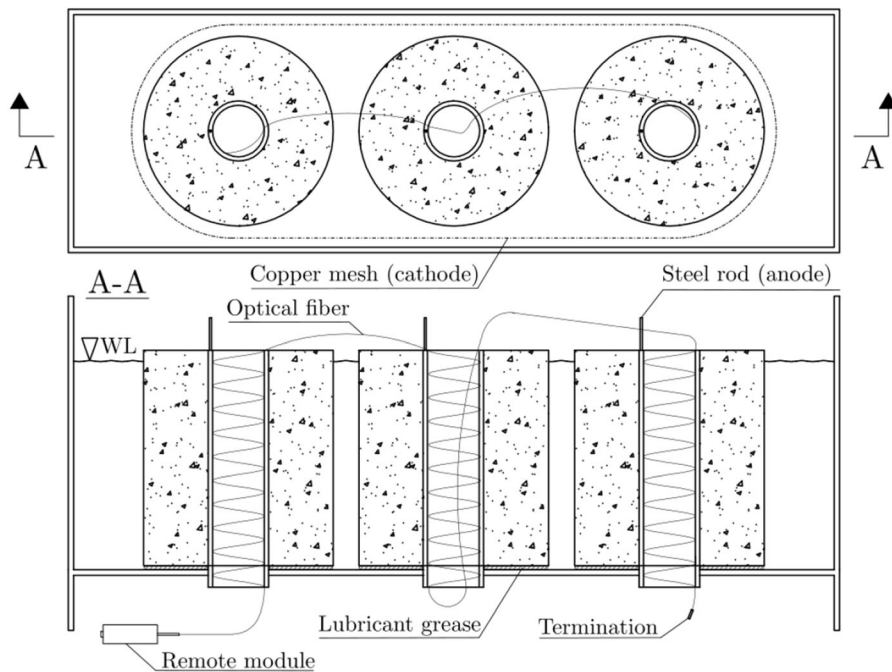
**Fig. 4** Experimental setup for test types C30, C50 and FC30. Electrical current was applied to steel rods, welded to the steel bars, and a copper mesh, acting as a cathode, was placed around the specimens to complete the circuit

To accelerate corrosion, electrical current was applied to steel rods, welded to the hollow steel bars, and a copper mesh, acting as a cathode, was placed around the specimens to close the electrical circuit. The applied current density was limited to  $70\mu\text{A cm}^{-2}$ , which is considered to be a reasonable value to balance the conflicting requirements of mimicking natural corrosion and the need for short duration corrosion tests [24]. A custom made constant current source with multiple channels was used to apply an electrical current for a period of 41 days. This current source maintained the current density by adjusting the magnitude of the potential difference when the electrical resistivity in the sample changed.

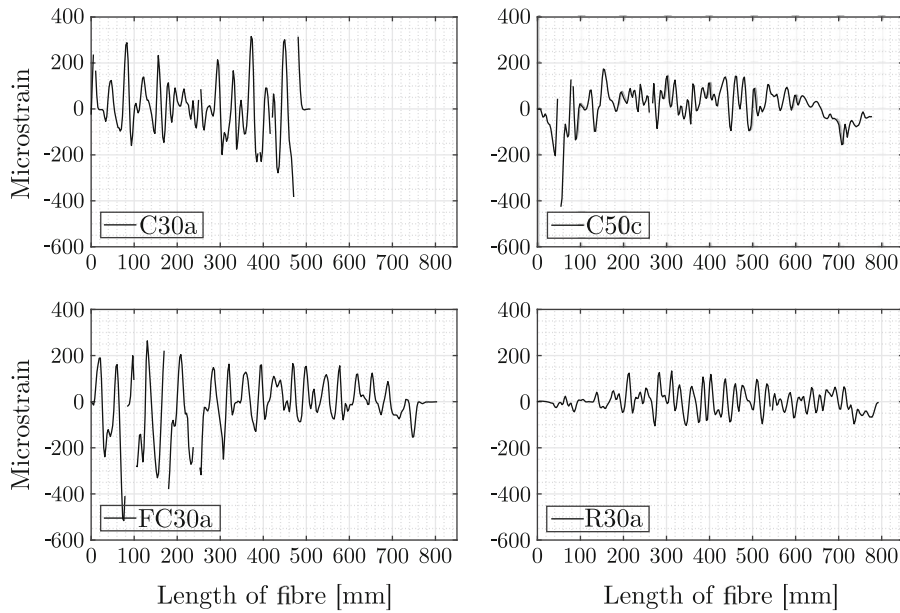
**Fig. 7** Profiles of measured strain for four different specimens after one day of impressed current. The strain measurements start from the top surface of the specimens, i.e. the measurements start from the end facing the air and continue downwards

in the steel bars. Note that the length of the fibre in specimen C30a is shorter compared to the others, as this particular fibre had fewer turns

In Fig. 7, strain profiles along the fibre measured after one day of corrosion propagation are presented for one specimen in each series. In these measurements, the strains are relative to the strain in the specimens prior to the corrosion experiment, as a new reference configuration was initialised for each fibre before corrosion started. As can be seen, the strain profiles for

all specimens displayed fluctuating measures of extension and shortening along the fibre length, indicating a non-uniform distribution of radial stress at the surface of the steel. The reason for this behaviour of strain measurements is further discussed in Sect. 3.4. The reference specimen, R30a, had lower peak values of the strain than the specimens with the same geometry subjected to accelerated corrosion, C30a and FC30a. Also, in general, C50c displayed lower peak values than C30a and FC30a.

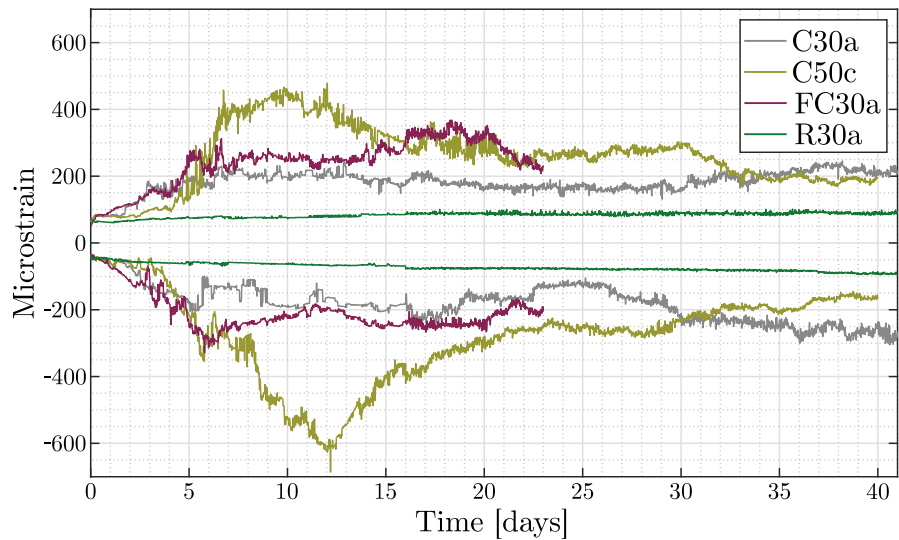
**Fig. 8** Average strain of local maxima and minima of each fluctuation cycle (Fig. 7), respectively, along the optical fibre, as a function of time. (R)eferece, (C)orrosion and (F)rost damaged sample with 30 or 50 mm concrete cover thickness

To study the strain development with time, the mean value of local maxima and minima of each fluctuation cycle were studied (Fig. 7). These mean values and its development with time are shown in Fig. 8 for specimens C30a, FC30a, C50c and R30a. The strain showed the smallest peak values in the reference specimen, R30a. The average strain increment evolved slowly, less than  $\pm 50$  microstrain, over the entire period in this specimen. For specimen C30a, the average strain increased to approximately  $\pm 200$  microstrain after five days of corrosion propagation. After seventeen days, the strain decreased slightly but increased again after twenty-six days. Largest strain magnitudes were obtained for specimen C50c (with a larger cover), with 450 and -650 microstrain measured after 12 days and thereafter reducing values. For FC30a (subjected to freeze-thawing before corrosion), the strain increased in magnitude approximately linearly up to  $\pm 300$  microstrain. Thus, FC30a had slightly larger strain values than the corresponding specimen C30a subjected to corrosion only. Unfortunately, at day twenty-three in the experiment, the fibre broke, which is why no measurements were obtained for FC30a after this period.

The thickness of the concrete cover affected the measured strain in the optical fibre (Fig. 8). For C50c, the strains were larger and the peak occurred later compared to the other specimens. Therefore, a larger

radial pressure and more energy was required to crack the larger concrete cover. For specimens C30a and FC30a, small differences were observed, as seen in Fig. 8. However, no consistent difference could be observed when comparing measurements on all specimens of type C30 and FC30. This may be related to the small number of freeze and thaw cycles (5) applied prior to corrosion, thus their limited impact on the capacity of the concrete cover [28, 29].

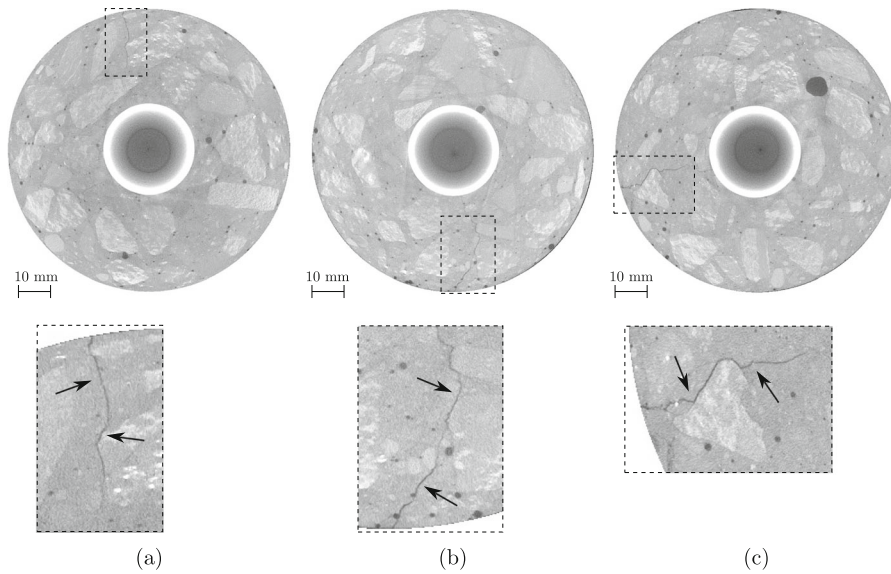
**Fig. 9** One cross-sectional slice of **a** R30a, **b** R30b and **c** RC30c, respectively. The images reveal cracking, as indicated by the solid black arrows

XCT was carried out on the specimens of types C30, FC30 and R30 after the corrosion phase. Figure 9 shows one cross-sectional slice for all reference specimens (R30). Cracks in the concrete cover can be identified for all specimens, as indicated with solid arrows. The width of the cover cracks increased with the radial distance from the steel. The XCT data did not reveal corrosion products in the scanned reference specimens, indicating non-corroded condition of the steel. Hence, cover cracking of the reference specimens was probably caused by another mechanism than

In Fig. 9, the XCT data revealed the presence of longitudinal cracks in the concrete of the reference specimens. These cracks were determined to be unrelated to corrosion, as the steel appeared non-corroded in the XCT data which was further corroborated after sandblasting of the extracted steel, as shown in Table 3. All specimens underwent two drying phases; when the optical fibres were mounted and prior to the XCT scan (see Fig. 1). During these phases, drying shrinkage took place, thus imposing restraint stresses in the specimens prior to the corrosion experiment. Despite cracks were not observed on the surface of the specimens prior to the corrosion experiment, the possibility exists that restraint stresses and subsequently internal micro-cracks were induced by shrinkage. However, as a new reference configuration was established for the fibres with respect to these restraint stresses prior to the corrosion experiment, only the change in strain from this state was monitored (Figs. 7 and 8). Therefore, any quantitative assessment of these restraint stresses in the specimens before corrosion started could not be performed.

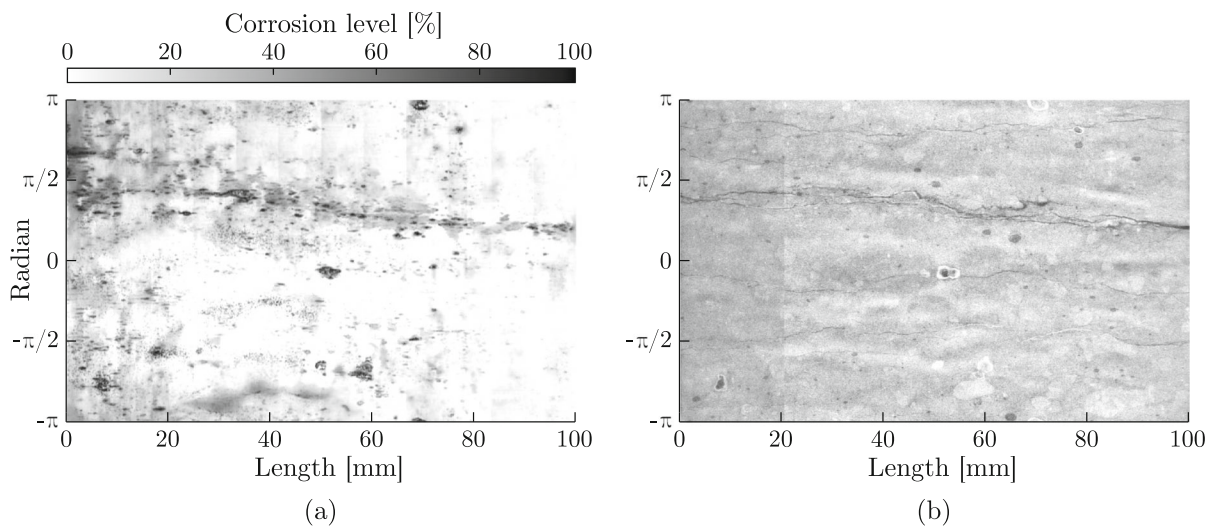
**Fig. 10** C30a **a** Corrosion level, and **b** internal cracking as a function of radian and length of the specimen

In Fig. 10, a contour plot of the corrosion level and XCT data revealing internal concrete cracking close to the steel is shown for C30a, over both the radian and length of the specimen. The left and right vertical boundaries of each figure corresponds to the top and bottom side of the specimen, respectively. The internal

cracking in Fig. 10b was evaluated at a radial distance 1.6 mm from the surface of the bar, see circle R1 in Fig. 12a. The evaluation of grey-scale values at the positioning of the circle was done by interpolation of nearest-neighbouring pixels. Note that the corrosion levels are quite large, up to 98%, as they were calculated for the tube, not a solid bar. The corrosion level appears to be non-uniform around the bar, with a

localised band of corrosion along the length. Interestingly, a larger crack (Fig. 10b) can be seen in the same region. In total, five radial cracks can be identified. Some deep corrosion pits can also be observed (Fig. 10a), and it can be noticed that their location agrees with air voids visible in Fig. 10b.

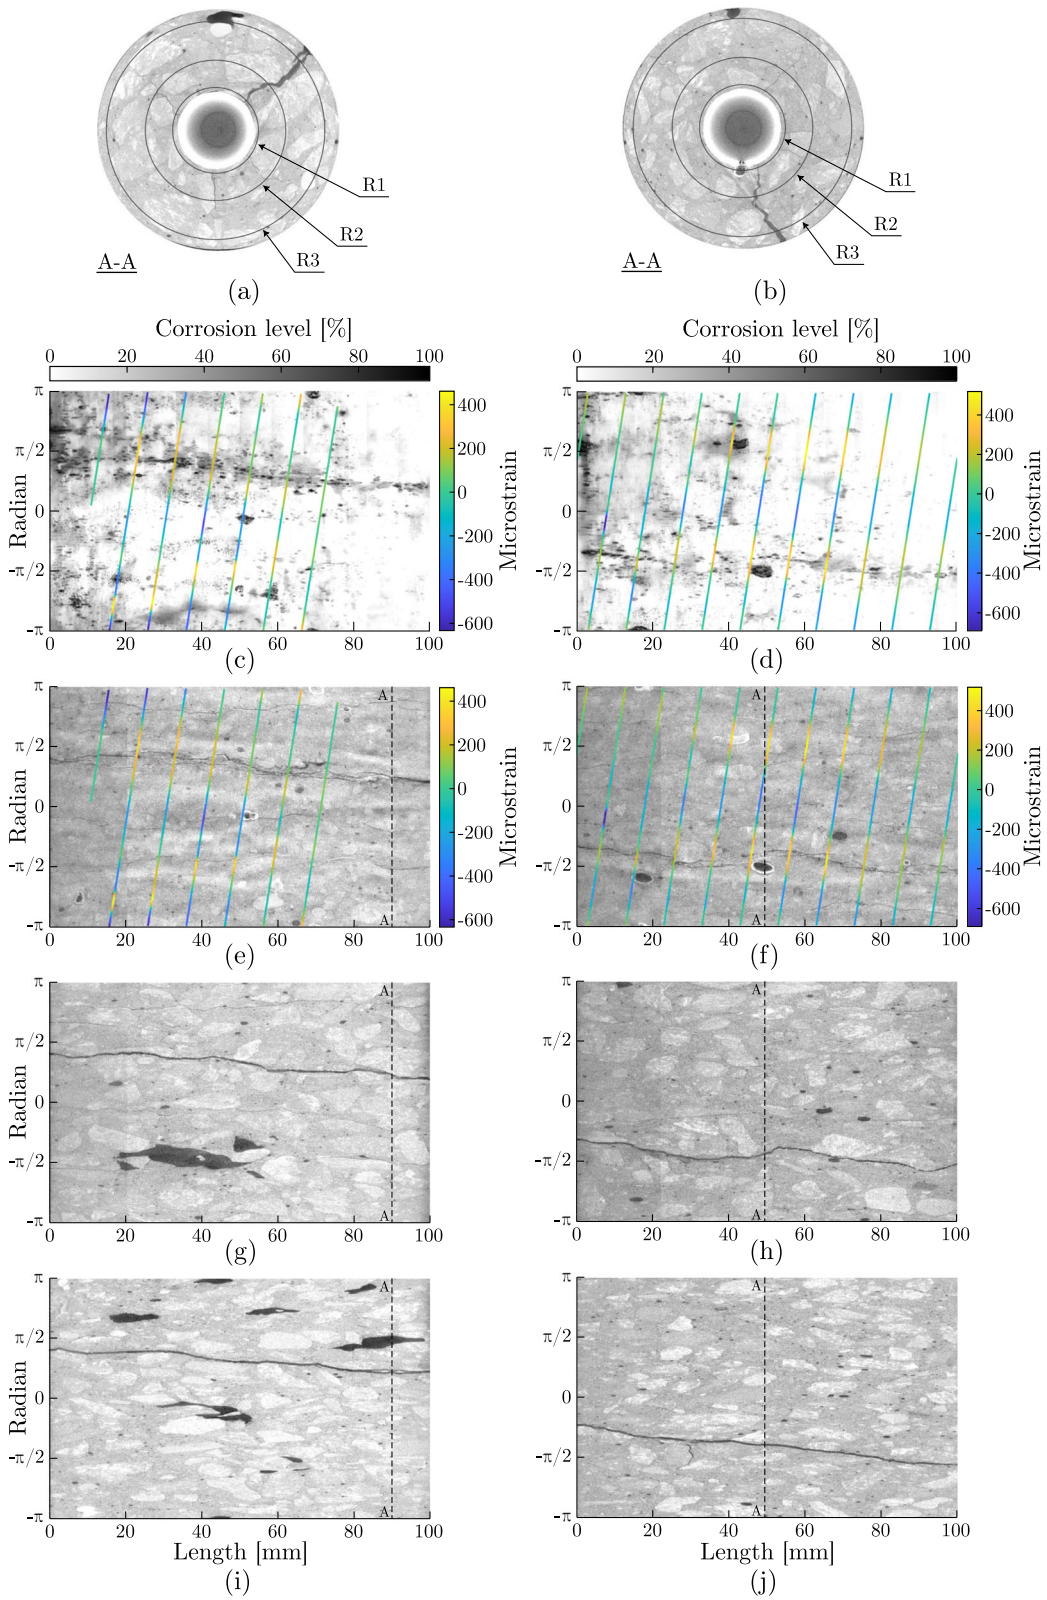
◀ **Fig. 12** Corrosion level, concrete cracking and strain measurements along the optical fibre, shown for C30a (left column) and FC30a (right column). **a–b** One cross-sectional slice of each specimen. **c–d** Corrosion level and strain measurements at the end of the experiment. **e–f** Internal concrete cracking, evaluated at radius R1, and strain measurements at the end of the experiment. **g–h** Internal concrete cracking evaluated at radius R2. **i–j** Internal concrete cracking evaluated at radius R3

The interaction between corrosion level, measured strain in the fibre, and concrete cracking was studied for C30a and FC30a and shown in Fig. 12. Below the cross-sectional slices of the specimens (i.e. Fig. 12a–b), the corresponding distribution of corrosion level and measured strain in the fibre at the end of the corrosion phase are shown (Fig. 12c–d). Analogously, the distribution of concrete cracks are evaluated at three different radial distances from the surface of the steel bars. Figure 12e–f show the distribution of concrete cracks along radial distance R1 for each corresponding specimen, with the measured strain as an overlay. Cracking shown in Figs. 12g–h and 12i–j are evaluated along radial distance R2 and R3, respectively. Close to the SCI, several micro-cracks can be observed (Fig. 12e–f). However, cracking localised into one larger crack for each specimen, as seen in Fig. 12g–j. A localised band of corrosion runs along the length of both specimens, correlating well with the position of the larger cover crack. This indicates that corrosion localised into bands in these regions after cracking of the cover. The hollow steel bars displayed extension strains in the regions where the dominant crack was located. This is clearly visible for FC30b (Fig. 12f), where the peaks in strain along the fibre follows the crack pattern with good precision. For C30a (Fig. 12e), the locations of the peak values in strain correlate well with the crack pattern for the first three turns of the fibre, but deviates slightly for subsequent turns. This deviation is likely due to uncertainties in the positioning of the fibre, which was difficult to determine. For the data presented herein, the extension strains, measured in correspondence to the cover crack, can be interpreted as indicative of stress relief, as the strain measurements are relative to the residual state prior to corrosion.

The distribution of hoop strain around the steel was found to be non-uniform for all specimens during the complete corrosion experiment, with hoop strains varying from extension to shortening. Additionally, a non-uniform distribution of corrosion products was observed in all specimens exposed to accelerated corrosion, i.e. C50c (Fig. 11), C30a and FC30a (Fig. 12). These specimens showed a localised band
