Evolution of self-healing performance of UHPC exposed to aggressive environments and cracking/healing cycles

Bin Xi · Liberato Ferrara

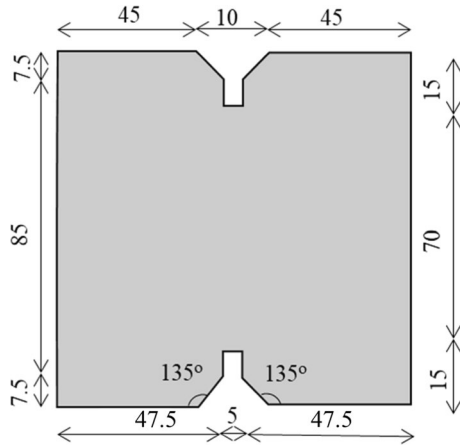
**Fig. 1** Geometry of DEWS sample(unit:mm)

Large slabs of UHPC were cast and subsequently cut into beams with $500 \times 100 \times 50$ mm [7, 28]. These beams were then stored at a controlled temperature of 20 °C and humidity of 90% for a maximum duration of 1 year to minimize the impact of delayed hydration on the self-healing properties. To assess the relationship between tensile stress and crack opening displacement (COD), the beam samples were further processed into double edge wedge splitting (DEWS) samples, as depicted in Fig. 1. Previous studies have confirmed that this testing methodology is particularly effective for straightforward identification of UHPC tensile constitutive behaviour [24, 26, 28].

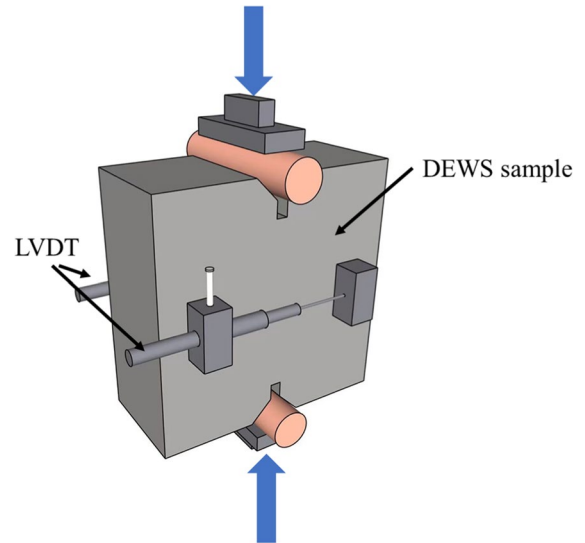
**Fig. 2** Set-up of pre cracking test

The DEWS samples underwent a pre-cracking phase under displacement-controlled Instron machine, with a loading rate of 0.005 mm/s. The crack opening displacement (COD) at the midsection of both sample surfaces was recorded using linear variable differential transformers (LVDTs), as illustrated in Fig. 2. Once the average COD measured by the LVDTs reached 0.30 mm, unloading tests were

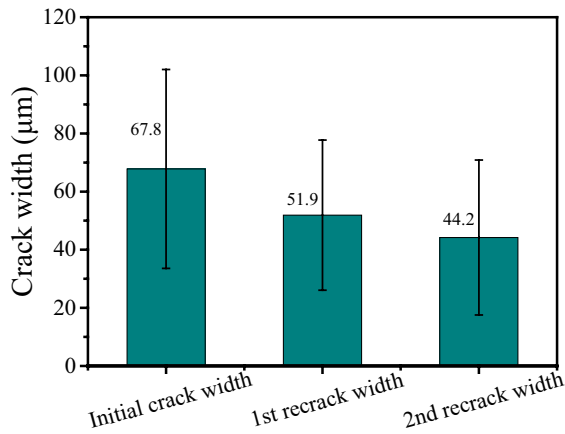
**Fig. 3** Distribution of crack width (The error bar is standard deviation)

Figure 3 shows the distributions of crack width for the samples after initial cracking, 1st and 2nd re-cracking. The average crack widths of UHPC samples are 67.8 µm, 51.9 µm and 44.2 µm after initial cracking, 1st and 2nd re-cracking respectively. The inherent variability in material properties and fiber dispersion, which could potentially influence the unloading response, may be invoked to rationalize the observed dispersion in crack width at the conclusion of unloading. In addition, reference samples without crack/healing cycles were set up for each stage. The reference samples were exposed continuously for 1 month, 3 months and 6 months after pre-cracking, and then subjected to splitting tests until failure. Also in this case for each exposure condition and duration three nominally identical specimens were tested.

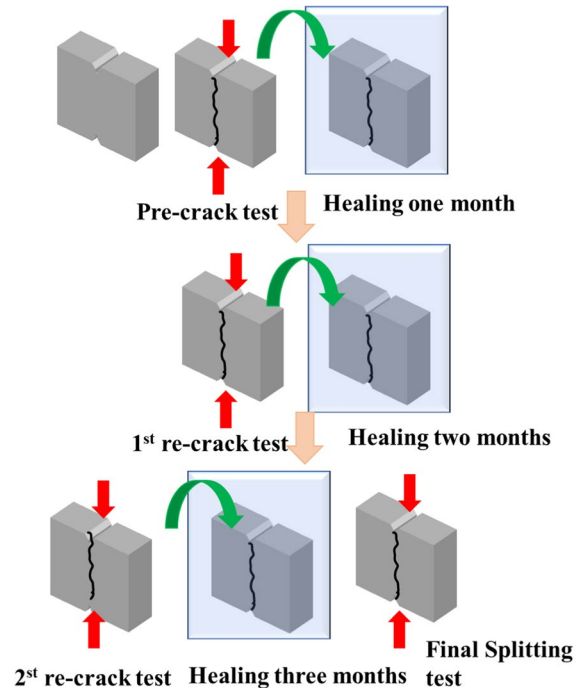
**Fig. 4** Scheme of cracking-healing cycles

Figure 4 presents the crack/healing cycles scheme:

1. pre-cracked samples → immersion in tap/salt/geothermal water for 1–3–6 months without 1st and 2nd re-cracking and healing cycles → final splitting test;
2. sample with 1st and 2nd re-cracking and healing cycles: pre-cracked samples → healing in tap/salt/geothermal water for 1 month → 1st re-cracking and healing cycle → healing in tap/salt/geothermal water for 2 months → 2nd re-cracking and healing cycle → healing in tap/salt/geothermal water for 3 months → final splitting test.

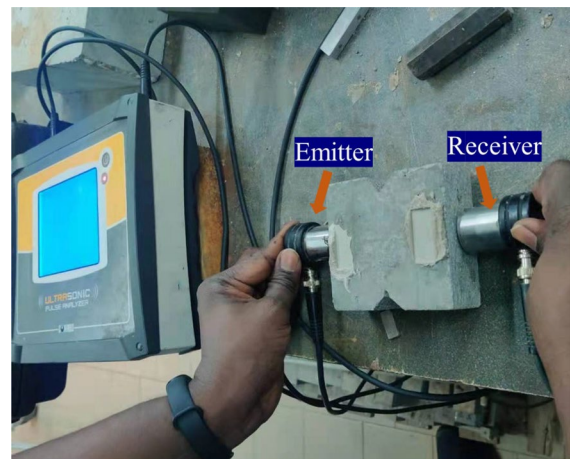
Fig. 6 Schematic diagram of UPV

The UPV test is a well-recognized and frequently employed method for assessing both the damage and self-healing capabilities of concrete [19, 30–32]. It involves the measurement of the velocity of the sound waves that propagate between an emitter and a receiver through the concrete. The velocity of these waves changes when passing through a discontinuity,

typically a crack in concrete, as a function of the depth and width of the same crack. For the experiments conducted in this study, the distance between the transmitter and receiver was kept constant at 100 mm, equal to the specimen dimension, as illustrated in Fig. 6. The diameter of the transducer used for the test was 50 mm, and the frequency of the signal used was 50 kHz. The UPV tests were conducted on three types of samples: intact, pre-cracked, and sealed at different time periods. To calculate the wave velocity, the transmission time of the wave through the sample was recorded.

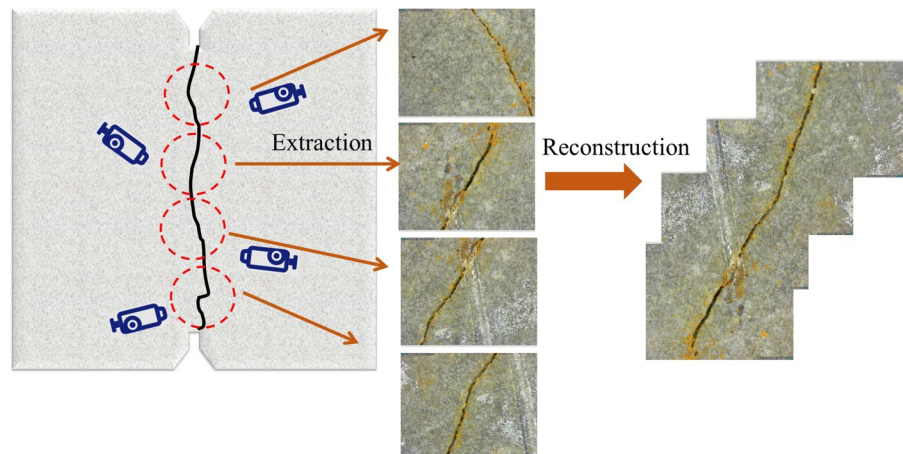
Fig. 5 The process of crack extraction and reconstruction

The crack width in the samples was recorded at different curing times using a digital optical microscope and the DinoLite Capture software. To capture the complete crack, multiple photographs of each crack were merged in Phothoshop®, as shown in Fig. 5. The area (A_{area}) and length (l_{length}) of the cracks were then determined using the mathematical and statistical tools available in Phothoshop®. The average crack width was obtained by dividing A_{area} by l_{length} . The crack closure capacity was assessed by calculating the crack self-sealing index (ICS) according to Eq. (1).

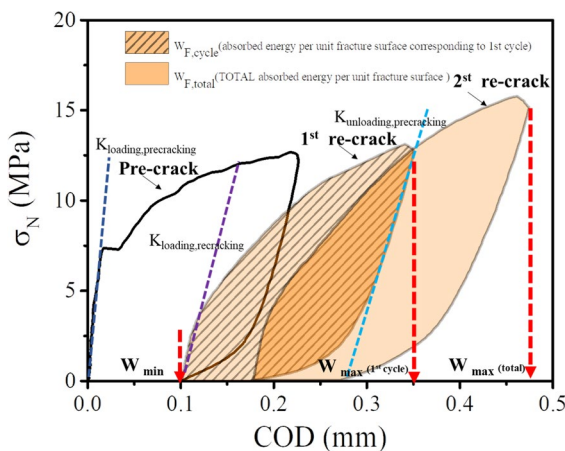
Fig. 7 Example of tensile stress (σ_N) versus COD curves. Methodology definition to obtain the absorbed energy per unit fracture surface (W_F), and $K_{unloading,precracking}$, $K_{loading,precracking}$ and $K_{loading,recracking}$

The study focused on analysing the mechanical property recovery of DEWS samples through stress versus COD curves obtained from pre-cracking and post-healing re-cracking/failure tests. This was achieved by calculating the Index of Stiffness Recovery (ISR) and the equivalent post-healing re-cracking tensile stress σ_{eq} . The methodology employed for this analysis is succinctly delineated in Fig. 7, along with the corresponding Eq. (3). Equation (4) allows for the computation of the equivalent post-healing re-cracking tensile stress σ_{eq} , which is determined by dividing the work of fracture by the change in crack width [33], as also shown in Fig. 7.

where $K_{unloading,precracking}$ denotes initial unloading stiffness in precracking test; $K_{loading,precracking}$ represents initial loading stiffness in precracking test; $K_{loading,recracking}$ represents re-cracking stiffness in re-cracking test.

ISR calculations were performed for each tested sample under different environments and time intervals using Eq. (3) and Fig. 7. Figure 11 illustrates that, after 1 month, varying degrees of stiffness recovery are observed in all samples. The ISR values are calculated as 25.8%, 20.1%, and 15.6% for tap water, salt water, and geothermal water, respectively. This indicates that the cracks are not only sealed but also healed. The cracked UHPC exhibited the ability to restore its mechanical properties due to the self-healing effect.

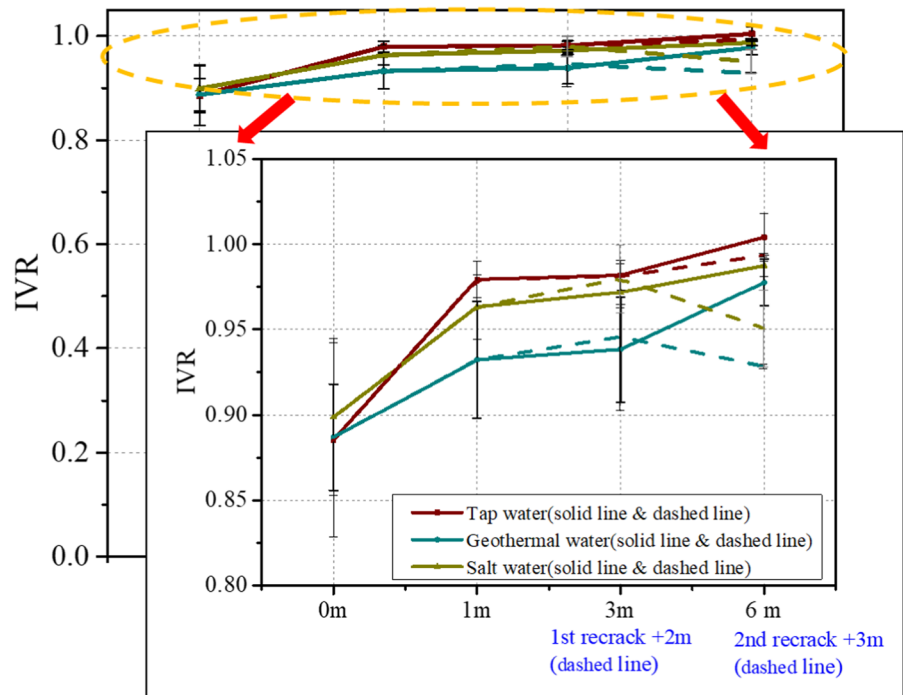
Fig. 8 Comparison of IVR (The reference samples are represented by solid lines, while the re-cracked samples are depicted with dashed lines.)

IVR measurements were conducted on samples exposed to three different types of water: tap water, saltwater, and geothermal water, over varying time intervals. The IVR values, depicted in Fig. 8, demonstrate a consistent upward trend with prolonged exposure durations, indicating the occurrence of a self-healing mechanism within the cracks. Notably, the healing rate is most pronounced in tap water, while it is least effective in geothermal water. For reference, after 1 month, the IVR values are recorded as 0.98 for tap water, 0.963 for saltwater, and 0.932 for geothermal water. Subsequently, after 3 months, the IVR values exhibit marginal improvement, reaching 0.982, 0.972, and 0.938 for tap water, saltwater, and geothermal water, respectively. The IVR values of samples exposed to tap water during the first crack/healing cycle, closely resembled those of samples continuously soaked in tap water (Reference) for 3 months. Samples exposed to saltwater and geothermal water exhibit heightened IVR values after the first cracking/healing cycle. These values are not only comparable but, in some individual cases, surpass the values observed in samples consistently immersed in the same water conditions. Specifically, the average IVR values for saltwater and geothermal water

are measured at 0.98 and 0.946, respectively. The close proximity of these values suggests that the first re-cracking does not adversely affect the self-healing performance. This resilience is attributed to the formation of new reactive products, facilitated by the exposure to the healing environment, which incorporates fresh, unreacted material into the reopened cracks.

Nonetheless, as the samples undergo the 2nd crack/healing cycle, it became evident that the velocity recovery significantly diminished in samples exposed to the water environment for a total of 3 months in comparison to those subjected to continuous immersion for a more extended period of 6 months. To illustrate, after 6 months of exposure to tap water, the IVR value for the samples is recorded at 1.004. Subsequently, in the 2nd cracking/healing cycle, the IVR value dropped to 0.993, which means that the ability to recover speed was weakened, but the value was still higher than 0.981 in the first cracking/healing cycle. For specimens exposed in aggressive environments after 2nd crack/healing cycle, the IVR value was at 98% of the first cycle and 97% in salt water and geothermal water, respectively, but the specimens still recovered more than 95% of the specimen's IVR value after initial cracking.

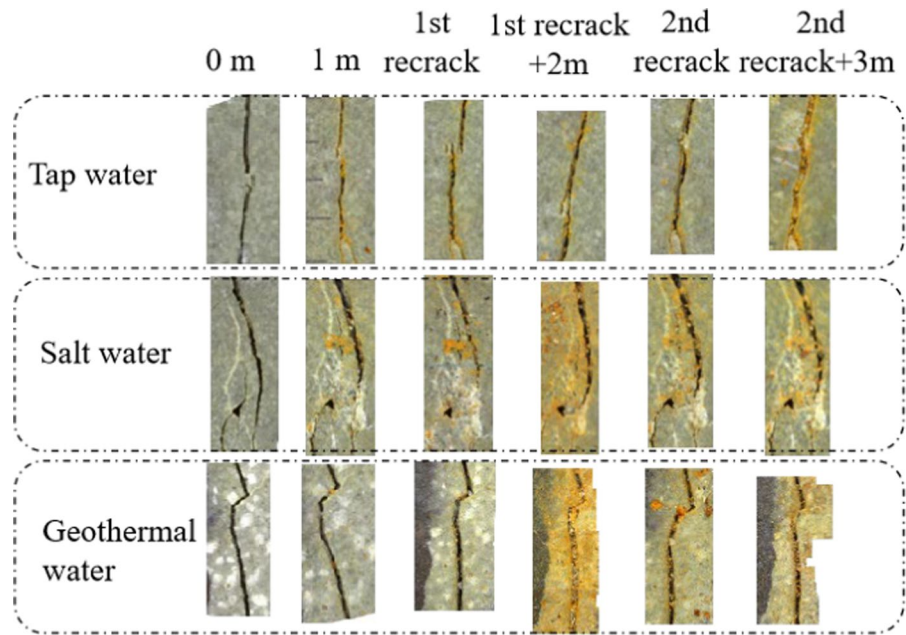
Fig. 9 Variation of crack width in different environments and times

The typical change of crack width with exposure time in different water environment is shown in Fig. 9. Figure 10 further illustrates the variations in ICS over time for tap water, salt water, and geothermal water. The results demonstrate varying degrees of self-healing effects in all three environments as the exposure time increases. After 1 month, the ICS values for tap water, salt water, and geothermal water are 66.2%, 60.9%, and 44.7% respectively. This trend aligns with the findings of the UPV in first month.

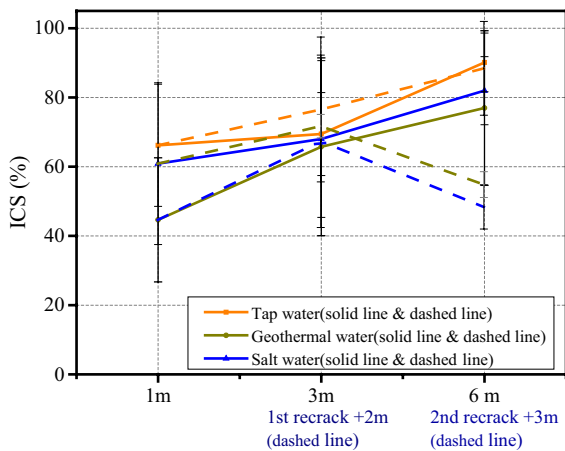
Fig. 10 Comparison of ICS (The error bar is standard deviation—The reference samples are represented by solid lines, while the recracked samples are depicted with dashed lines.)

Additionally, after the 1st crack/healing cycle, the ICS values reach 76.5% in tap water, 71.7% in saltwater, and 67.4% in geothermal water. Notably, these figures exceed the ICS values observed in samples consistently exposed to tap water and geothermal water over a 3-month period. This phenomenon unfolds due to the reopening of partially sealed cracks, allowing for deeper water penetration into the crack inside. Subsequently, this triggers an extensive hydration reaction, facilitating the closure of these cracks.

healing cycle, the ICS significantly decreases compared to samples exposed to water continuously for 6 months. The ICS values register at 88.4%, 54.9%, and 48.4% for exposure to tap water, saline water, and geothermal water, respectively. These values are notably inferior to those exhibited by samples subjected to continuous water exposure for the aforementioned 6-month duration, which record ICS values of 90.1%, 82%, and 76.9%, respectively. The ICS values

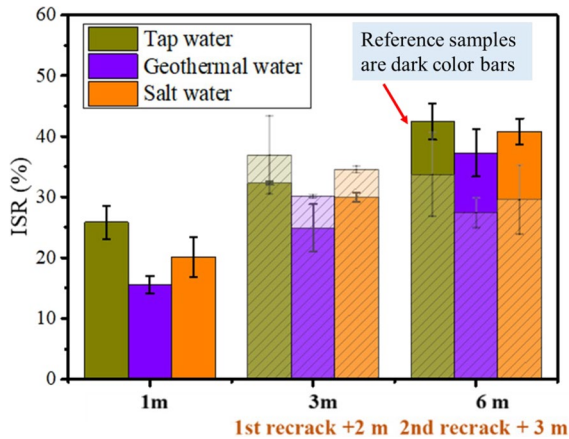
Fig. 11 Comparison of ISR values. (re-cracked samples are transparent bars)

After undergoing 3 months of continuous water exposure, the ISR values exhibit notable improvements, with values reaching 32.3% for tap water, 30% for saltwater, and 24.9% for geothermal water. Notably, the samples subjected to the 1st cycle display

higher ISR: 36.9% for tap water, 34.5% for salt water, and 30.2% for geothermal water. This observed trend is consistent with the findings regarding UPV and ICS. The prolonged exposure of the crack to water leads to increased hydration reactions, and re-opening the cracks allows more Ca^{2+} to be released from the cement to penetrate inside the cracks, where they are more involved in the healing reaction thus promoting crack closure.

However, it is crucial to note that, following the 2nd cycle, ISR values exhibit a significant decline when compared to the values obtained after 6 months of continuous water exposure. The ISR values decreased to 33.7% for tap water, 29.5% for saltwater, and 27.4% for geothermal water after 2nd cycle. These figures align closely with those observed after just 3 months of continuous water immersion. Repeated loading exacerbates the damage and, which, with the progressive consumption of the available reactive particles in the UHPC sample, contribute to decrease the level of self-healing and stiffness recovery.

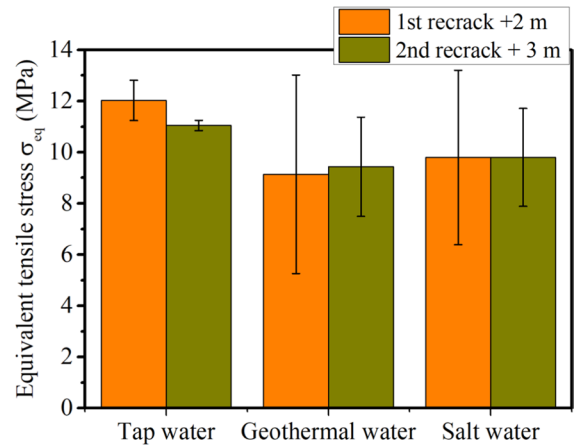
Fig. 12 Comparison of equivalent tensile stress σ_{eq}

Furthermore, Fig. 12 presents the calculations for equivalent tensile stress σ_{eq} . After the 1st re-cracking,

σ_{eq} exhibit the highest value in tap water at 12 MPa. It is closely followed by saltwater, reaching at 9.8 MPa, and geothermal water, which has the lowest σ_{eq} value of 9.1 MPa. Following the 2nd cracking, these values are 11, 9.8, and 9.4 MPa, respectively, for the aforementioned water environments. The calculated values in equivalent tensile stress, and their trends for the different loading and healing scenarios, provide further confirmation to the evidence, put forward e.g. in [34], that the mechanical crack healing phenomena also occurs at the fibre-matrix interface level, affecting the recovery/persistence of the fibre-matrix bond and hence directly resulting into the calculated recovery of the mechanical capacity [34].

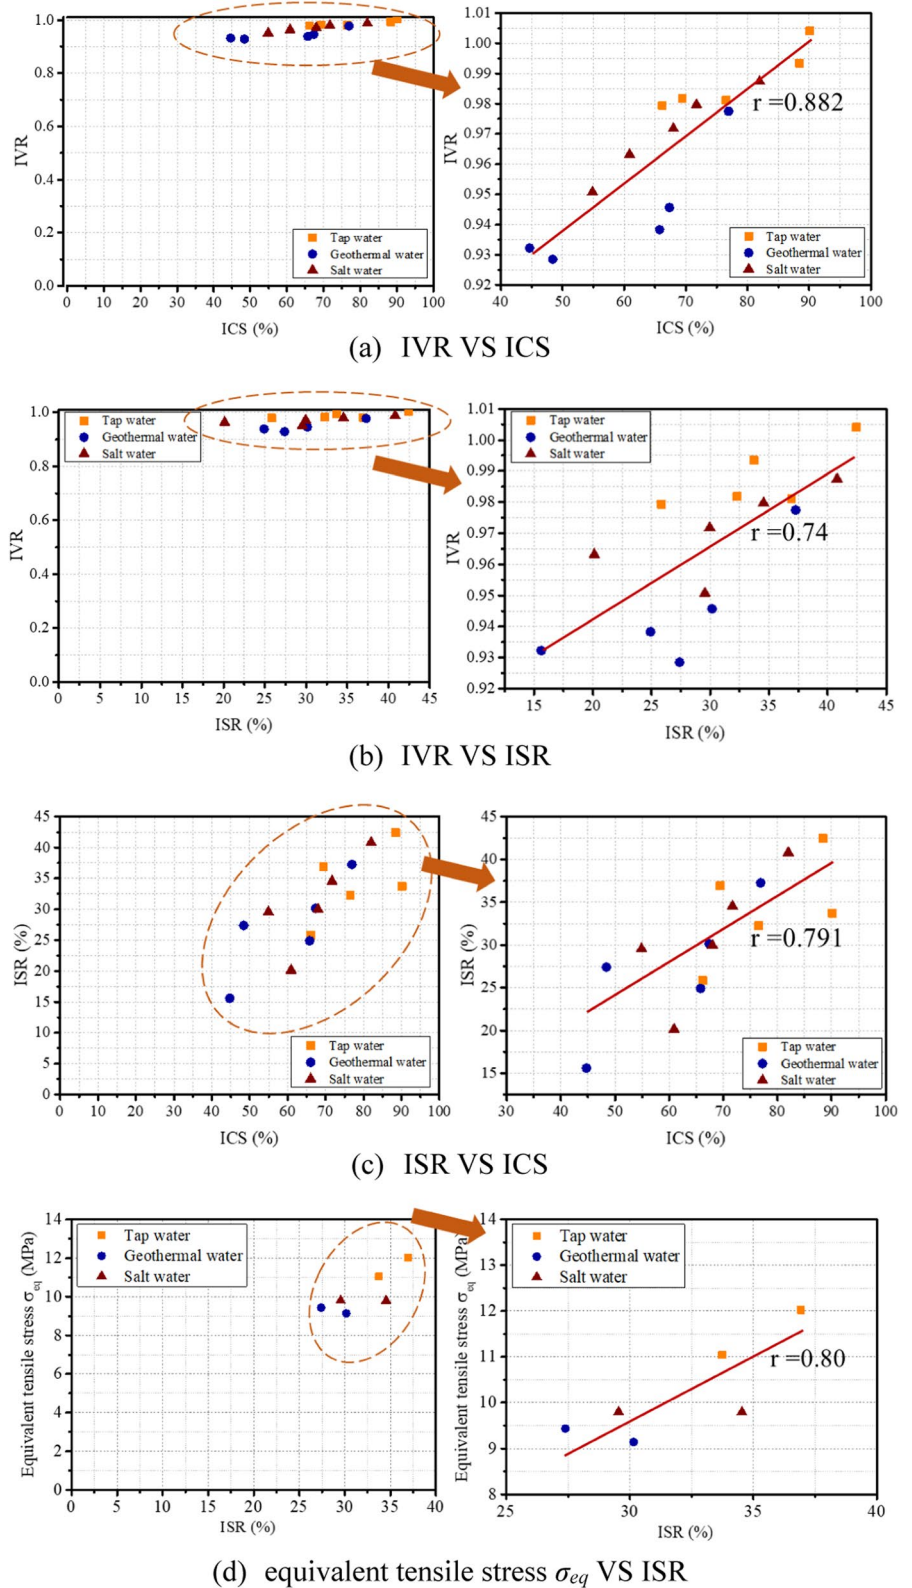
Fig. 13 The relationship between the evaluation indicators of self-healing effect

Figure 13 plots the relationships between the indicators. Their Pearson correlation coefficients (r) are more than 0.5, showing positive correlation. This further confirms that the mechanical properties and the level of self-healing recovery are highly correlated. ICS is from a microscopic observation of the crack surface, while IVR is from a qualitative measure of internal crack closure. Both indicators show a very high correlation coefficient ($r=0.882$), suggesting that crack healing exists not only on the crack surface but also within the crack. This promotes further recovery of the mechanical properties. It is worth noting that an ISR greater than 35% requires significant crack healing (ICS greater than 70%).

In addition, Fig. 13d shows that the equivalent tensile stress σ_{eq} and ISR also exhibit a strong correlation coefficient ($r=0.80$). The increased level of self-healing also enhances the properties of the interface between the fibres and the matrix, allowing further recovery of the overall mechanical properties obtained.
