Research on residual bending capacities of used wood members based on the correlation between non-destructive testing results and the mechanical properties of wood*

Abstract: To quantitatively assess the residual strength of wood members after rot and infestation using non-destructive testing (NDT), the multi-point Resistograph method was applied to test six used wood beams with initial imperfections. Each wood beam was then divided into a shorter segment for mechanical tests and a longer one for bending capacity tests. With the help of finite element analysis using ANSYS, bending capacity is predicted by taking account of the initial imperfections. Results show that there is a significant correlation between drill resistance values and strengths for small specimens. Therefore, the strengths of wood at other measurement points may be obtained through drill resistance values. The beams showed a near linear behaviour up to the maximum load with poor ductility performance in bending capacity tests. It can also be found that the effects of initial imperfections on failure modes and ultimate loads are significant. The lateral side of specimen BA1 has serious infestation and the bottom

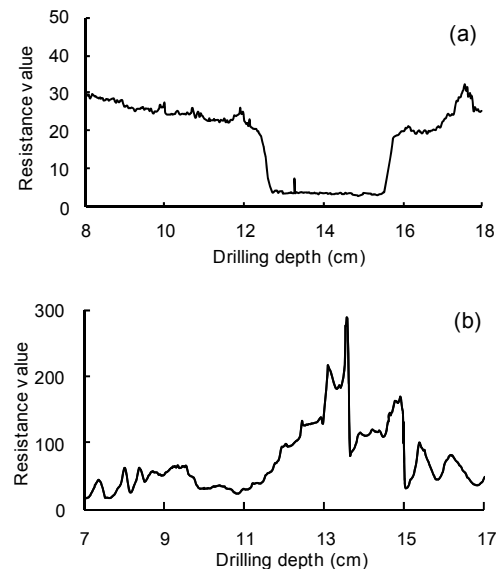
Fig. 1 Resistance-depth curves tested by the Resistograph (a) Serious insect parts of Douglas fir; (b) Knot positions of Douglas fir

measurement point toward the pith. The initial imperfections of the wood beams were detected by the Resistograph. With the help of an electric motor, a probe of the Resistograph was drilled into the wood member at a constant rate. The voltage of motor is constant, and the size of electric current responds to the drill resistance. So a relationship between the drill resistance value and the depth is obtained. Some drill resistance curves are shown in Fig. 1. The horizontal axis of the curve represents the depth of the probe piercing, and the vertical axis represents the drill resistance of the probe. Wood density changes and internal decay, cracks, insects, etc. will change with drill resistance values, which will be shown on the curve.

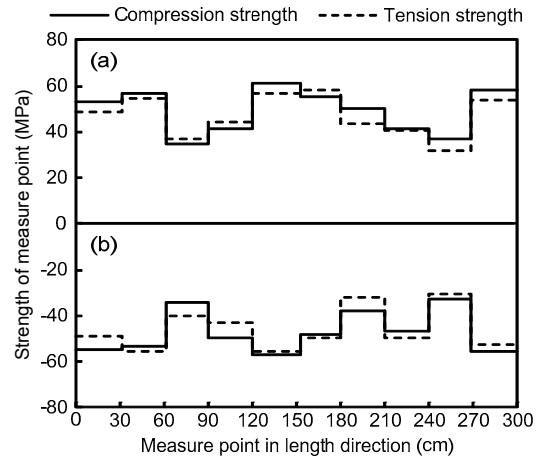
Fig. 3 Interval strength represented by each measure point in BA1
(a) Upper half of the beam; (b) Below half of the beam

For the large segment of wood beam used in the capacity test, substituting the drill resistance value into Fig. 2, we can obtain the strength of the small specimen considering the influence of damage by insects. As can be seen from Fig. 3, BA1 was divided into many zones and one measure point was set in each zone. It can be assumed that the strength of these measure points represents the strength of each zone. Other wood members are similar. Note that knots must be avoided when the beam is tested because the resistance value obtained from knots does not reflect the real strength of the zone.

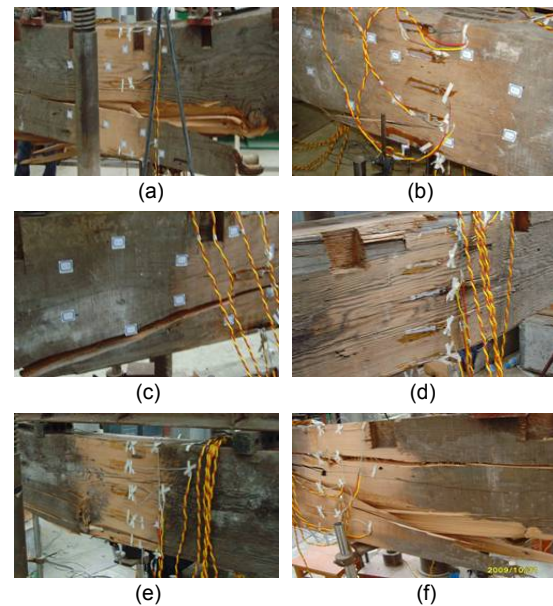
Fig. 4 Failure modes of timber specimens
(a) BA1; (b) BA2; (c) BA3; (d) BB1; (e) BB2; (f) BB3

Failure modes and ultimate loads of other wood beams are shown in Table 3 and Fig. 4.

These six beams all had initial imperfections of varying degree. These imperfections influenced failure modes and ultimate loads. There was severe insect damage in BA1 before loading and its ultimate load is lower. There were some big cracks in BA2 before loading and it was finally damaged along cracks with lower ultimate load than other beams without initial cracks. The ultimate loads of BA1 and BA2 are

67.6% and 64.8% of that of BA3, respectively. There were big knots at the bottom of BB1 and BB3. They were both damaged by wood fractures around those knots. The ultimate loadings of BB1 and BB3 are 83.9% and 81.0% of that of BB2, respectively.

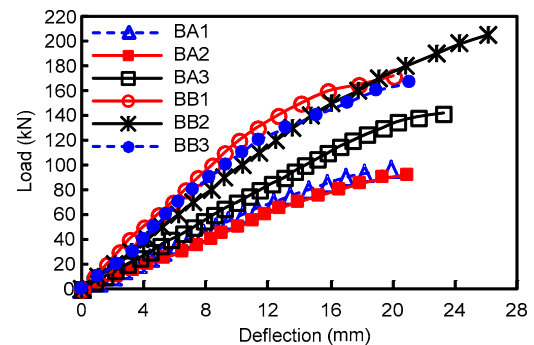
Fig. 5 Load-deflection curves of BA and BB

Load-deflection curves of these two groups are shown in Fig. 5.

From Fig. 5, it is shown that the ultimate load and the rigidity of BA3 are larger than those of BA1 and BA2. Damage of BA1 by insects was much more serious, and there was a large crack at the bottom of BA2. So these two specimens both had obvious initial

imperfections before loading. Load-deflection curves of these three specimens were almost linear from loading to failure. It means that the ductility of these three specimens is poor and failures are basically brittle.

Big knots in BB1 and BB3 at the bottom influenced their mechanical performance. Ultimate loads of them were both less than BB2. The stiffness of BB1 was the largest. At the initial stages of loading, the stiffness of BB3 was large but at the latter stages, the stiffness decreased gradually after wood fractures around knots. Load-deflection curves of these three specimens showed an almost linear increase from loading to failure. It means that the ductility of these three specimens is also poor with basically brittle failures.

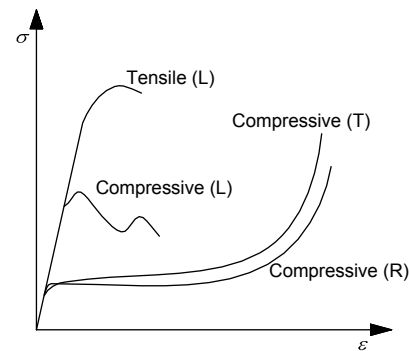
Fig. 6 Typical wood constitutive relation (Wang, 2010)
 ϵ represents the strain of wood; σ represents the stress of wood; L, R, and T represent the longitudinal, radial, and tangential directions of wood, respectively

The compression modulus parallel to the grain is much larger than that vertical to the grain, which is shown in Fig. 6 (Wang, 2010).

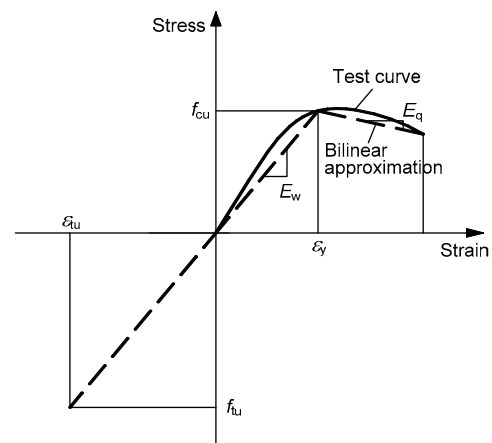
Fig. 7 Stress-strain curves of wood parallel to grain
 ϵ_y : yield strain of wood in compression; ϵ_{tu} : ultimate strain of wood in tension; f_{cu} and f_{tu} : ultimate stresses in compression and tension; E_w and E_q : elasticity and tangent moduli

Fig. 7 is the stress-strain curve parallel to the grain. In Fig. 7, "the test curve" refers to the stress-strain relation curve of a small specimen parallel to the grain, which was obtained in Section 3.

1. The tension modulus and compression modulus of elasticity are almost identical.
2. When wood bears tension parallel to the grain, there is no obvious plastic deformation stage before damage. The stress-strain curve is almost linear and the failure mode is brittle. When wood bears compression parallel to the grain, there is an obvious plastic deformation stage before damage because of the buckling instability of wood fibers.

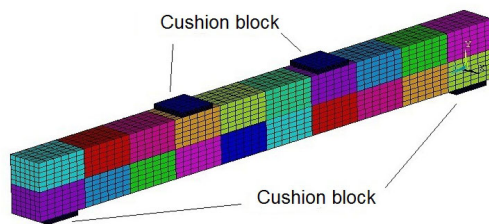
Fig. 8 Finite element model of the wood beam

yield criteria, which takes into account elastic parameters and the anisotropic yield strength of wood to analyze its elastic-plastic behaviour. The model is divided into a grid of sixths along its width, twelfths along its height, and sixtieths along its length. The mesh size is approximately $50\text{ mm}\times 33\text{ mm}\times 25\text{ mm}$, and the beam is simply supported (Fig. 8). The Newton Raphson method was used in the process of analysis.

The following aspects have been taken into account when setting the finite element model (FEM). (1) According to the results of NDT, the materials strengths of different zones of the wood beam are different (Fig. 3). In the calculation model in Fig. 8, different colors represent different zones and the material strength obtained from NDT for each zone has been adopted separately. (2) Cushion blocks have been set in the model to prevent local stress concentration. Common nodes have been adopted at junctions of the wood beam and cushion blocks.

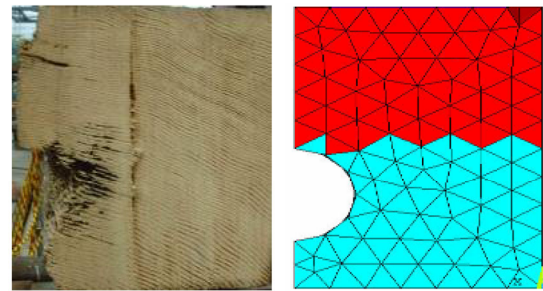
Fig. 9 FEM simulations of initial imperfections (a) Section damaged by insects; (b) Crack; (c) Knot

BA1 had suffered from severe damage by insects such that a partial cross-section became invalid. Therefore, this part was not considered and the cross-section of the BA1 after meshing is shown in Fig. 9a.

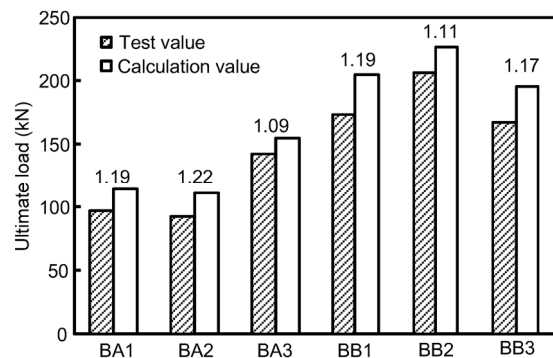
Fig. 11 Comparisons of ultimate loads between test and calculation

Comparisons of ultimate loads between test and calculation are shown in Fig. 11. Digits in Fig. 11 represent the ratio of the calculated value to the test value.

Fig. 11 shows that the calculated values of ultimate loads of all specimens are all larger than those from the tests but the values differ within less than 22%. For some reasons not yet known, calculated values are always slightly greater. There are several factors may lead to this variance between experimental results and numerical simulation: the scale effect, the imperfection of constitutive model, and the local nature of NDT. This question requires further study.

account in FEA, the ratios of calculated values to test values are still large, at 1.19 for BA1 and 1.22 for BA2.

There were big knots at the bottom of both BB3 and BB1. Although the influence of wood knots has been dealt with in FEA, the ratios of calculated values to the test values are still large, at 1.19 for BB1 and 1.17 for BB3.
