Improving the dynamic behaviour of historic buildings using experimental data: application to a Baroque church

Rosario Ceravolo[1,2] · Erica Lenticchia[1,2] · Gaetano Miraglia[1,2] · Linda Scussolini[1]

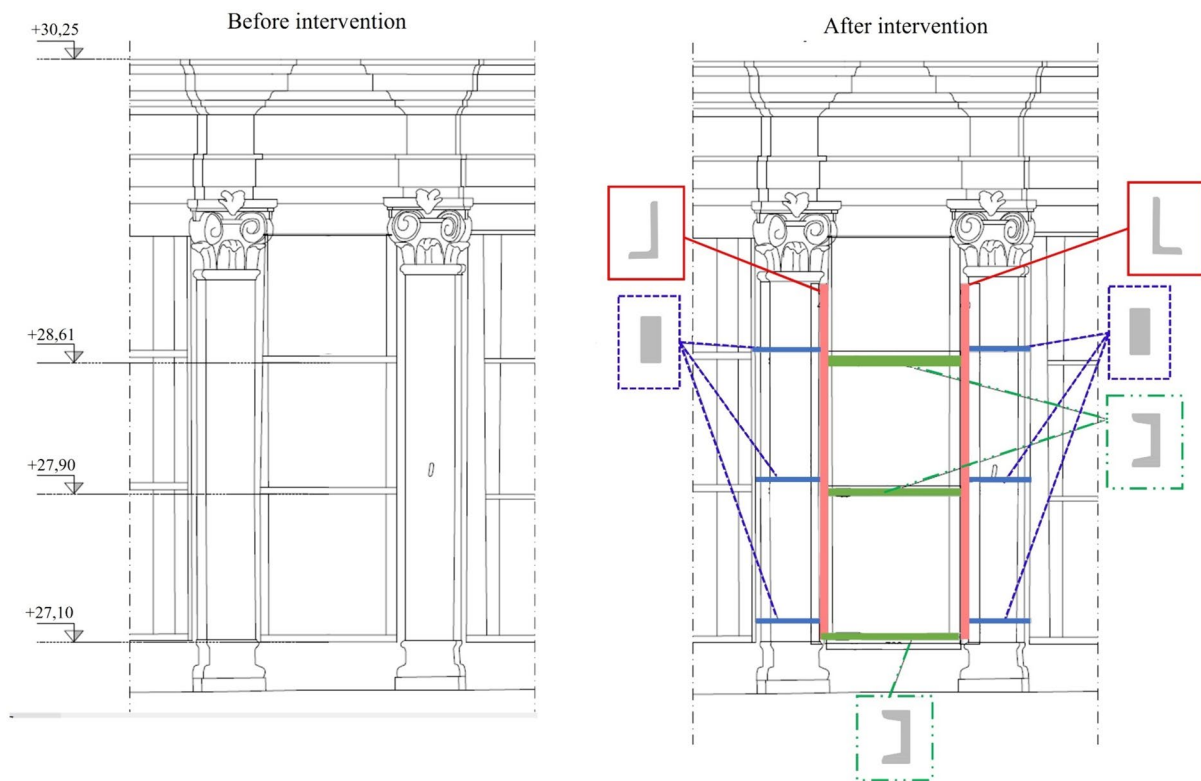
Fig. 5 Details of the lantern before and after the intervention with the corresponding profiles

In the case of the lantern, the intervention consisted of sixteen *L*-shaped profiles with uneven sides along the columns, aligned with the interior corners of the windows. As a result, each column features two metal uprights. In addition, three *C*-shaped profiles were installed in correspondence of the windows and connected to the sidewalls using

countersunk screws. The system, as described, works as a circled cage inside the lantern, favouring a global behaviour, and is represented in Fig. 5.

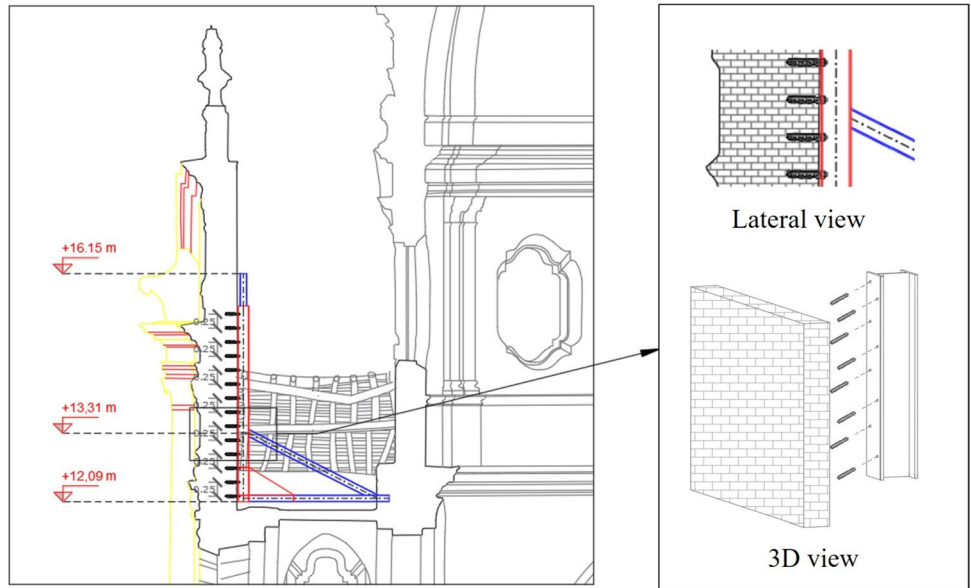
Fig. 6 Details of the connection between metal frame and masonry façade

All the metal profiles used are made of galvanized steel S235 JR. Chemical connectors were used to link the metal frame to the masonry wall of the tympanum to simulate the behaviour of a parallel collaborating system. The chosen chemical anchor is composed by the injection cartridges of chemical resin. The connectors were positioned between the wing of the vertical uprights and the masonry within a strip 2.50 m long. A schematic representation of the connectors can be found in Fig. 6.

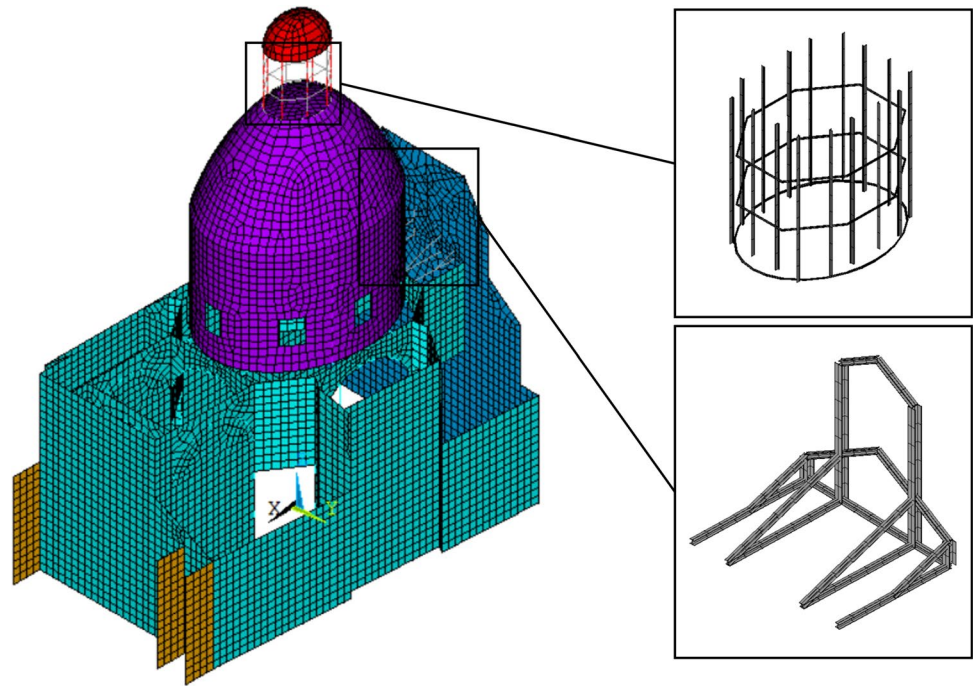
Fig. 7 Installed intervention on the lantern (**a**) and on the façade (**b**)

The systems installed on the lantern and on the façade are reported in Fig. 7.

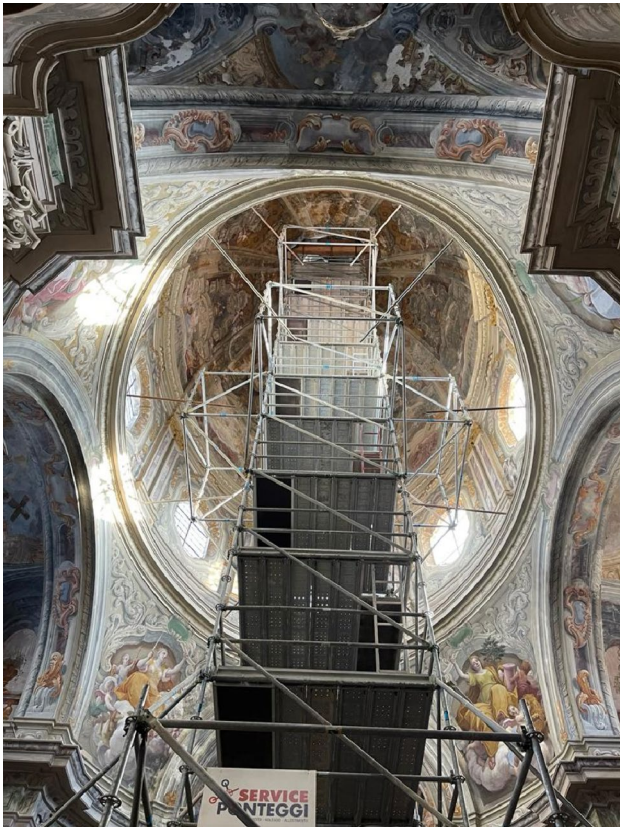
Fig. 12 Picture of the scaffolding

temporary scaffolding built inside the church to connect the lantern to the base for the ongoing restoration work on the frescoes. A separate discussion should be made for the newly detected frequency component at 3.88 Hz. To support these hypotheses, on 2023, June 19th a further dynamic experimental campaign was carried out to identify the scaffolding vibration modes. The scaffolding is depicted in Fig. 12.

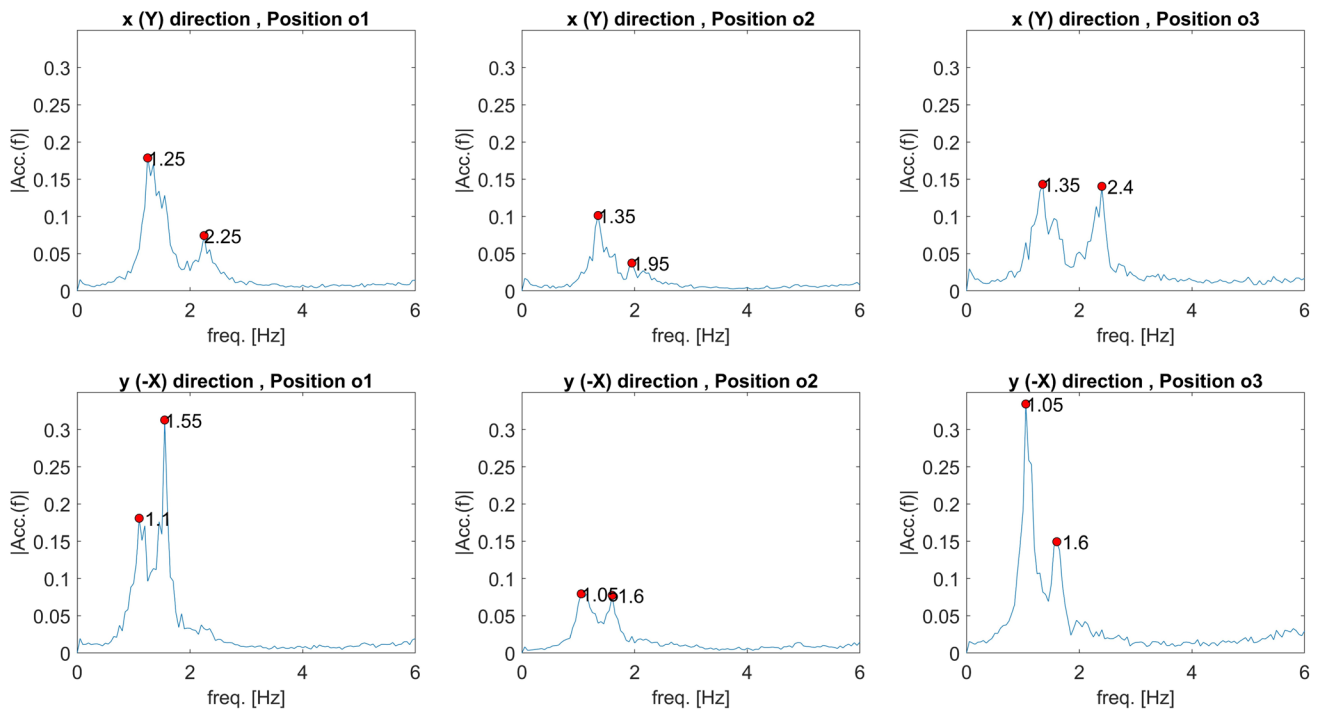
A triaxial MEMS accelerometer was sequentially placed in three different positions on which scaffolding accelerations were acquired for a total duration of 200 s, with signals sampled at 400 Hz. The Fourier spectra of the acquisitions are shown in Fig. 13.

Fig. 13 Fourier spectra of the recorded accelerations of the scaffolding for sensor positioned in "o1", "o2" and "o3". X and Y define the global reference system direction, while x and y define the local reference system direction of the sensor

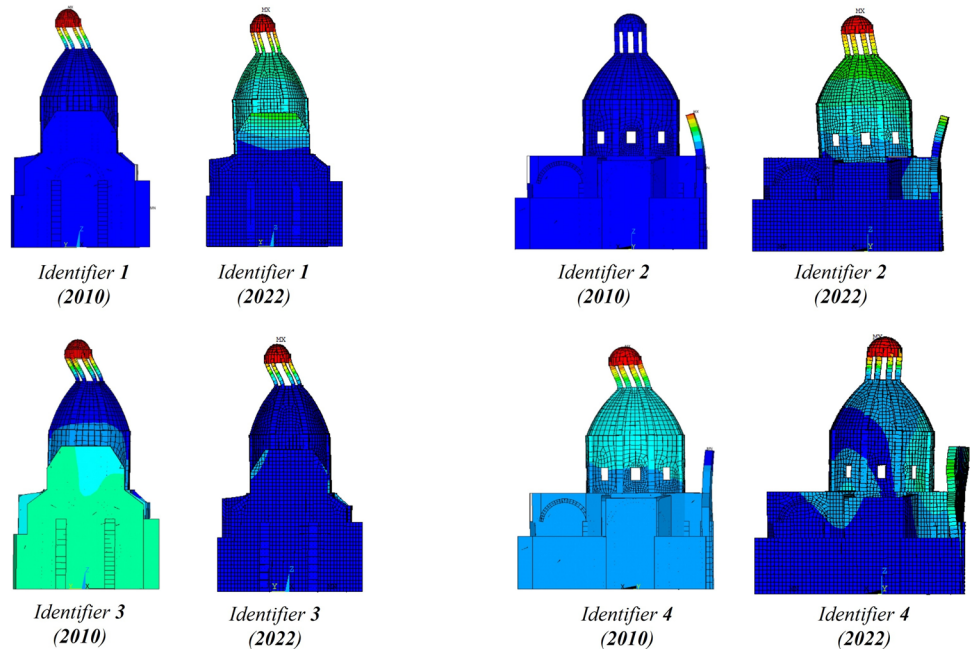
Fig. 14 Updated values of the elastic modulus of the macro-elements

From Fig. 14 it is observable that the basement, the drum − dome system, and the lantern present values of the elastic modulus which are progressively lower. Moreover, the updated value of the elastic modulus of the basement is in line with the one resulting from the mechanical tests presented in Table 3. The elastic modulus of the façade, which represents the other vulnerable element of the church, confirms that it has substantially different values from the body of the church, as also highlighted by the model updating process carried out in 2010. This seems to be mainly ascribed to the material, as all surveys carried out after the installation of the intervention described in Sect. 3.1 highlighted a good connection between the façade and the rest of the church. Moreover, the presence of a regular masonry texture and the absence of cracks at the intersections were confirmed. Finally, the external walls present a very high value of the elastic modulus. However, as underlined by the sensitivity analysis, any value virtually taken by this

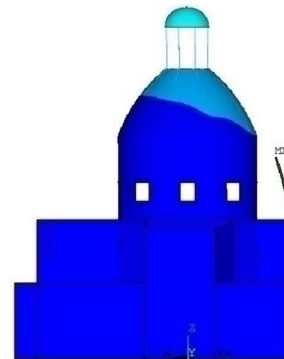
A further observation concerns the local mode of the façade that was not acquired in the 2010 campaign. In the updated model with interventions, this mode stands at a frequency that is incremented from the one without interventions, 2.87 Hz, to 3.58 Hz, this being consistent both with the new mode identified at 3.88 Hz and with the reduction of the overhang due to the contrast of the metal frame. At any rate, verification of local modes will be possible when

Fig. 16 Mode shape of mode at 3.88 Hz predicted by the new calibrated FE model with (left) and without (right) retrofitting interventions

the definitive permanent monitoring system is installed. Figure 16 depicts the comparison between the mode shape of the mode at 3.88 Hz predicted by the new calibrated FE model with and without upgrading interventions, respectively.

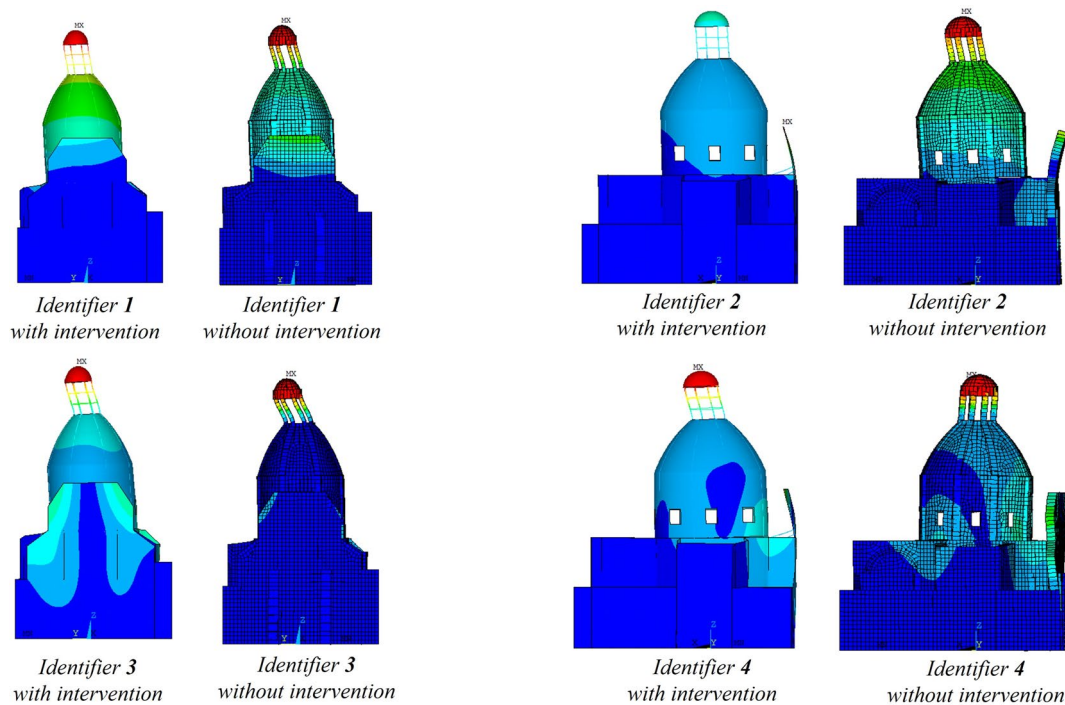
Fig. 17 Comparison between the mode shapes of the FEM before and after the interventions by employing the 2022 model without and with the interventions

As can be seen in Fig. 17, the mode shapes of the numerical model did not change significantly from the pre-intervention to the post-intervention situation. This is an expected finding since interventions such as the ones carried out on this church do not affect the mass and/or the stiffness like other techniques. From Table 8, it can be observed that the modes of the two models are consistent, without any inversion of modes. However, a small discrepancy involving the additional mode identified at 3.88 Hz (see Fig. 16 for clarification) can be observed: on the one hand, in the case of the model without intervention, it corresponds to the first numerical mode, while in the case of the model with interventions, it corresponds to the third numerical mode. This
