Reconnaissance report and preliminary ground motion simulation of the 12 May 2008 Wenchuan earthquake

Louise Wedderkopp Bjerrum · Kuvvet Atakan ·
Mathilde Böttger Sørensen

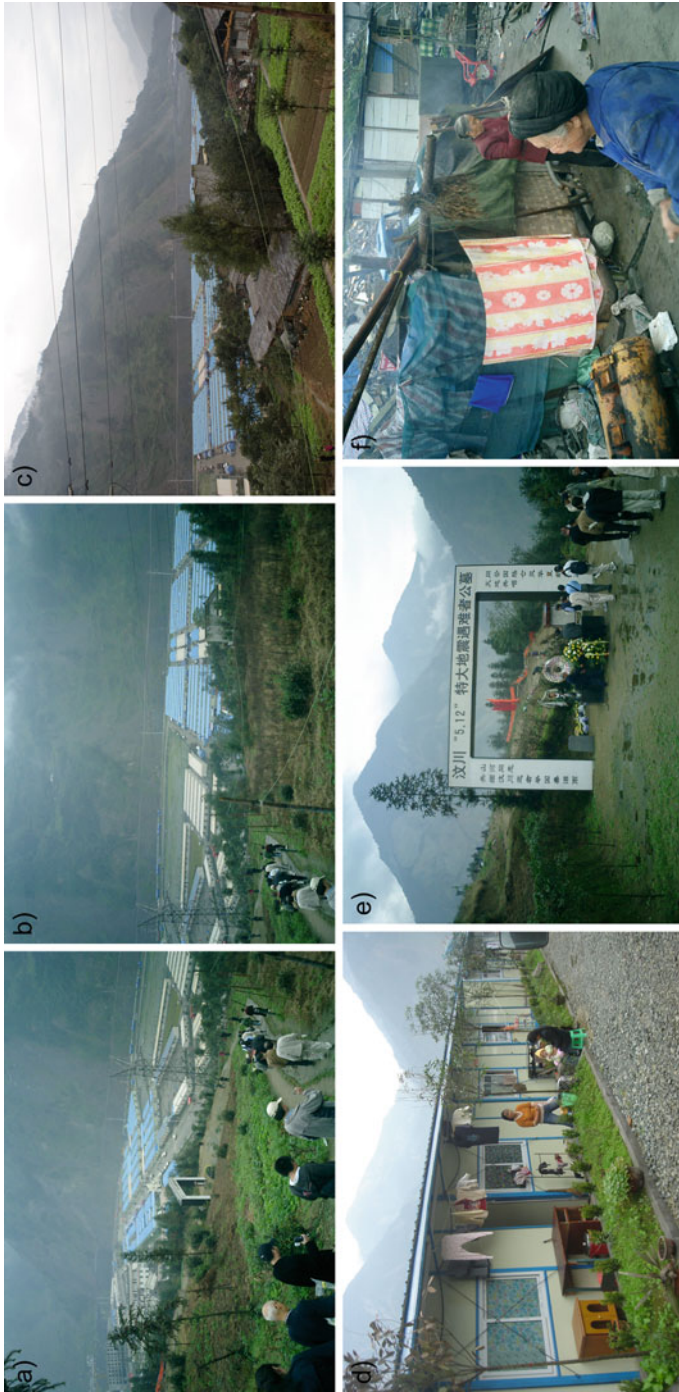
In Yingxiu, in the epicentral area, two large temporary shelter towns had been constructed; one covering a large part of the valley south of the city (Fig. 22a–d), the other on top of a nearby hill. New schools and activities for the children were established, and large gardens were available for growing vegetables for the surviving population. The memorial site for the earthquake was located on the hill side, between the upper and lower shelter town (Fig. 22e). In addition to the large number of shelters provided by the authorities, there were several self-constructed shelters/tents of various qualities. In Yingxiu, the shelter shown in Fig. 22f, was situated only few meters from the fault scarp shown in Fig. 3a.

Fig. 22 a–d Temporary shelter towns near Yingxiu, extending through the narrow valley south of the city. Landslide scarps are visible in the background. e Memorial site for the earthquake in Yingxiu. f Self-constructed shelter near the fault scarp in Yingxiu

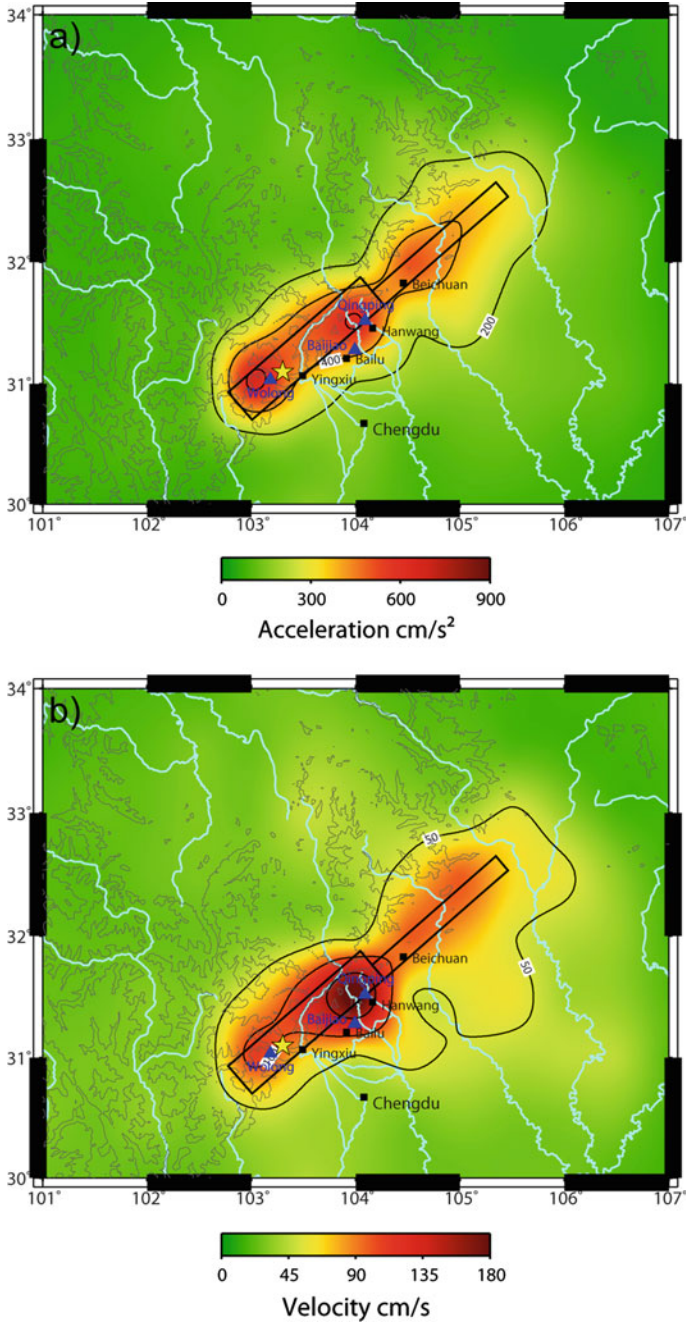
respectively. In Fig. 24b, the maximum PGV values are shifted and extended to the northeast of the fault plane as a result of rupture directivity due to the unilateral rupture towards the northeast. The continuity of maximum ground motions along the entire fault can be associated with the fault model, which has asperities distributed throughout the central part of the fault plane (Ji and Hayes 2008).

Fig. 24 Simulated **a** PGA and **b** PGV distributions in the study area. *Black boxes* indicate the surface projection of the fault plane. The *star* shows the epicenter, *blue triangles* indicate three seismograph stations; Wolong, Baijiao and Qingping. The *black squares* mark cities visited during the field trip

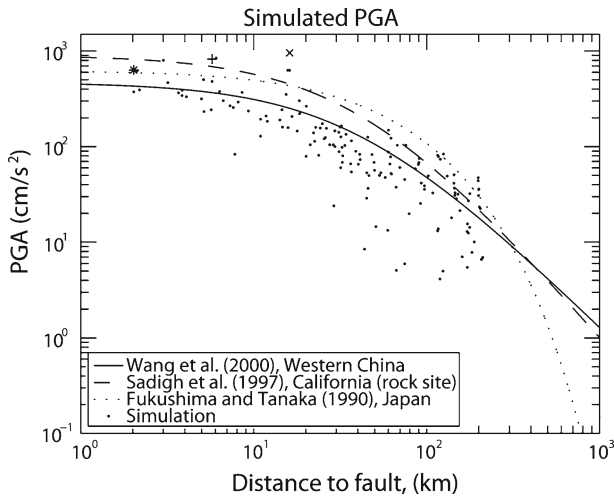
Fig. 25 Comparison of simulated PGA (*black dots*) to attenuation relations, of Wang et al. (2000), Sadigh et al. (1997) and Fukushima and Tanaka (1990) (see legend). The X, + and * show the recorded peak values for Wolong, Baijiao and Qingping stations, respectively

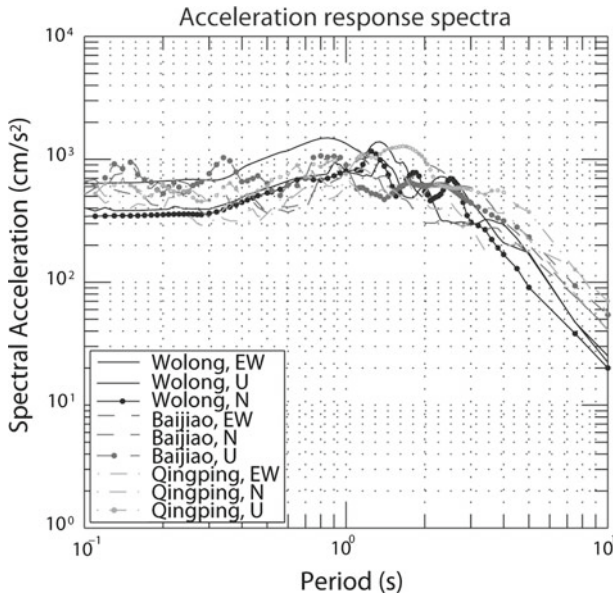
Fig. 27 Acceleration response spectra of the three stations Wolong, Baijiao and Qingping. All three components are shown (see legend for specifications). Station locations are shown in Fig. 25

The strong ground shaking experienced during the Wenchuan earthquake, combined with an unfavourable frequency distribution of the ground shaking, lead to the collapse of many buildings. The simulated acceleration response spectra for Wolong, Qingping and Baijiao are shown in Fig. 27. These indicate that the ground shaking had a predominant period between 0.1 s and 1 s. This is in agreement with the recorded signals for which the predominant response spectral accelerations range between 0.1–0.6 s (Li et al. 2008a).
