Performance of industrial buildings during the Emilia earthquakes in Northern Italy and recommendations for their strengthening

Dionysios A. Bournas · Paolo Negro · Fabio F. Taucer

Abstract A series of earthquakes, the highest of magnitude M_w 5.9, hit a portion of the Po Valley in Northern Italy, which was only recently classified as seismic. The paper reports the findings and the lessons learnt from a preliminary field survey which was conducted immediately after the second event. As a result of the economic attitude of the affected area, and possibly of the characteristics of the event, an unprecedented number of industrial precast buildings were affected, resulting into most of the casualties as well as in large economic losses. Whereas most of the damaged and collapsed buildings were designed for gravity loads only, evidence of poor behavior of some precast buildings designed according to seismic provisions were discovered. The paper provides a description of the performance of precast buildings, highlighting the deficiencies that led to their poor behavior as well as some preliminary recommendations.

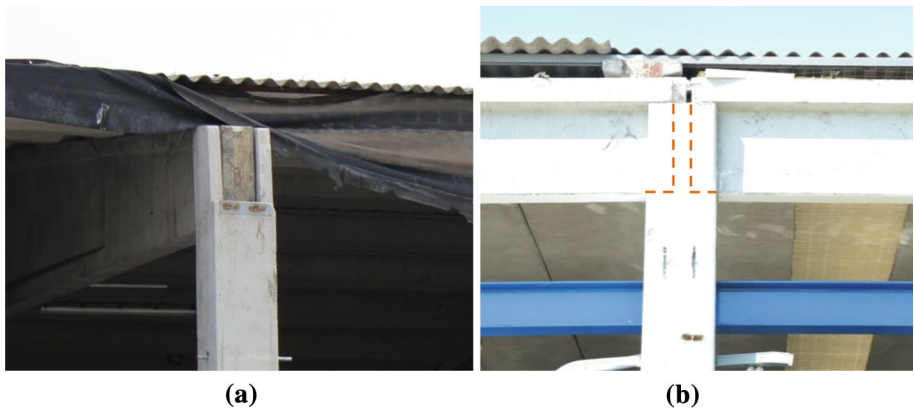
Fig. 7 **a** Seating of double slope precast beams showing the fork at the *top of the column*: seating at an *end column*. **b** Seating at an intermediate column of a “T” section beam (with *dashed lines* indicating the section of the beam at the seat pocket)

The weak link in the vast majority of the industrial buildings visited was the absence of mechanical connections between roof-girders and columns. The most common typology corresponded to double-slope beams, simply supported over special openings (forks) at the top of columns as shown in Fig. 7. This typology was used in Italy during the 60s and 70s for agricultural buildings, now being replaced by the more common flat-roof systems. In this connection typology, the capacity of transferring lateral loads depends entirely on the static coefficient of friction between the supporting surfaces of beam and column and on the length of the beam seating when the friction forces are exceeded by the earthquake force demands.

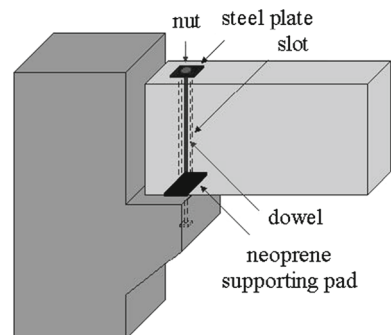
Fig. 12 Detail of a pinned beam-column joint connection

The main feature of precast industrial buildings constructed with seismic provisions lies in the type of beam-column connections. When horizontal forces are taken into consideration in design, the most common connection system for the construction of single-storey industrial buildings in Europe comprises hinged beam-column connections by means of dowel bars (shear connectors). This type of connection is able to transfer shear and axial forces resulting from the seismic actions. Practically, the horizontal beam-column connection is established by means of vertical steel dowels (typically one or two) which are protruding from the column into special beam sleeves, as shown in Fig. 12. This pinned beam-column connections are constructed by seating the beams on the column capitals and by holding the beam ends in place by the use of these vertical steel dowels.

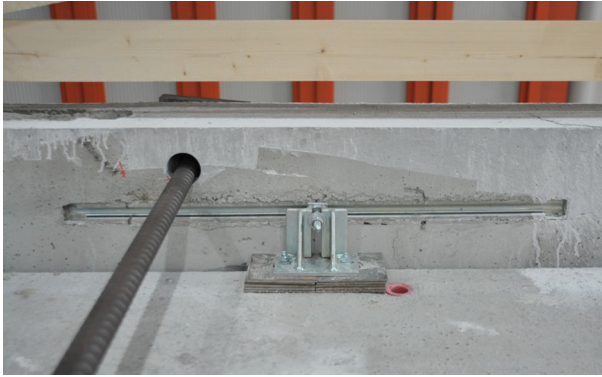
Fig. 22 Panel connection device that provides resistance in the vertical and out-of-plane directions and accommodates large relative deformations in the lateral direction

In order to ensure the standard design approach in which the claddings do not contribute to seismic response, stringent design criteria for the design of the connections should be enforced: connections devices should be able to provide the required strength in the vertical and out-of-plane directions while accommodating large relative deformations in all other directions (Fig. 22). A viable option would be to prescribe adequate fail-safe restraints, so that the panels would not fall even in case the relative displacement capacity of the connection is exceeded.
