# Using Observational Method to Manage Safety Aspects of Remedial Grouting of Concrete Dam Foundations

**Abstract** As concrete dams age, the need for remedial grouting to reduce the seepage and uplift pressure in the rock foundations under them increases. Based on a case study of a Swedish dam with very low calculated safety against sliding, this paper discusses the application of the observational method (as defined in Eurocode 7) to manage safety aspects during remedial grouting. The studied case was complex in that grouting works posed the risk of causing increased uplift pressure, which could have induced sliding failure along a shallow, persistent, horizontal rock

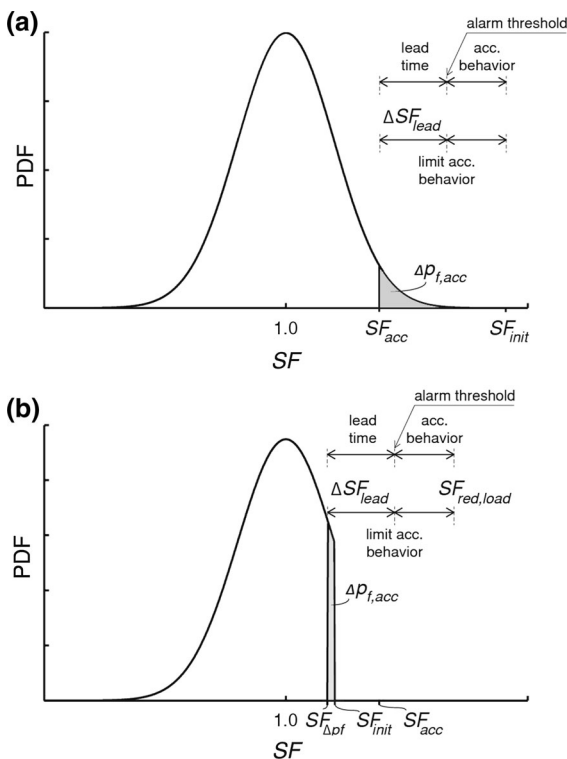
For some dams, like the studied dam with  $SF_{init} = 1.06$ , the relationship  $SF_{init} < SF_{acc}$  may hold. A dam owner willing to accept the same increase in failure probability,  $\Delta p_{f,acc}$ , during the grouting works, regardless of the initial safety calculation, consequently accepts additional loads until  $SF_{\Delta pf}$  is reached (Fig. 9b). However, the margin between  $SF_{init}$  and  $SF_{\Delta pf}$  may not always provide the required safety margin to allow for the lead time and a range of acceptable behaviour. An additional margin can then be created by reducing the driving loads on the dam, until a safety factor  $SF_{red,load}$  is reached. Some options are to perform grouting during the summer to avoid ice loads, to install rock anchors, or to lower the reservoir level temporarily. However, as discussed above, the dam must not be subjected to a very low value of  $SF$  for long periods. Therefore, waiting for several months before conducting grouting works, for example, to avoid ice loads, becomes questionable.

Even if  $SF < SF_{acc}$  during project execution, the suggested approach conforms to Federal Energy Regulatory Commission (2002), which notes that the required safety factor should reflect the degree of uncertainty in the safety assessment. This is visualized by the truncated probability distribution in Fig. 9b; the dam is stable for  $SF > SF_{init}$ , and it can only fail if it is subjected to loads larger than any previously experienced load. Therefore, the limits of acceptable behaviour may correspond to a safety factor less than  $SF_{acc}$ .

In practice, the assessment of  $\Delta p_{f,acc}$  and  $SF_{\Delta pf}$  can be troublesome for dams with very low  $SF_{init}$ . However, considering the significant probability density causing failure adjacent to the  $SF_{init}$  in Fig. 9b,  $\Delta p_{f,acc}$  implies only a limited acceptable decrease from  $SF_{init}$ . Consequently,  $SF_{\Delta pf}$  may, for practical convenience and for a conservative solution, be approximated with  $SF_{init}$ .

To illustrate this concept, a limit of acceptable behaviour and the corresponding lead time is presented for the studied dam. Given the fact that  $SF_{init} = 1.06$  is already low, no additional decrease in safety is allowable in practice. The current loads must, therefore, be decreased to create a safety margin until a

satisfactory  $SF_{red,load}$  is reached. The required lead time for the contingency action (increasing the drainage capacity in case it is insufficient) is estimated to be 15 min, given that the drill rig is on standby. The rate of increase of the piezometric pressure is assumed to be 100 kPa/h at the piezometers, until arriving at the linear pressure distribution normally assumed for dams without drains. For the same range of acceptable uplift pressure as before (less than the limit of acceptable behaviour  $\bar{u}_{joint,lim}$ ), the average maximum uplift pressure in the joint as measured by the piezometers becomes  $\bar{u}_{joint,lim} + 25$  kPa. This corresponds to a piezometric pressure at the drains,  $u_{drains}$ , of 90 kPa (Fig. 8). To keep the risk level constant, this requires a drawdown of the reservoir level by at least 1.5 m (Table 2). Assuming that the drawdown does not affect the initial uplift pressure (Fig. 6),  $SF_{red,load}$  would be 1.21 when the grouting work begins. If  $\bar{u}_{joint,lim}$  is reached,  $SF = 1.15$  for a reduced reservoir level.

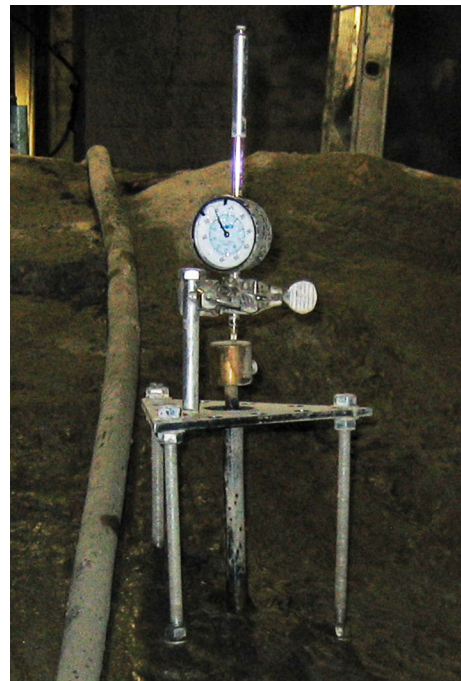
**Fig. 10** One of the extensometers used to measure vertical displacement. Image by authors

The grouting instructions in the studied case included a monitoring plan. The piezometric water pressure was to be monitored using six piezometers (Fig. 5). They were to be continuously checked in an automatic system both during grouting and until at least 4 h after grouting was finished or until the piezometric pressures had stabilized. The vertical displacement was to be continuously monitored during grouting at two places using extensometers (Figs. 5, 10). The staff at the site was to be observant of any signs of a washout occurring.
