Assessment of Coating Performance on Waterwalls and Superheaters in a Pulverised Fuel-Fired Power Station

Nigel Simms¹ · Maud Seraffon² · Andy Pidcock¹ · Colin Davis²

Abstract Protective coatings offer one route to increase the lives of heat exchangers in pulverised fuel power plants. A range of candidate coatings have been exposed on the waterwall and superheaters of a 500 MWe UK power station unit for periods of up to ~ 4 years (24,880 operating hours), during which time this unit was fired on a mixture of UK and world-traded coals. Both nickel- and iron-based candidate coatings were included, applied using high velocity oxy-fuel or arc-wire process; a selection of these also had a surface sealant applied to investigate its effectiveness. Dimensional metrology was used to evaluate coating performances, with SEM/EDX examinations used to investigate the various degradation mechanisms found. Both the waterwall and superheater environments generated their characteristic corrosion damage morphologies which depended on the radial positions around the tube. Coating performances were found to depend on the initial coating quality rather than composition, and were not improved by the us

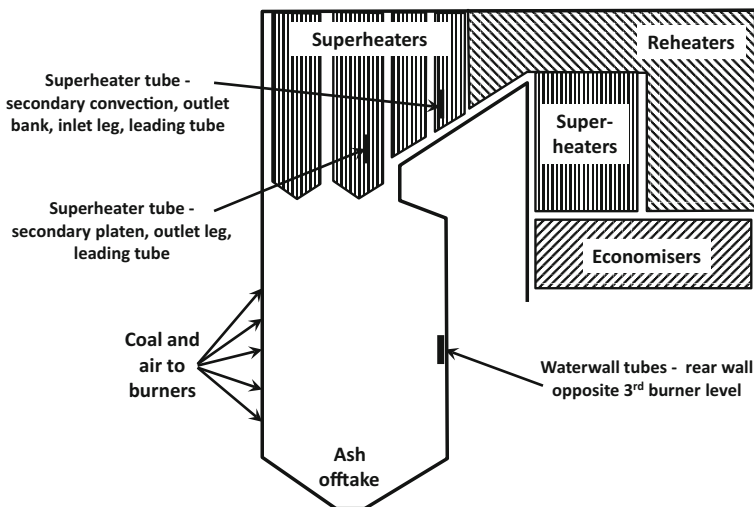
Fig. 1 Cross-section through power station unit showing the locations of trial-coated tubes

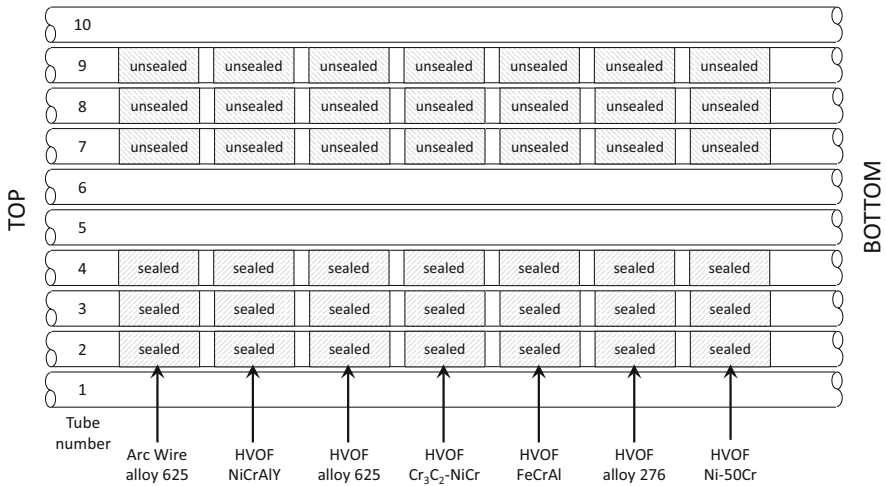
Tubes 2/3/4 and 7/8/9 of the furnace wall panel were externally coated with approximately 200-mm long bands of alloy 625 (arc-wire sprayed), NiCrAlY, alloy 625, Cr_3C_2 in Ni–Cr matrix, FeCrAl, alloy 276 and Ni-50Cr (Fig. 2). With the exception of the alloy 625 applied by arc-wire spraying, all coatings were applied using HVOF. Tubes 2/3/4 also had the seal coating applied on top of the bands of coating. Tubes 1, 5, 6 and 10 were not coated. It should be noted that the tubes had already been assembled into a section of furnace wall panel, and so this restricted access for the coating processes and resulted in coatings that were thicker at the tube crowns (see Results).

Fig. 2 Coating distribution on waterwall panel—all applied by HVOF except one by arc-wire spray

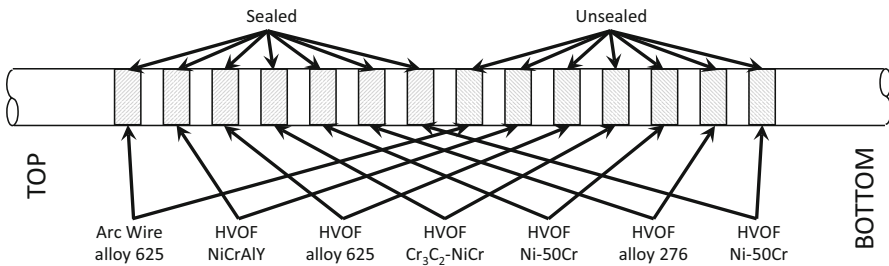
The tubes for installation in the primary platen superheater, outlet leg, and the secondary convection superheater, outlet bank, inlet leg, were externally coated with bands approximately 100 mm long of arc-wire sprayed alloy 625, NiCrAlY, HVOF alloy 625, Cr_3C_2 in a Ni–Cr matrix, Ni-50Cr, alloy 276 and Ni-50Cr which were repeated once along the length of the tube (Fig. 3). These coatings were applied evenly around the individual tubes. One set of coatings had an additional seal coat (Fig. 3).

Fig. 3 Coating distribution on the primary platen superheater outlet leg and secondary convection superheater outlet bank inlet leg
