# Fracture of a Paper Manufacturing Machine Felt Guide Roll

Tim A. Jur · R. Dean Harris

Submitted: 31 March 2014 / Published online: 4 July 2014  
© ASM International 2014

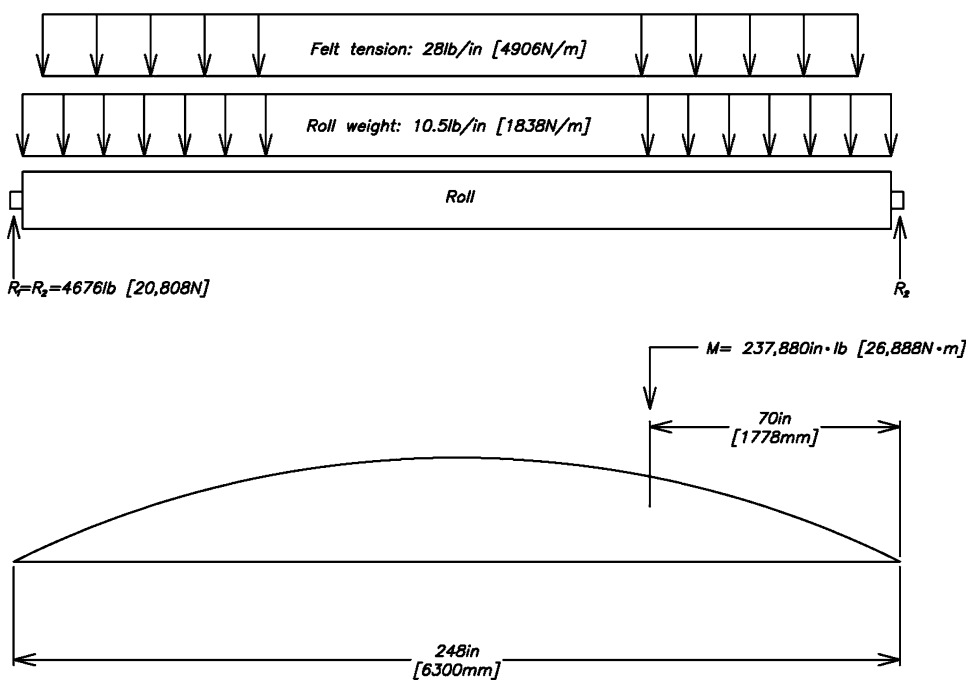
**Fig. 12** Roll load diagram and corresponding moment diagram

Figure 12 shows a basic model of the roll represented as a simply supported beam. The loads on the span of the

Shown also as part of Fig. 12 is the corresponding moment diagram, identifying the bending moment at the fracture location to be 237,880 lb-in. (26,888 N m). As the roll rotates, the corresponding fully reversed stress (without compensating for the variation in a roll wall thickness) would be 1770 psi (12,204 kPa). Other contributing loads due to, say, hoop stress in a rotating cylindrical shell and the centripetal force exerted by the balancing weight on the roll wall would be negligible.
