Wenchuan earthquake fault and seismic disaster*

Boming Zhao^{1,*} and Xiwei Xu²

Abstract Major cases of the $M_S8.0$ Wenchuan earthquake are obtained through field investigations of the epicenter and high-intensity areas, and the relationships among earthquake faults, ground motion and earthquake disasters near fault zones are analyzed. Both strong deformation and ground rupture lead to significant damages of the buildings, indicating that it is necessary to keep safe distance away from active faults and to take other necessary measures. There are two reasons for that the buildings near the surface rupture zones have withstood in the strong earthquake, other than their seismic resistance capacities, with the first being the site condition, and the second the reduced effective stress and low rupture velocity. The forms of structural damages are complex in the fault areas, with shear failure and tensile and compressive damages. Those structures in urban areas that have used qualified materials and followed the building codes performed well in the earthquake. Survey results also indicate that structures of flexible materials may show better seismic performance.

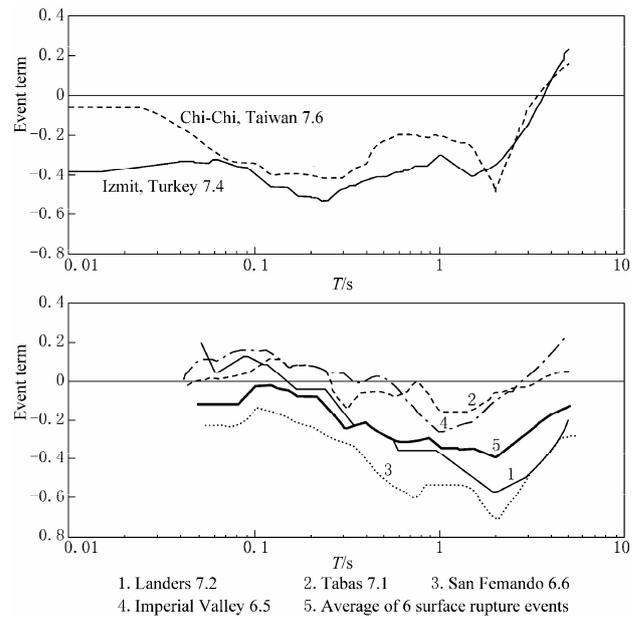
Somerville (2003) indicated that the ground motion generated by buried rupture with period around 1 s is larger than that generated by surface rupture. Figure 2 shows ratio of response spectra of recorded ground motions to that of an empirical attenuation relationship for surface rupture earthquakes. Kagawa et al (2004a, b) analyzed the macroscopic fault rupture parameters, *i.e.*, the total rupture area A_0 , the stress drop σ_0 and the ratio of the combined asperity area to the fault area A_a/A_0 , and found that effective stress drops, asperity slip contrast and slip velocity are lower for the cases of surface rupture earthquake than buried rupture earthquake (Table 1). The results suggest that the buildings are damaged mainly by the effect of surface dislocation, rather than by the strong ground motion.

Figure 2 Ratio of response spectra of recorded ground motions to that of an empirical attenuation relationship for the cases of surface rupture earthquake. The zero line represents the level of the empirical attenuation relationship (from Abrahamson and Silva, 1997).

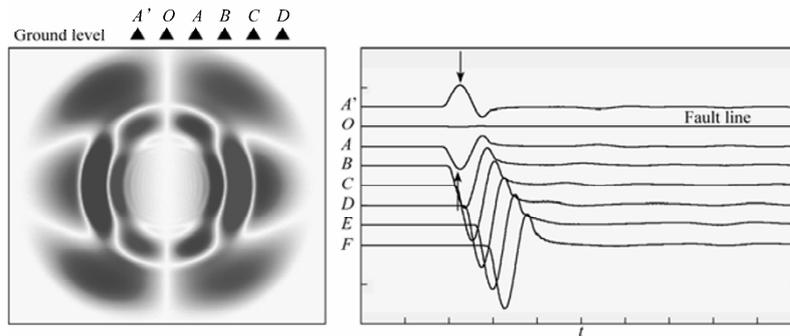
Figure 3 Test simulation of ground displacement based on a simple model. Left indicates source rupture and wave propagation, right indicates synthetic displacement of vertical component at site array cross the fault O .

surface rupture zone, landslides and other geological disasters are very serious. The results of field investigation about Bailu are good examples for it (Photos from 7 to 14). The vertical displacement situation is simulated at the rupture moment of the fault sources rupture. As shown in Figure 3, O is the fault trace, and A' and A are the observation points on both sides of the fault, respec-
