Weld Failure Analysis of Air Radiator

Fengjun Lv · Guoru Fu

Abstract The air radiator had been in service for more than 30 years until a notch failure occurred. In this paper, a rare notch failure is completely investigated by means of macroscopic and microscopic observations, microstructural inspection, chemical analysis, and residual stress test. The results show that the notch failure mode of the air radiator is attributed to high-cycle fatigue fracture, due to the welded lapping surfaces near the notch on both sides of the corrugated plate trough not being put onto one plane during the welding process. Therefore, in order to prevent or reduce possible tensile stress, it is recommended that the welded lapping surfaces be put onto one plane before welding.

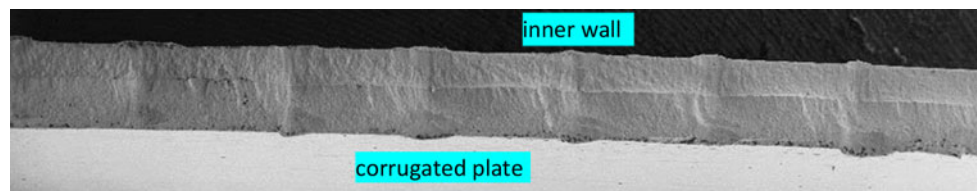
Fig. 9 The microcharacteristics of fractures along the seam weld indentation boundary

same macrocharacteristics as shown in Figs. 7 and 8. Both fractures are flat and perpendicular to the exterior surfaces, with dark black colors and non-metallic luster. No plastic deformations are found either. On both fractures, the jagged stripes corresponding to the positions of the welding corrugations are parallel to each other and uniformly spaced, with a spacing of about 1.5 mm.

The other two-side fractures of the inner wall also have the same macrocharacteristics, and they are made up of several fractures with different inclined angles; the max inclined angle is about 45°. Except the fracture along the indentation boundary of the seam weld, other fractures of the corrugated plate are perpendicular to the corrugated plate surface, and no plastic deformations are clearly found.

The fractures of the inner wall and the corrugated plate along the weld indentation boundary have obvious fatigue characteristics. Between each welding corrugation, there is a linear fatigue origin, and the fatigue crack starts at the welded interface between the inner wall and the corrugated plate as shown in Figs. 9 and 10. No cracks and defects are found in the fatigue origin zone as shown in Fig. 11. In the fatigue propagation zone, the radical lines and fatigue steps
