Analysis of structural integrity of a non-completed 28 year-old building in the city of Patos de Minas (MG)

Received: 30 June 2016 / Accepted: 4 November 2016 / Published online: 18 November 2016
© Springer International Publishing Switzerland 2016

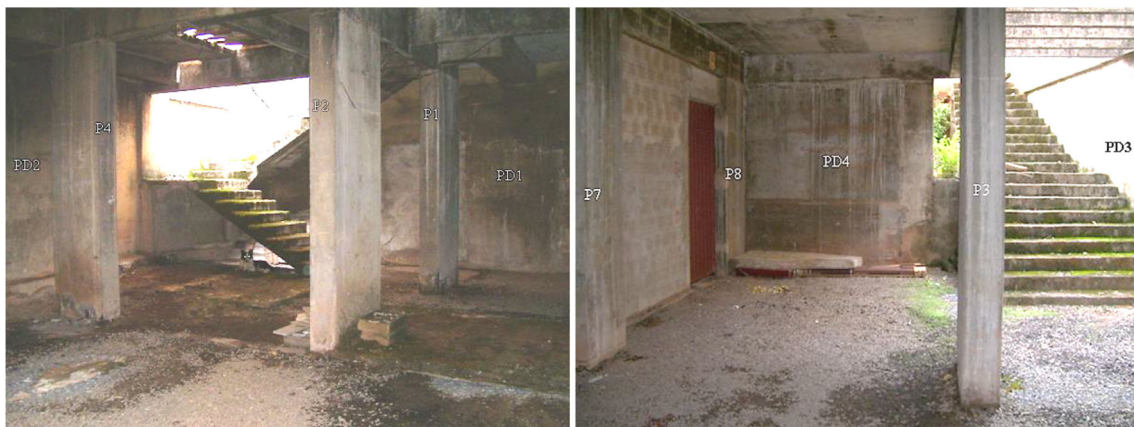
Fig. 2 Structural elements used for analysis

For the field analysis, mainly underground elements were used, since they were not as deteriorated as the ones from ground floor. Figure 2 illustrates part of the analyzed structural arrangement.

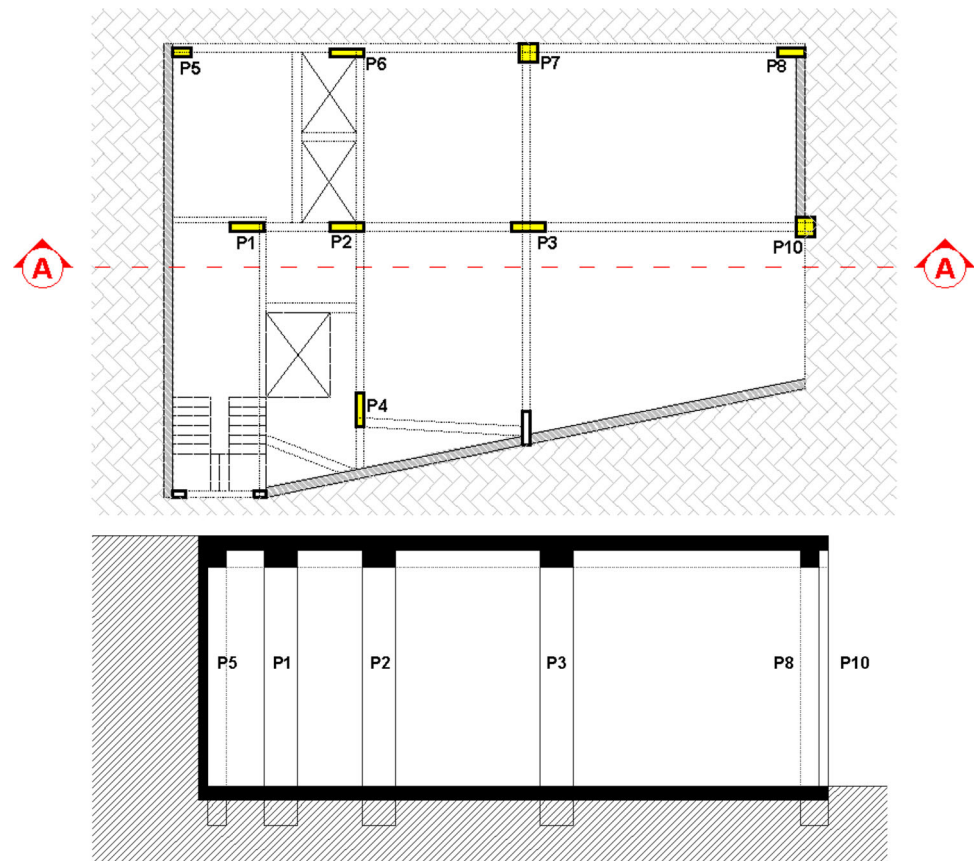
Fig. 3 Schematic representation of the building in plan layout and in section

The test areas were distributed according to the dimension of the analyzed structural element, this way, the bigger the element, the more areas were necessary to represent the material in the study. The bigger quantity of areas also permits to verify the homogeneity of the material. Eight columns were analyzed, with dimensions ranging from 25 to 60 cm of thickness and 80 to 102.5 cm in width, and other three diaphragm walls of varied widths. The Fig. 3 shows the schematic representation of the building in plan layout and in section.
