Landform Geometry for Restoration of Mountain Roads and Landslide Hazard Resilience

Abstract

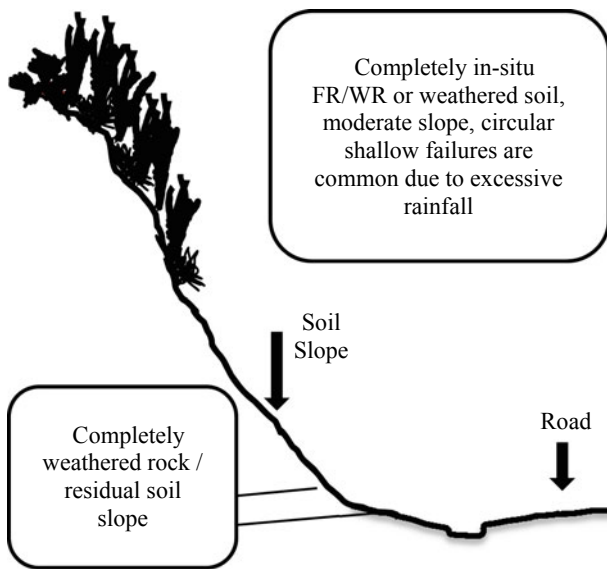
Soil slopes fail differently, depending on the site settings (upper and lower slope stability), geometry, resistance to erosion, and other topographical factors. However, the numerical simulations have shown the collapse patterns, Type-a and Type-b in Figs. 15 and 16 are less likely to occur. And resistance to collapse is mainly governed by the unsaturated soil parameters. However, any prolonged heavy rainstorms will saturate the soil surface. In such instances, shallow slope failures are significant (Russel et al. 2008). According to the site records, a relatively low-cost, eco-friendly remedial design will help enhance the slope stability.

Fig. 15 Type-a: No rocks/rock outcrop at the upper slope, lower slope is stable or failed with in-situ residual soil formations. Limited or less potential threat of slope failures

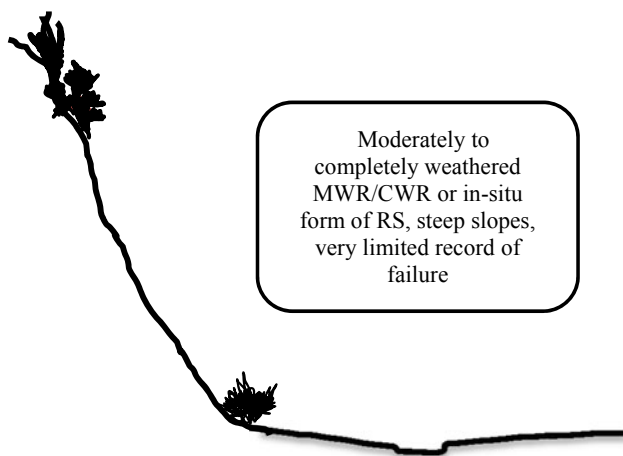
Fig. 16 Type-b: In-situ formed soil or completely weathered rock, less tendency or less potential slope failure according to field evidences

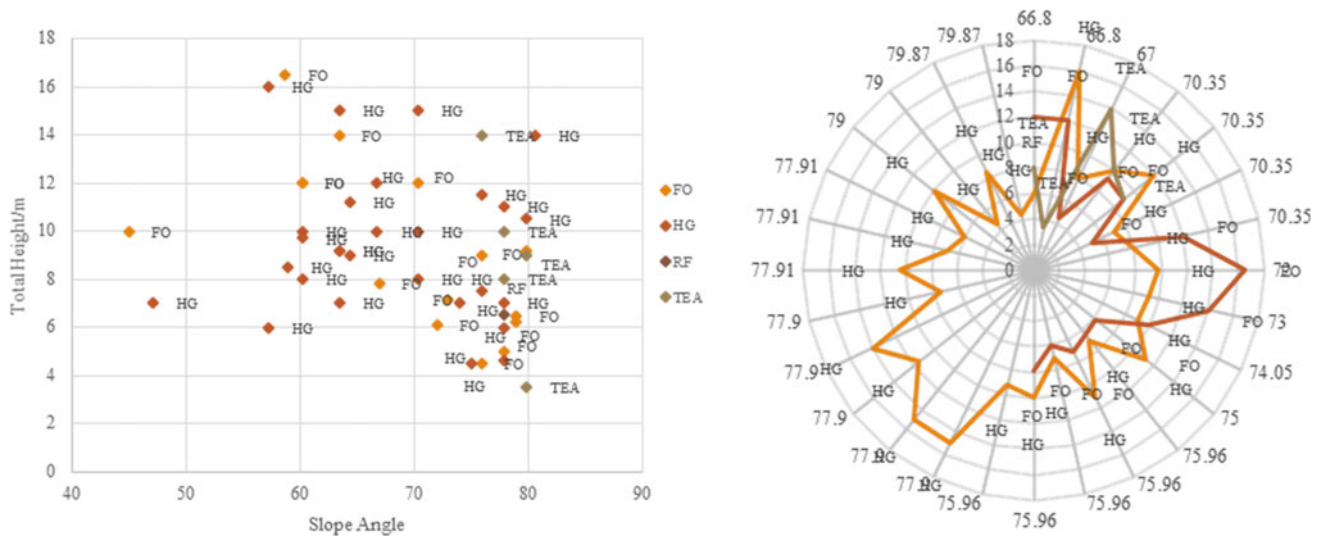
Fig. 19 Unstable slope records of stability plots for Slope Angle vs Total Height of earth cutting against to Land use above the road/upper slope segment (FO-Forest, HG-Home Garden, RF-Reforestation, and TEA-tea plantation). Height below 3.2 m is stable

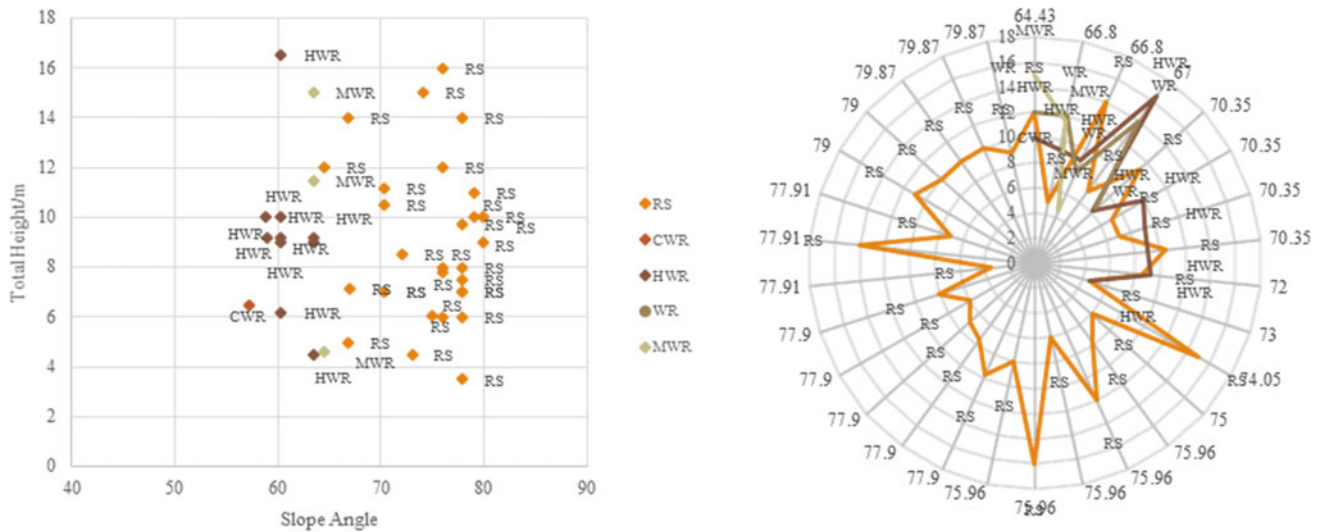
Fig. 20 Unstable slope records of stability plots for Slope Angle vs Total Height of earth cutting against Geology (ie. highly to completely weathered rock; HWR, MWR, CWR and residual soil condition; RS). Cutting Height below 4.6 m is stable

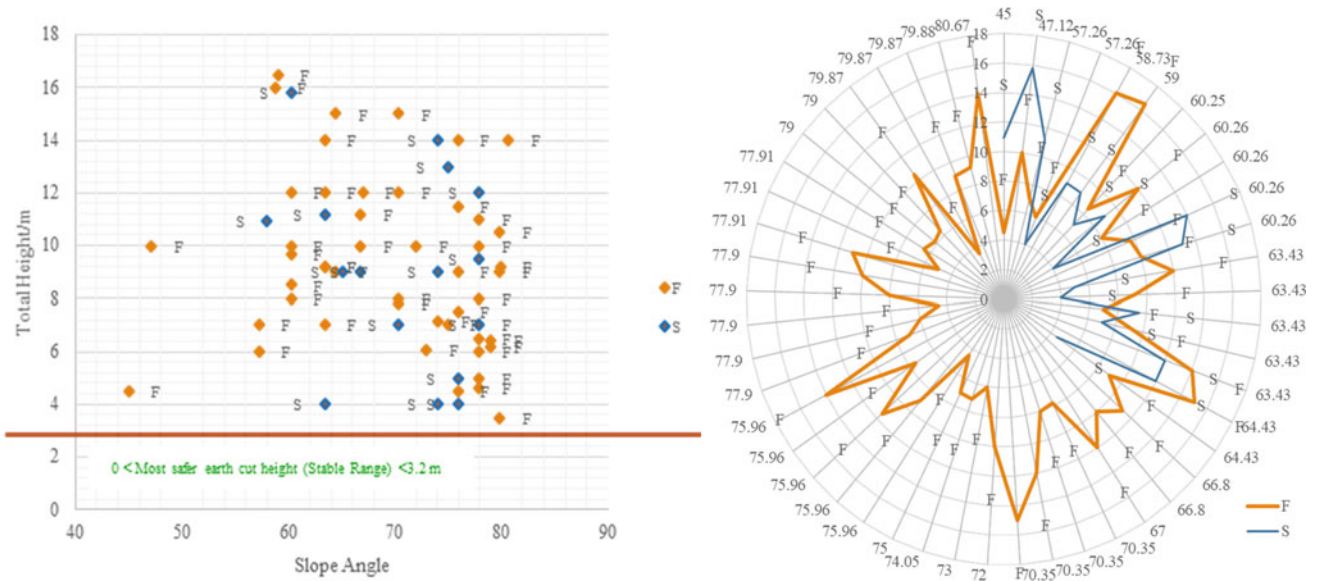
formations often cover these areas, indirectly contributing to high values of apparent cohesion during the non-saturated condition. Slopes of completely weathered soils (including highly weathered rocks) retain themselves in place due to the unsaturated behavior of soils, as shown in Fig. 21. Therefore, many cut-slopes of height not exceeding 3.2 m are potentially stable or can be restored with the least cost of remedial measures.

Fig. 21 Decision making stability plots for Slope Angle versus Total Height of Earth cut; Each point data contains different visual and physical characteristics including geology (highly to completely weathered rock, land surfaces), multiple landforms, stability criteria, failure-F and stable-S. Study concludes height below 3.2 m is stable even under different geological conditions or land use
