# The Glendoe Tunnel Collapse in Scotland

S. R. Hencher<sup>1</sup>

## Abstract

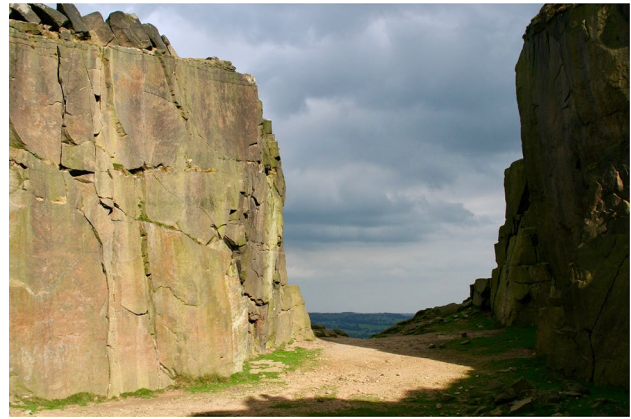
Fig. 2 The Cow and Calf Quarry, Ilkley, West Yorkshire, UK

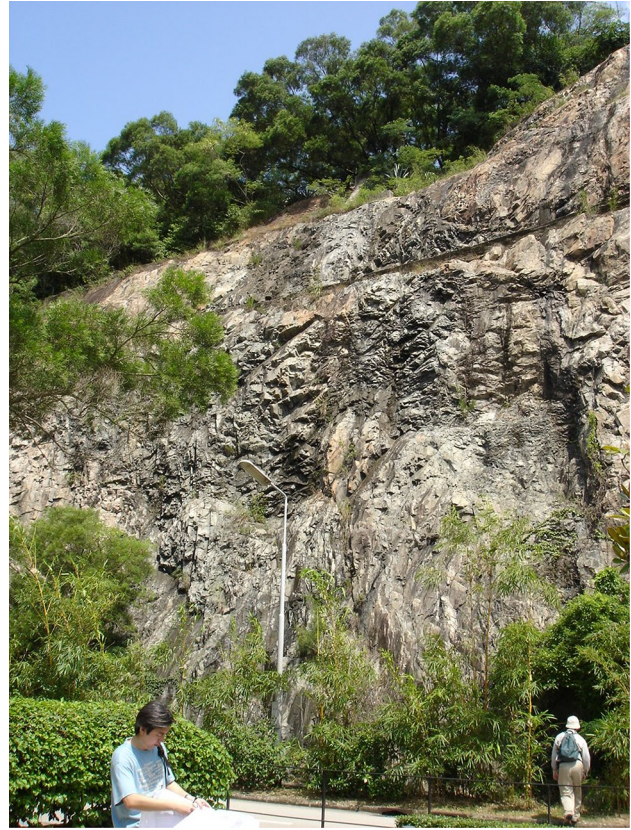
considered by one of the Client's advisors that the measures proposed by Halcrow were excessive. A visit was made to the site by a Halcrow director with other geotechnical engineers to examine the rock in detail. It was observed that there were slabs of steeply dipping rock, many of which were undercut and some showing some degree of opening. That condition, combined with the knowledge of a history of rock falls at the site, led to the conclusion that the proposed measures by the engineers were essentially correct and appropriate (Figs. 4, 5). The Client disagreed on the basis of advice from a separate consultant, and proceeded to terminate the Halcrow contract, opting for some reduced measures; it is unknown what works were actually carried out to the slopes. This simply illustrates that geotechnical opinions may differ about situations, and that the Client can adopt a riskier path, if he so chooses, and is so advised.

**Fig. 4** The Chinese University rock cut slopes, Hong Kong

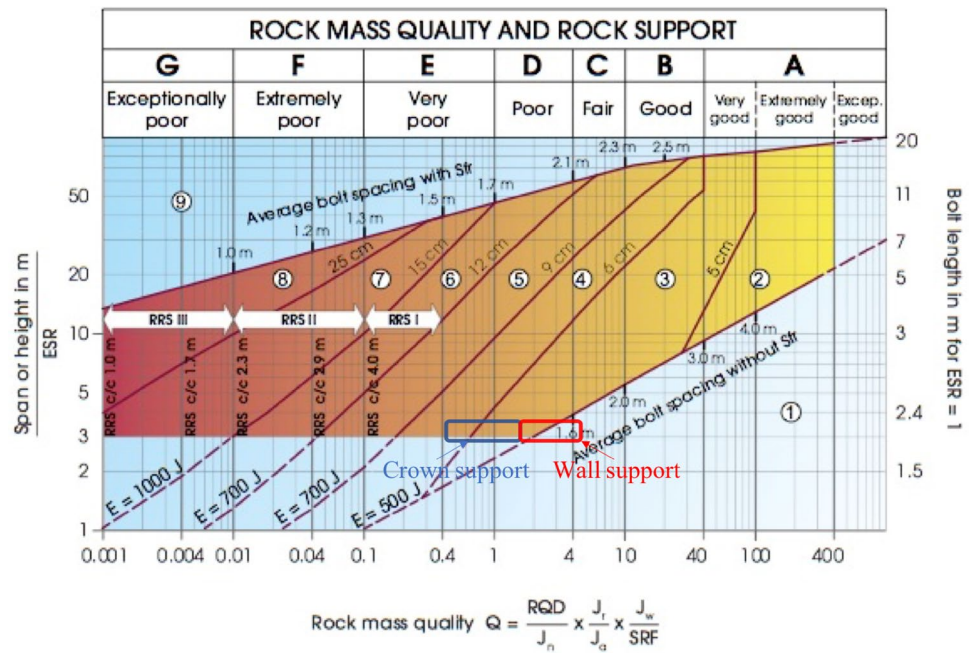
To use these values, it is necessary to examine the support class graph, reproduced here at Fig. 13. There would be some support required in the crown, less so in the walls of the tunnel and certainly no need for a fully lined option of 100% shotcrete (100 mm) and bolts. This

**Fig. 13** Q support chart from (Norwegian Geotechnical Institute (NGI) 2015)

complies with what was done (Class 2 plus backfilling of voids with shotcrete).
