Landslides in the marly slope of the Kapsali area in Kithira Island, Greece

B. Christaras · M. Argyriadis · E. Moraiti

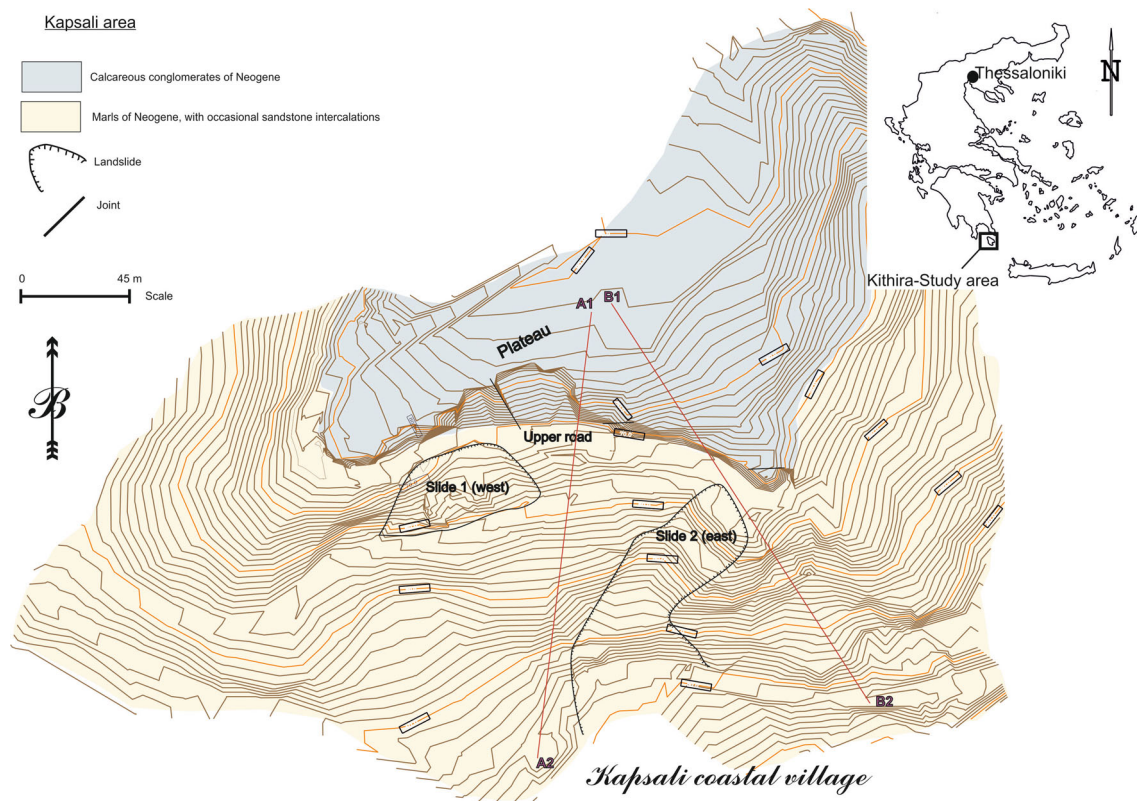
Fig. 1 Geological sketch with the location of the landslides and the studied cross sections (A₁–A₂ and B₁–B₂)

within the marl-rich sequence and stratigraphically below the conglomerates, which, consequently, were not affected by the slides (Fig. 1). The marl is generally weathered and in many instances, gives the impression of being a soil. Under dry conditions, the material is hard and cohesive but subject to wet conditions, it rapidly loses its cohesion. The water penetration is low, approximately 10^{-6} cm/s, if it is counted taking, into account, its grain size distribution ($k = 100 \times d_{10}^2 = 100 \times 0.001^2 = 0.0001$ mm/s = 10^{-6} cm/s). The landslides are totally located within the marl

The crest of the landslide is located at a height of 71 m (Figs. 1, 6) whilst the toe at a height of 62 m (Figs. 1, 5, 6). The landslipped mass covers an area of about $1,800 \text{ m}^2$, and is circular with an arc of 60 m and W–SW direction. This rotational movement created a backscar wall 2.5 m high and a horizontal opening of 0.5–1.5 m. In order to estimate the cohesion (c) and the internal friction (Φ) of the marl and to perform the slope stability analysis, we used the back analysis technique parameters for saturated ground; this approach simulates the rainfall conditions prevalent at the time of the landslides. From this, we arrived at the following data: $c = 4 \text{ kN/m}^2$ and $\Phi = 18^\circ$, for the given landslide geometry and safety factor $SF = 0.993$.
