Dynamic investigation on the Mirandola bell tower in post-earthquake scenarios

This paper proposes a benchmark study for VBM applied to the bell-tower of Santa Maria Maggiore Cathedral in Mirandola (Italy), which was heavily damaged by the 2012 Emilia earthquake sequence. In fact, valuable data gathered during two testing campaigns on the structure evidenced a correlation of different modal features with the post-earthquake scenario. A first dynamic test campaign, conducted in the aftermath of the earthquake, allowed to identify the modal parameters related to the damaged state of the tower bell, whereas the analysis of vibration data collected during a second campaign showed how the provisional interventions influenced the dynamic behaviour, increasing the global stiffness and varying the modal shapes of the structure.

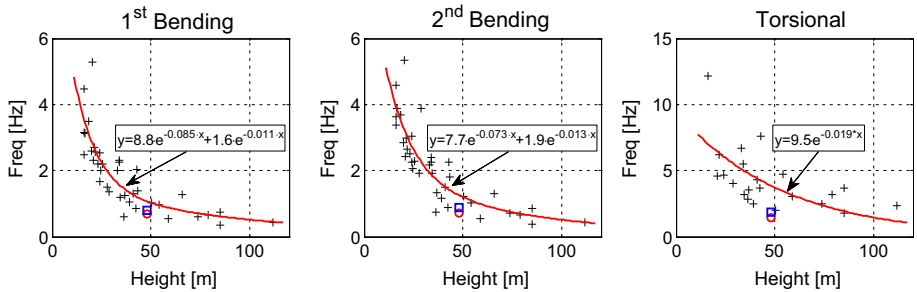
height represented by the lines in Fig. 8. This is most probably a symptom of a severely damaged structure, where box-like behaviour has been strongly affected. In fact, stiffness along the plane of the masonry walls is relatively less affected by the presence of cracks than torsional stiffness, which is influenced by the state of the connections between orthogonal wall panels. The full list of bell tower modes, up to the sixth, can be found in Table 2.
