Damage patterns in the town of Amatrice after August 24th 2016 Central Italy earthquakes

Gabriele Fiorentino¹

Keywords Amatrice earthquake · Strong motion records · Field survey · Collapse mechanisms · Vulnerability factors

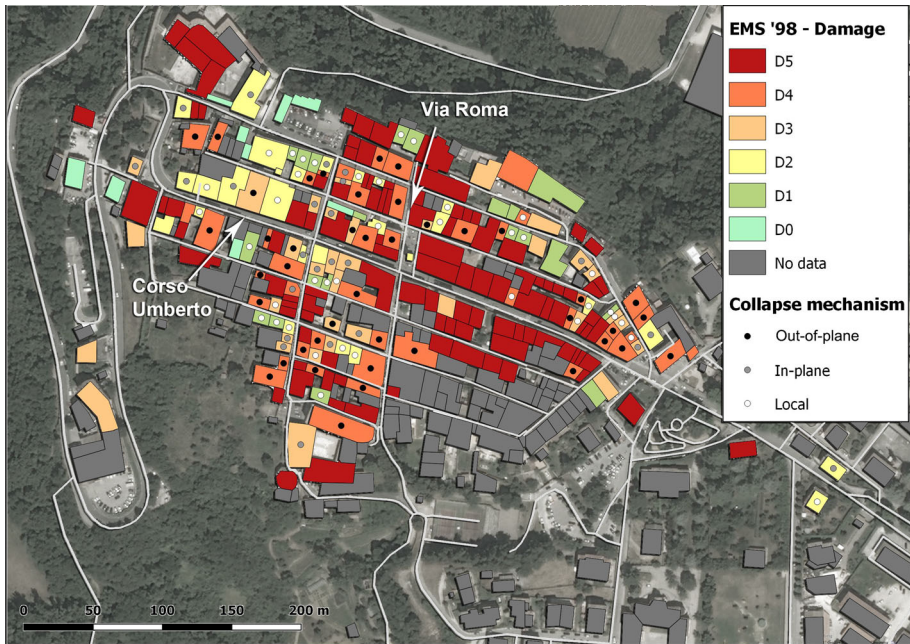
- the damage is assigned to single buildings, identified on the basis of the visual inspection;
- the field survey allowed to assign a damage level taking into account the whole situation of the single building and not only the condition of the roof;
- the map refers to the most probable damage mechanism only; a grey-scale-colored circle represents the type of mechanism: black circle for out-of-plane, grey circle for in-plane and white circle for local mechanism.
- in case of total collapse (D5) it was impossible to assign a mechanism.

The observation of the map allows to make the following considerations: many of the buildings which suffered major damage or collapsed lied along Corso Umberto, where the majority of the historical buildings are located (32 collapses out of a total of 105); the majority of the collapses in Corso Umberto happened east of Via Roma, while in the west part of the town the damage seems to be more scattered (see Fig. 11).

Fig. 10 Map of damage in Amatrice according to EMS-98 damage classification: The main mechanisms identified for each building are reported

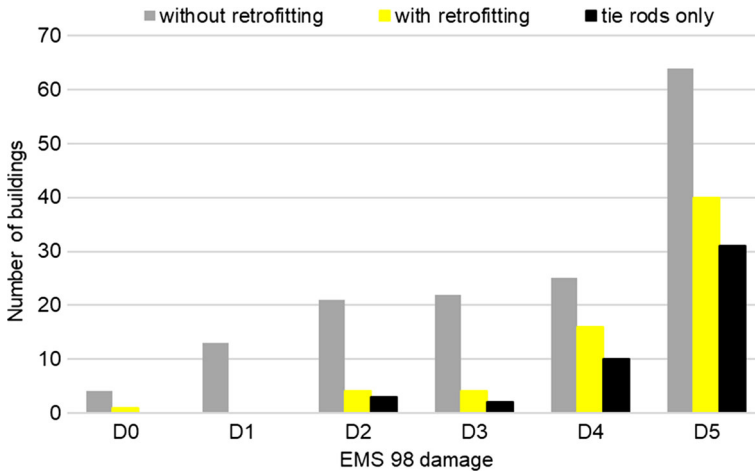
Fig. 13 Damage level of masonry buildings with and without tie rods

Many of the buildings inspected in Amatrice were provided with retrofitting systems, in particularly tie rods which constitute about 80% of the retrofitting interventions. Figure 13 shows the damage levels of masonry buildings without tie rods (grey bars), with any type of retrofitting system (yellow bars) and those who had only tie rods (black bars). The information was obtained by comparing the pictures of our survey with the images taken from Google Streetview©, dating to July and December 2011. It can be noted that many buildings which had tie rods suffered heavy damage and collapse, probably because in many cases the retrofitting had been made by means of inappropriate interventions, as depicted in Fig. 14. In fact, 31 out of 95 (32%) of the buildings which had a damage level

D5 had been retrofitted with tie rods. For damage level D4 there are similar results: 10 out of 35 (29%) had tie rods.

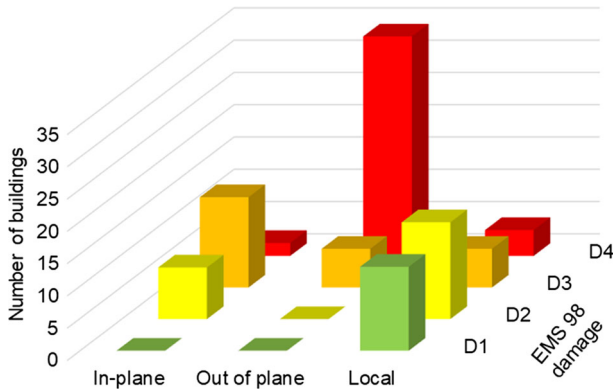
Fig. 15 Damage mechanisms for masonry buildings and D1–D4 damage levels

The most probable damage mechanism arises focusing on the 102 masonry buildings which have a damage level from D1 to D4 (from Table 1: 105 buildings—3 bell towers). In Fig. 15, for each damage level the number of buildings which had in-plane, out-of-plane and local collapse mechanisms is reported. For damage level D4 there were mainly out-of-plane mechanisms. In-plane mechanisms were identified mostly for damage levels D2 and D3, while local mechanisms are related mostly with levels D1–D2.

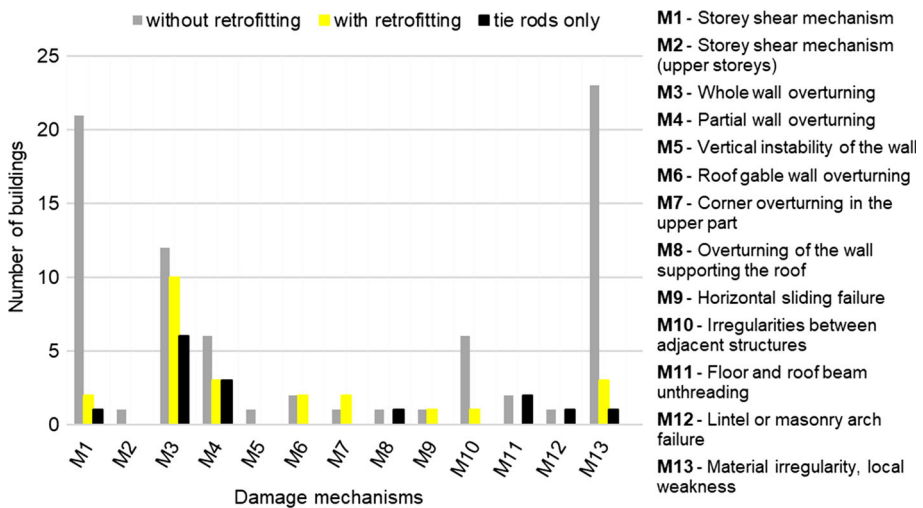
Figure 16 compares the different damage mechanisms identifying the buildings with retrofitting and tie rods. Differently to what expected in a retrofitted building, it must be observed that, among the buildings which suffered damage mechanisms M3 and M4 (total or partial wall overturning), 9 out of 18 buildings had tie rods, thus allowing to state that the presence of tie rods did not prevent the activation of out-of-plane mechanisms,

Fig. 16 Comparison between damage mechanisms and presence of tie rods for D1–D4 damage levels (see Table 3)

probably because of the poor masonry quality which did not allow an efficient force transfer system to the masonry.

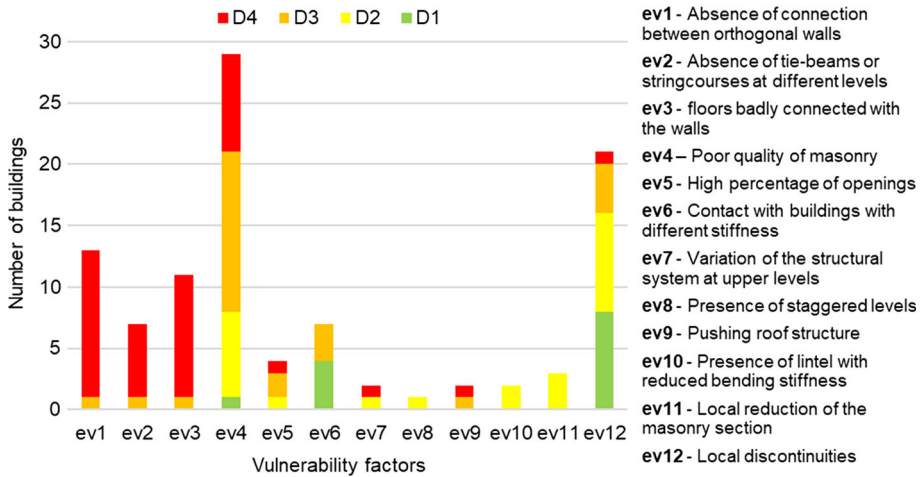
Fig. 17 Vulnerability factors identified for 102 masonry buildings and EMS 98 damage level

Figure 17 reports the vulnerability factors identified for 102 masonry buildings with damage level ranging from D1 to D4. The most relevant factors (more than 10 buildings affected) are:

Examples of the first two vulnerability factors are reported in Figs. 18 and 19. The above listed factors represent almost 75% of the buildings with Damage level D1–D4. It is possible to notice that D4 is mainly connected with vulnerability factors ev1 (absence of walls connection), ev2 (absence of stringcourses), ev3 (floor/walls bad connection), ev4 (poor quality masonry) and only in few cases with ev5 (high percentage of openings), ev7 (variations at upper levels), ev9 (pushing roof structure), ev12 (local discontinuities).

The vulnerability factors connected with the out-of-plane overturning of a wall (i.e. ev1, ev2, and ev3) are those related to the highest level of damage D3 and D4. The poor quality masonry (ev4) and local discontinuities (ev12) characterize all the damage scale.

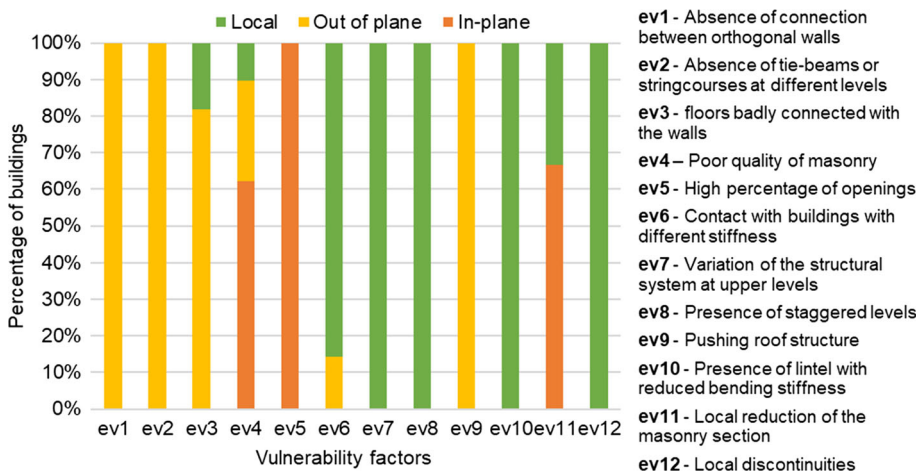
Figure 20 shows the type of damage mechanism (in-plane, out-of-plane, local) for each vulnerability factor.

It is worth noting that in plane mechanisms are only caused by ev5 (high percentage of openings), ev4 (poor masonry quality) and ev11 (local reduction of thickness). Out of plane

Fig. 20 Damage mechanism and vulnerability factors

mechanisms are due to ev1 (lack of connection between walls), ev2 (absence of string-courses), ev9 (heavy roof), and partially to ev3 (connection wall-floors), ev4 (poor quality of masonry) and ev6 (contact with other buildings with different stiffness). Local failure mechanisms are due to ev7 (variation of the structural system at upper levels), ev8 (presence of staggered levels), ev10 (presence of lintel with reduced bending stiffness), ev12 (local discontinities), and ev6.

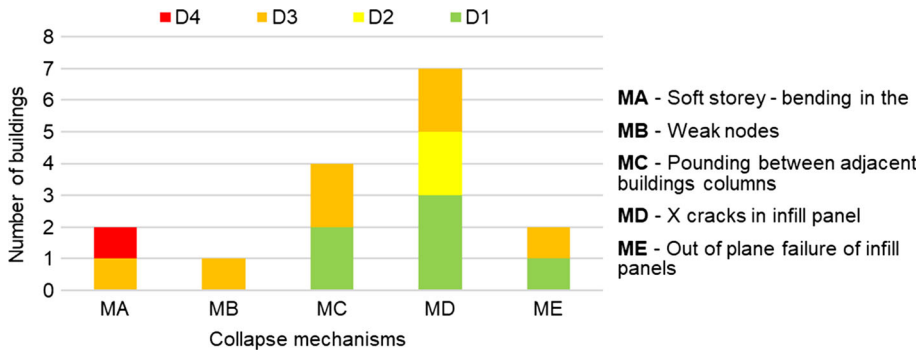
Fig. 21 RC buildings: correlation between damage mechanisms and damage levels for the 16 RC buildings with damage D1–D4

The most frequent type of damage for RC structures, as shown in Fig. 21, was the MD (cracks in infill panel) connected to the vulnerability factor evA (Table 4, frame with inadequate beams and infill walls). The Hotel Roma building, which was rated D4, presented a soft-storey mechanism and had been demolished at the date of our survey; therefore the damage level was assigned based on newspaper images.
