The M_w 5.4 Zagreb (Croatia) earthquake of March 22, 2020: impacts and response

Abstract

Keywords Masonry buildings · Cultural heritage · Physical damage · Emergency response · Post-earthquake inspection · Social impacts

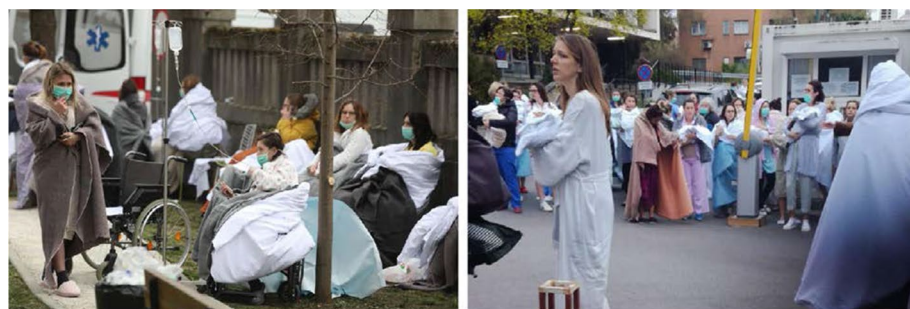
Fig. 1 Evacuation of pregnant women and mothers with babies from the Clinic for Women's Diseases and Obstetrics in Petrova Str. (Photo: Government of the Republic of Croatia, 2020)

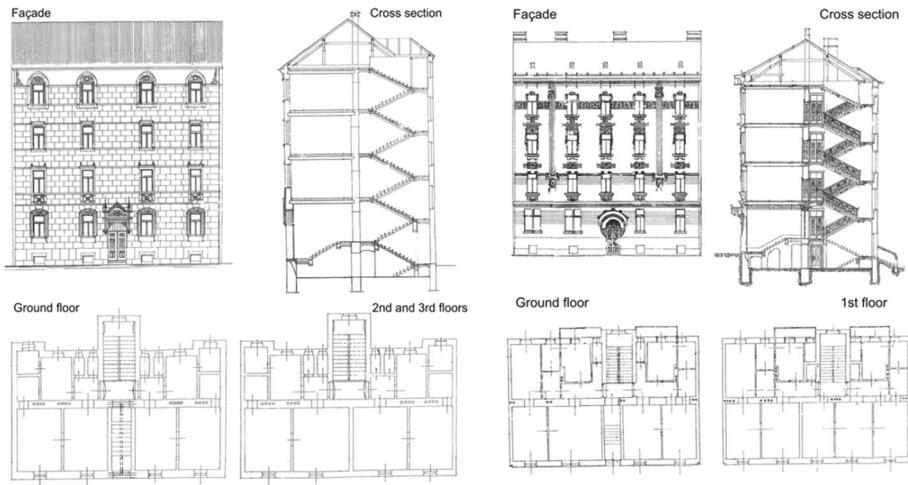
Fig. 4 Typical examples of unreinforced masonry buildings from the beginning of the twentieth century in the historic center (after Crnogorac et al. 2020)

In addition to the design characteristics, their age and often inadequate maintenance contributed to the poor performance of these buildings. Aggravating factors are surely the subsequent renovations, upgrades and conversions of the occupancy. The original up to 60 cm thick solid brick load-bearing walls, composed of two to three rows of moulded clay bricks, are often reduced in thickness or partially or even fully removed at the ground level to install street store windows. Steel lintels are frequently installed to span the new or extended openings. As well, in certain cases in the upper floors, partition and even interior bearing walls are completely disregarded as part of the structure and removed to gain space. Such interventions result in unsupported walls, which were initially continuous in the vertical direction, or in walls unsupported out-of-plane significantly weakening the structural system. These interventions are seldom documented and the current condition of the building differs significantly from the original documentation.

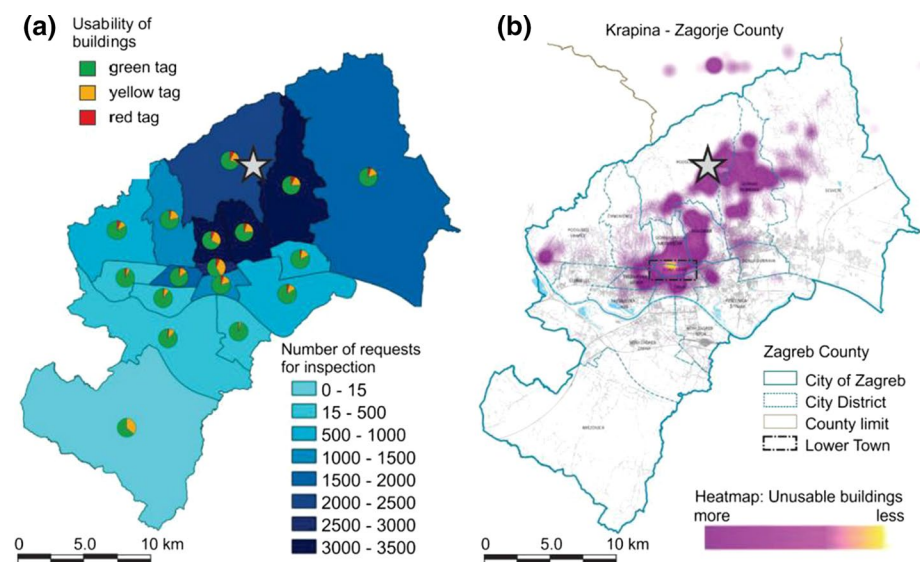
In total, more than 25,500 building inspections were performed or about 19.6% of the approximately 130,000 buildings within the city limits. Overall, about 75% of all inspected buildings were green tagged (U1 and U2), 20% temporarily unusable (PN1 and PN2) and 5% unusable (N1 and N2). The spatial distributions of building inspections at district level and building usability are given in Figs. 11 and 12.

Fig. 11 Impacts on buildings: **a** number of performed inspections (shades of blue color) and pie-charts of usability ratings across city districts (green-usable, yellow-temporarily usable and red-unusable; QGIS.org 2020); and **b** heat map of the unusable buildings. The epicenter is indicated with the star symbol (courtesy of the City Office for Strategic Planning and Development)

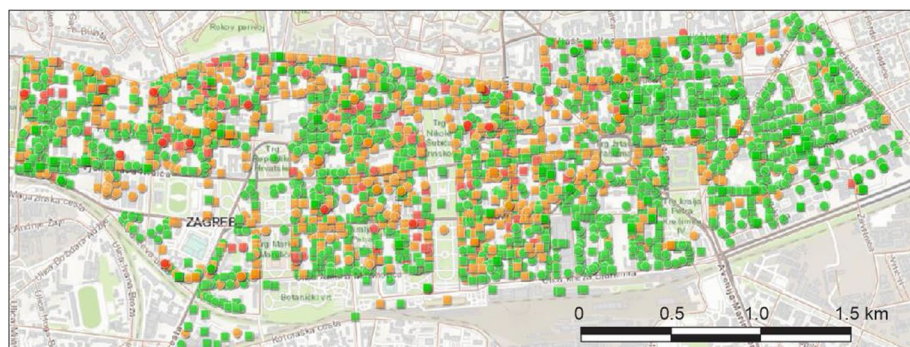
close to the epicenter. The heatmap of unusable buildings provides information of the relative density of damaged buildings per unit area (Fig. 11b). Inspection results suggest that nearly all of the damage occurred in older masonry housing units and heritage buildings not designed to resist lateral dynamic loads. About one third of all buildings in Zagreb were built before 1964, when the first Seismic Construction Code was

Fig. 12 Building usability in the Lower Town (indicated with dashed line in Fig. 11): green-usable, yellow-temporarily unusable and red-unusable (GIS BUD 2020)
