# Seismic performance of strengthened masonry structures: actual behaviour of buildings in Norcia and Campi Alto during the 2016 Central Italy seismic sequence

Romina Sisti<sup>1</sup> · Marco Di Ludovico<sup>1</sup> · Antonio Borri<sup>2</sup> · Andrea Prota<sup>1</sup>

## Abstract

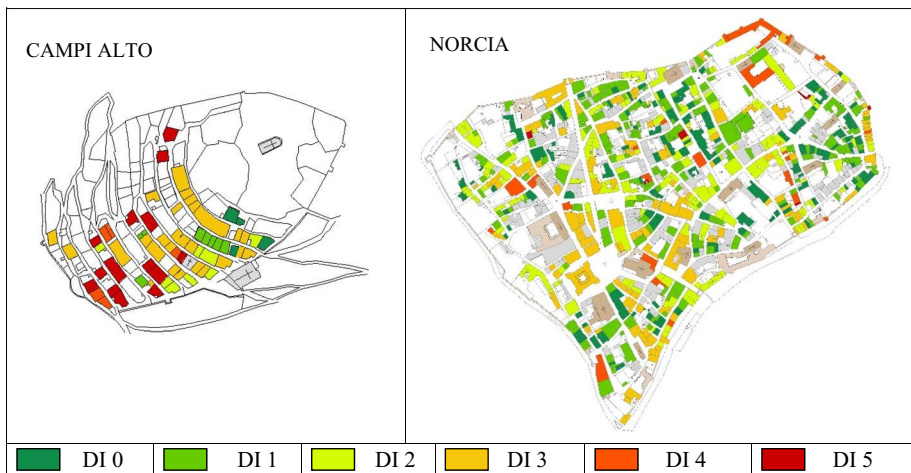
of MSUs resulted affected by local or global collapse, DI 5. The plan distribution of DI in Campi Alto and Norcia is reported in Fig. 13. In Campi Alto a higher concentration of buildings with DI equal to 4–5 is found in the lower part of the town. Comparing this map with the seismic microzonation map (Fig. 7) for buildings with a period of 0.1–0.5 s, it is observed that the lower part of the town is characterized by an AF of 1.1–1.4, while the upper part of the town has an AF equal to 1. When the MSU is part of a terraced building, consisting of several adjacent MSUs, its position in the compound of units does not seem to have a clear correlation with the damage index.

**Fig. 13** Maps of Campi Alto and the historic centre of Norcia: identification of the damage index rating of residential buildings

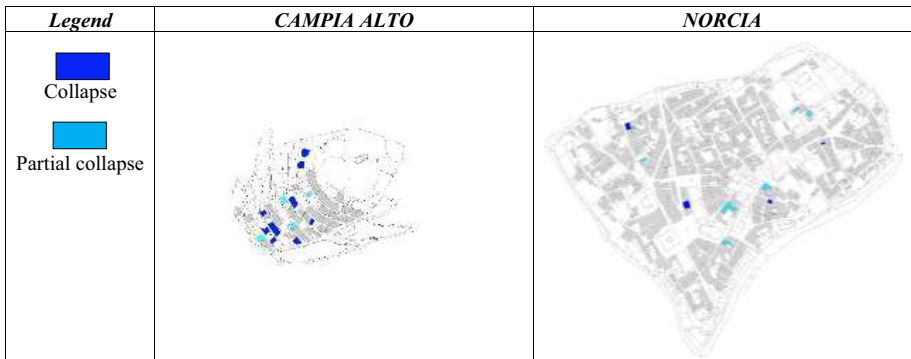
Furthermore, according to AeDES forms and *in situ* inspections specifically carried out by the authors resulted that in Campi Alto 13 MSUs collapsed (i.e. 9 full collapse and 4 partial collapse, see Fig. 15), corresponding to 26% of the entire built-up area. In particular, the full collapses affected 4 MSUs never consolidated, 4 renovated before 1982, and 1 renovated after 1982 while 4 partial collapses affected MSUs renovated after 1982. In Norcia, only 4 MSUs collapsed and 7 partially collapsed corresponding to about 2% of the dataset.

**Fig. 15** Maps of Campi Alto and the historic centre of Norcia: identification of total and partial collapses in residential buildings

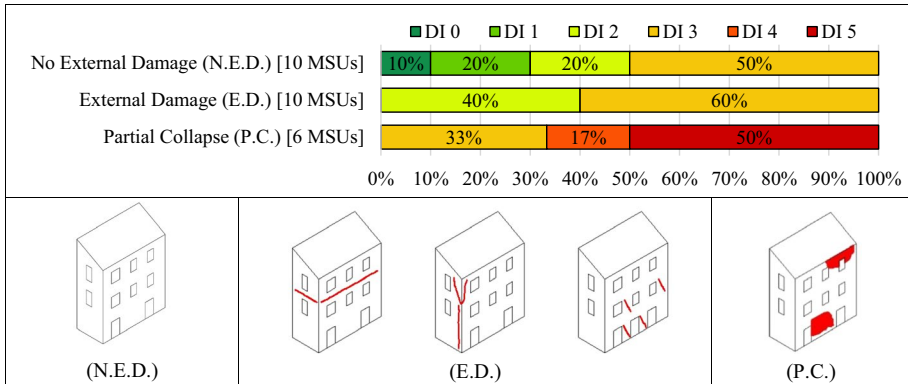
Figure 17 shows the distribution of the damage index evaluated according to the data collected in the post 2016 earthquake sequence by AeDES form. The 26 MSUs have been grouped in three categories based on the type of external damage detected during *in-situ* inspections carried out by authors: MSUs with no external damage (N.E.D.); MSUs with external damage (E.D.); and partially collapsed MSUs (P.C.). Note that during the *in-situ* inspections carried out by the author, it was possible only to evaluate the external condition of the buildings, whereas the AeDES data also considers the internal damage (unless the building was inaccessible); for that reason, also within the group "no external damage" 50% of MSUs has a damage index equal to 3.

Fig. 17 Damage Index distribution on MSUs located in Campi Alto
