Damage observations of RC buildings from 2023 Kahramanmaraş earthquake sequence and discussion on the seismic code regulations

Abstract

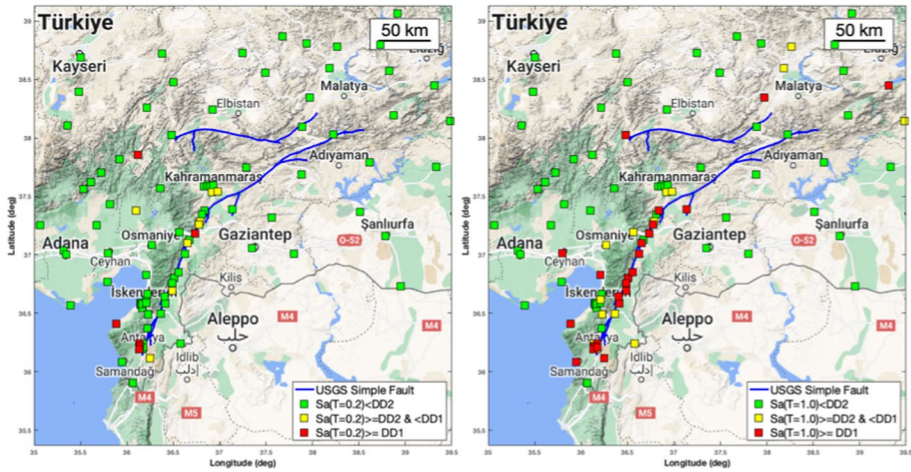
Ordinary RC buildings are designed for the DD2 level earthquake (475-year return period) but expected not to collapse at the DD1 level earthquake (2475-year return period). Figure 1 shows the spectral accelerations of the recorded motions from both earthquakes compared to the DD1 and DD2 levels for short (0.2 s) and long periods (1.0 s). For short periods, the spectral accelerations of DD1 level are exceeded only in few stations, mostly in Antakya, while for long periods there is exceedance at several stations along and around the fault line. The spectral shape, as well as the spectral ordinates of the hazard maps, may need to be revised after these findings.

Fig. 1 Stations that short period (0.2 s) and long period (1.0 s) spectral accelerations from both earthquakes of February 6, 2023 exceed DD1 (2475 yr) and DD2 (475yr) levels of the 2018 seismic hazard map (the strong ground motion data for producing the map is obtained from AFAD TADAS web platform)

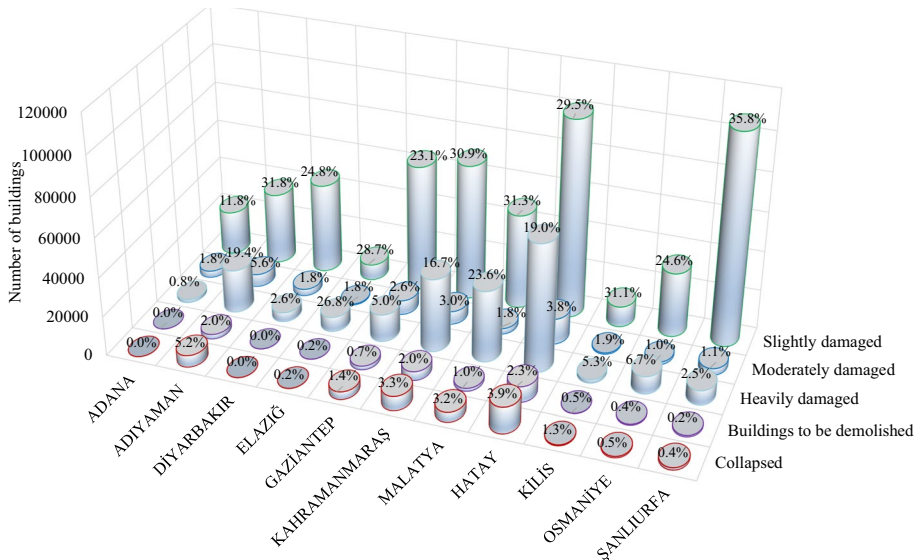
Ministry of Environment, Urbanization and Climate Change (MEUCC 2023) is the responsible body in Turkey for officially defining the damage level of each building after an earthquake. The distribution of damage per province, as per most recent data of 3rd of April 2023 (Fig. 2), shows high collapse ratios in Adiyaman, Gaziantep, Hatay and

Fig. 2 Results of post-earthquake damage assessment per province (MEUCC 2023)

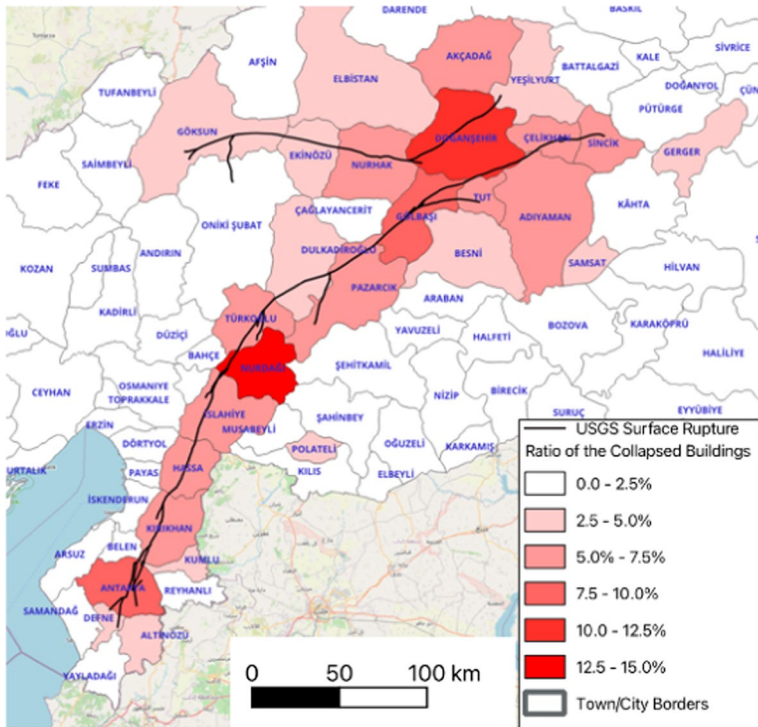
Kahramanmaraş provinces. Zooming in on county level, the largest collapse ratios correspond to Antakya, Nurdağı, Gölbâşı and Doğanşehir along the fault line (Fig. 3), as can be confirmed by reconnaissance observations by the authors themselves. For example, the collapse ratio in Nurdağı reaches almost 15%, unusually high as compared to the known collapse ratios from the past large earthquakes in Turkey (Bal et al. 2008a).

Fig. 3 Results of post-earthquake damage assessment per county (see (Reitman et al. 2023) for the fault rupture)

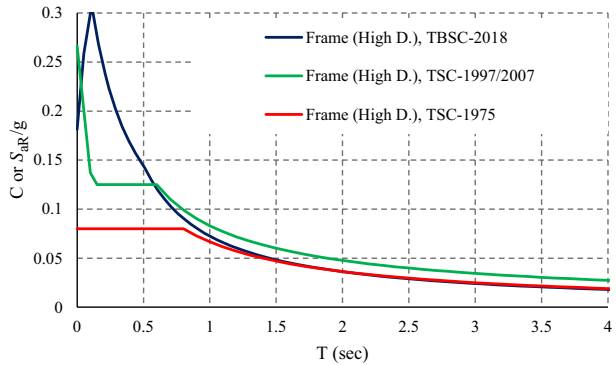
Fig. 26 Comparison of the lateral load coefficient spectra of the TSC-1975, TSC-1998/2007 and TBSC-2018 for ductile frame RC systems (Soil is assumed class C, Z3 for TSC-1975/1998/2007 and ZD for TBSC-2018)

The comparison of the seismic design codes is also made via lateral load coefficient spectra, which are similar to the inelastic design spectra in principle. As shown in Figs. 26 and 27, the TSC-1975 lateral coefficient values are smaller than those in the later codes, bearing in mind, however, that the 1975 code, together with the RC design standard, introduced higher safety factors to the concrete and steel materials, as explained above. The exact overstrength caused by these larger safety factors would depend on the section properties, however, the ratio of this extra overstrength applied from 1975 to 1984 fluctuates between $2.26/1.5 = 1.51$ and $1.18/1.15 = 1.03$, considering safety coefficients of concrete and reinforcing steel, respectively. On the other hand, *effective section stiffness coefficients* are utilized for modeling of RC members in TBSC-2018 thus leading to higher period values of vibration modes and corresponding lower spectral accelerations.

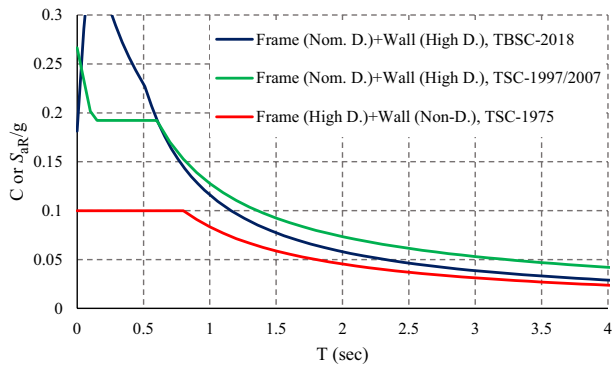
Fig. 27 Comparison of the lateral load coefficient spectra of the TSC-1975, TSC-1998/2007 and TBSC-2018 for wall-frame RC systems (Soil is assumed class C, Z3 for TSC-1975/1998/2007 and ZD for TBSC-2018)
