Destructive impact of successive high magnitude earthquakes occurred in Türkiye's Kahramanmaraş on February 6, 2023

Abstract

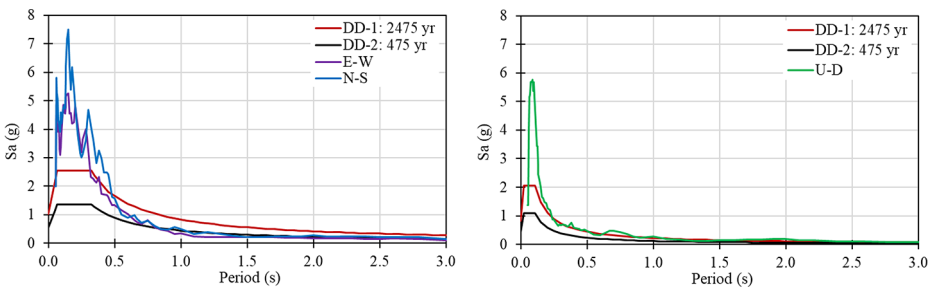
Upon the horizontal and vertical elastic design spectra are investigated, it is observed that the elastic design spectrum, created for an earthquake risk having a return period of 475 years (corresponding to earthquake level DD-2 in TBEC 2018) was exceeded in the

Fig. 2 Pazarcık Earthquake ($M_w = 7.7$), Station 4614 (Kahramanmaraş/Pazarcık), Response Spectra ($\xi = 5\%$, $V_{s,30} = 541$ m/s, Soil class: ZC)

locations of Karamanmaras, Hatay, Gaziantep, and Adıyaman during the Pazarcık Earthquake ($M_w = 7.7$). However, the elastic design spectrum created for an earthquake risk having a return period of 2475 years (corresponding to earthquake level DD-1 in TBEC 2018) was only exceeded in Karamanmaras and Hatay provinces. Moreover, during the Elbistan Earthquake ($M_w = 7.6$), while the design spectrum created for DD-2 was exceeded only in Malatya and Karamanmaraş, the design spectrum of DD-1 earthquake level was not exceeded in the region except at station 4612 in Elbistan for the periods higher than 1.2 s. The design spectra have not been exceeded in other places in the area.

Additionally, it is determined that the earthquakes mainly affected the short-period buildings having a fundamental period of lower than 1.0 s and corresponding to low and mid-story structures. Therefore, the damage increased in the region because it generally has low and mid-story building stock. Nevertheless, the buildings with large periods seemed affected only at station 4612. Moreover, the buildings with large overhangs were also severely damaged in the region because the vertical components of the recordings were very high and exceeded the design spectra.

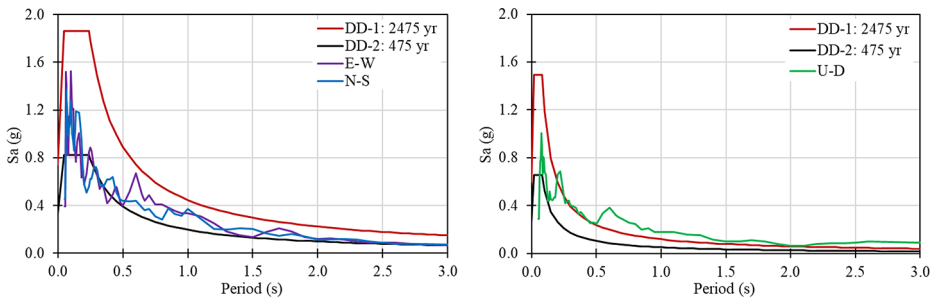
Fig. 3 Elbistan Earthquake ($M_w = 7.6$), Station 4406 (Malatya/Akçadağ), Response Spectra ($\xi = 5\%$, $V_{s,30} = 815$ m/s, Soil class: ZB)
