# Investigation of Damage in and Around Kathmandu Valley Related to the 2015 Gorkha, Nepal Earthquake and Beyond

Tsuneo Ohsumi · Yoichi Mukai · Hideo Fujitani

**Abstract** An earthquake with a magnitude of 7.8 ( $M_w$ ) occurred at 11:56 NST (local time) on 25 April 2015, in the central part of Nepal (Gorkha). We organized a damage survey team and dispatched it to the affected area for several periods following the earthquake (May 26 to June 3: first trip, June 17 to 24: second trip, August 16 to 21: third trip and October 27 to November 2: forth trip) to investigate the damage and collect data. We found traditional construction methods are stronger than imagined. Many traditional earthquake-resistance technologies exist in Nepal. The first and second surveys were to collect timely statistical information on the damage to brick and stone masonry buildings and to confirm the availability of data and their sources for subsequent surveys. We also carried out a first-hand building damage survey in selected areas. The investigation of the strong-motion data set from the USGS Center for Engineering Strong Motion Data includes information from stations in Nepal that continued to functio

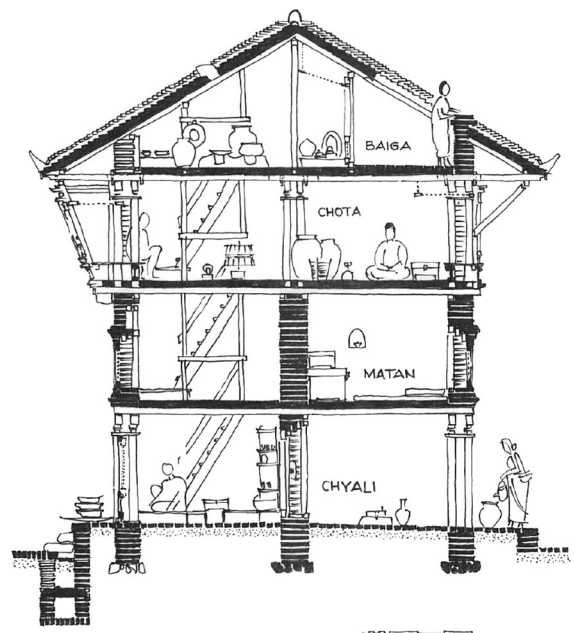
**Fig. 10** Typical cross section of a multiple-story building (after Toffin 1991)

In urban core areas, four-story buildings dominate, and more than a third of the buildings are five stories or higher. The construction of the Nepalese traditional four-story house is shown in Fig. 10. These are mainly brick masonry structures, but many of them have been extended vertically by adding additional stories to the original three- or three and a half-story buildings. In addition, many of them are divided vertically for the

use of separate families because of the local custom of succession of property. This contributes to higher seismic risk, even if one does not consider the poor building technology actually adopted for the construction.

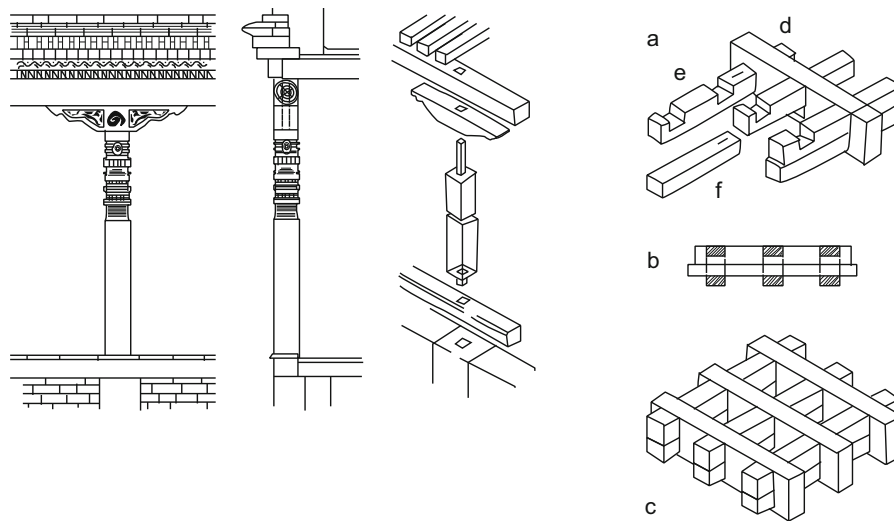
The traditional method of construction, which does not use metal with timber (Fig. 11) has prevented degradation for a long time. This type of construction should be repaired using traditional methods without resorting to modern methods. This traditional construction method resist motion throughout the structure during earthquakes (Fig. 12). The traditional structures caused brittleness transformations and defective corners of the structures related to the 2015 Gorkha

**Fig. 11** Timber technology (after Toffin 1991)—detail of opening canopy—**a** exploded, perspective; **b** transversal section; **c** perspective of assemblage elements; **d** main frame; **e** secondary frame; **f** wedge key

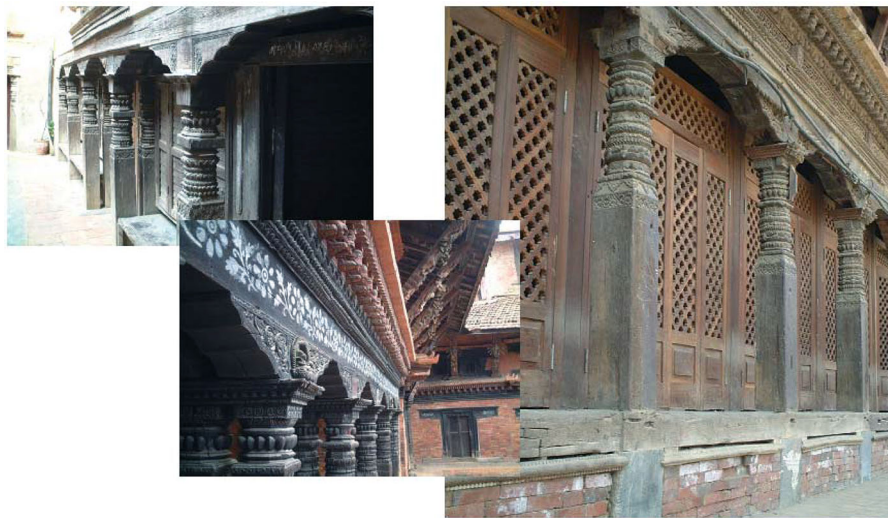
**Fig. 12** Traditional construction method resist motion throughout the structure during earthquakes (photo by T. Ohsumi)

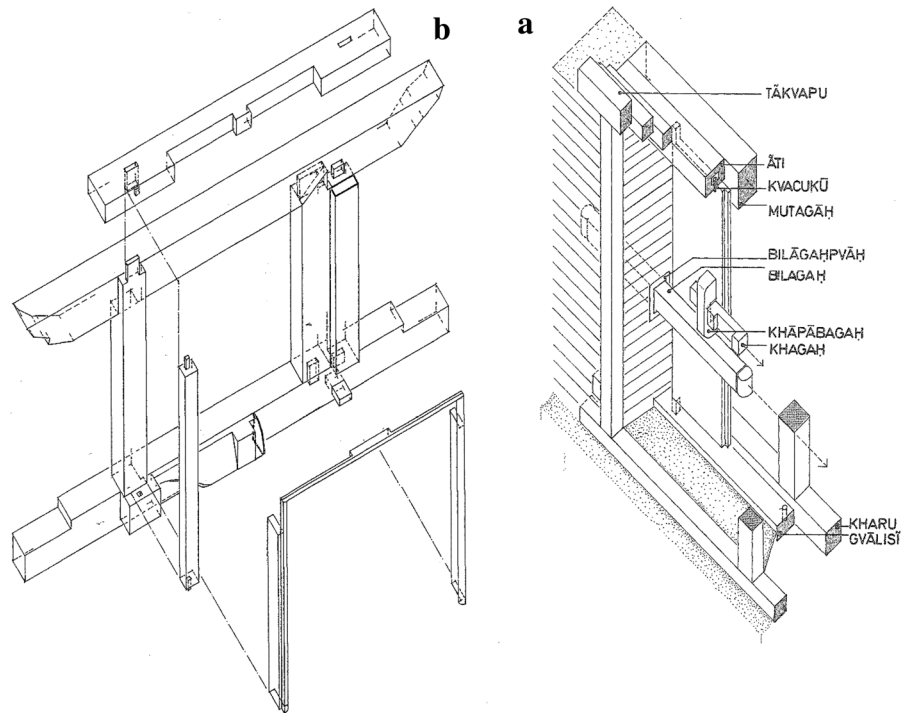
outside wall and the inside. The wooden frame and the door fixed from both sides has reinforced stiffness in an opening (Fig. 15). Shuttering windows (*Pasahdhi*) consists of a lower panel or planks inserted into a joint and locked in its position by a rail and a movable shutter. The shutter is fastened at the ceiling joints before the rail and panel are removed (Fig. 16).

**Fig. 16** Shuttering window: **a** (photo by T. Ohsumi) and section of a shuttering window: **b** (after Gutschow et al. 1987)

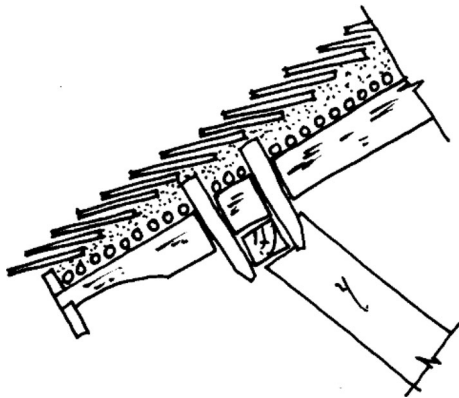
Roof soil, which is cured clay/silt, prevents heat conduction from sunlight and is water resistant indoors (Fig. 17). Flying weeds cause the roof for long year.

For the infiltration of rainwater, the building deteriorates. The roof renovation is important periodically.

**Fig. 17** Typical roof cross section. (courtesy of Assistant Prof. Ram Prasad Suwal with Nepal Engineering College)

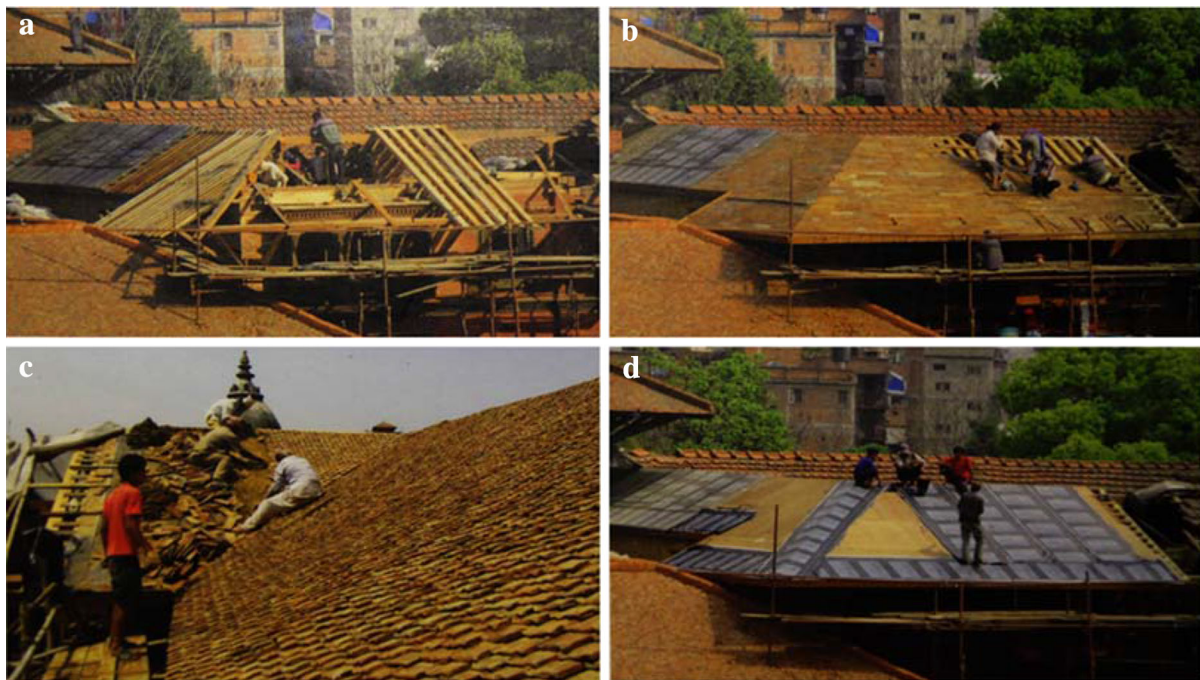
The Patan palace was renovated with assistance from the Kathmandu Valley Preservation Trust (KVPT) and the Sumitomo Foundation in 2013 (Fig. 20). Thus, in

Patan, after the earthquake, this palace had only partial damage at the top of the structure (Gajur and Baymvah).

**Fig. 20** Renovation of the structure and the covering of the roof was carried out in 2011: **a** (top left) installation of timber rafters, **b** hand wood planking, **c** waterproof membrane, **d** traditional

terracotta roof tiles on a mud bed (from information plate at the Patan Museum)

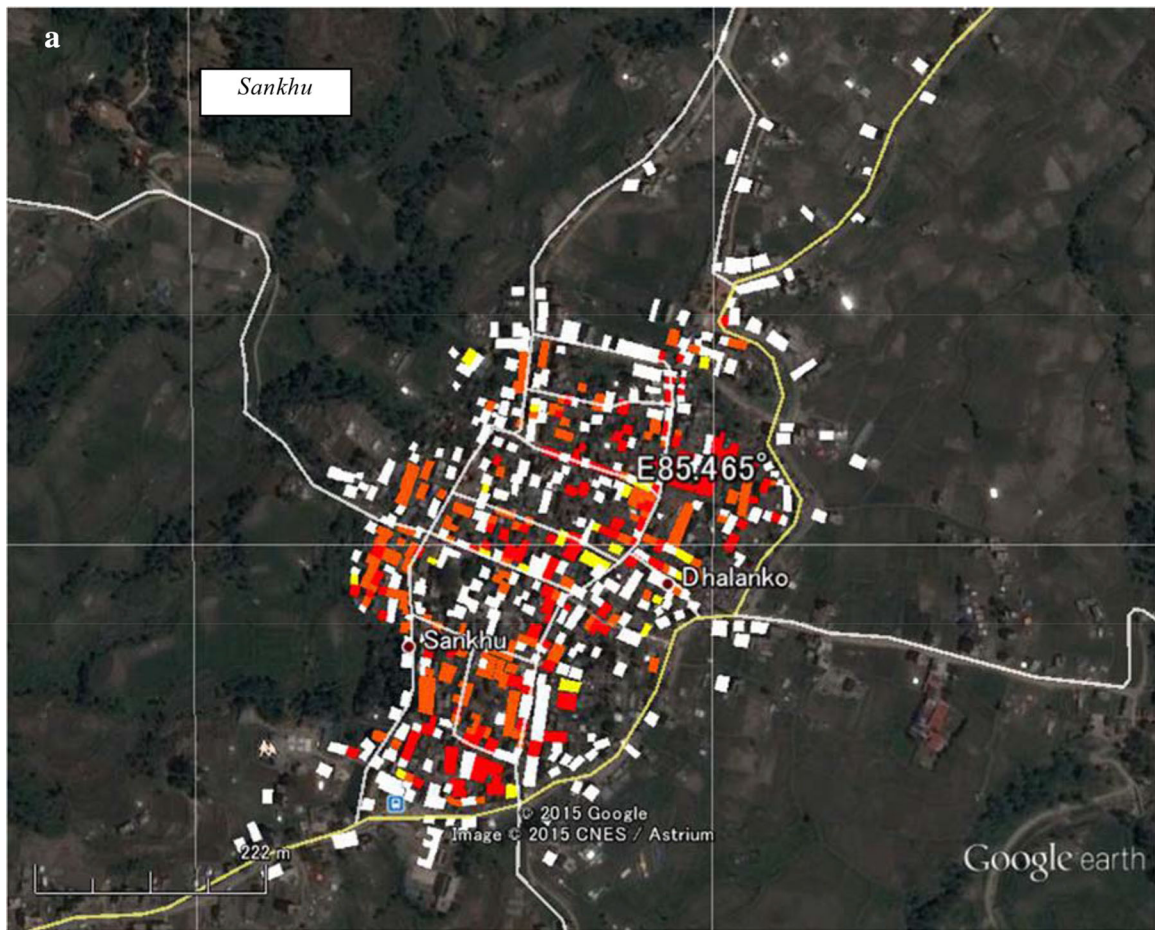
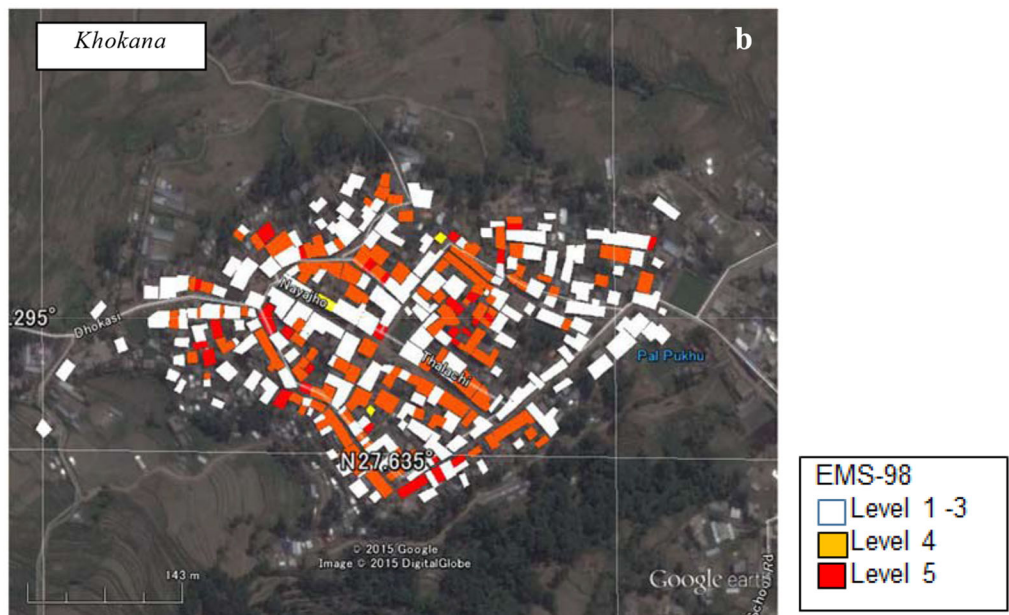
Damage extent was surveyed for every house in Sankhu on August 17–18, 2015 (Fig. 21a) using EMS-98. A high-resolution image from March 12 (before the disaster) was obtained via Google Earth™ prior to the survey. This image was used to identify the position of each building before the earthquake, based on which the extent of damage to each building was estimated in accord with EMS-98.

Khokana was once Newari village and has retained its tradition and culture as a World Heritage Site in Nepal. A damage survey was conducted for every house in Khokana on August 19–20, 2015 (Fig. 21b).

◀ **Fig. 21** Survey of damage extent for every house in Sankhu (a), and Khokana (b) (Ohsumi et al. 2015; Watanabe et al. submitted)

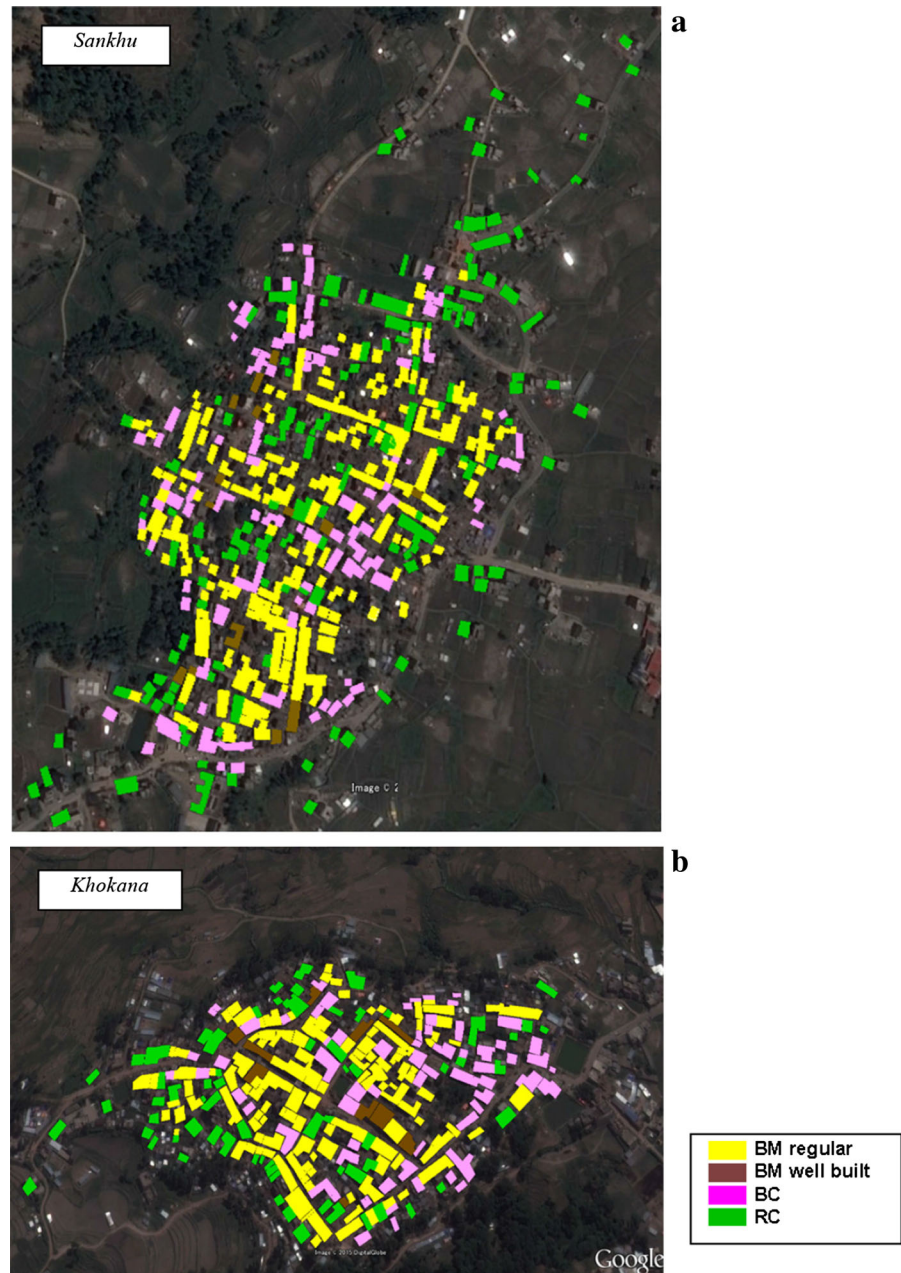
Figure 22a, b show the survey of building type classification for every house in Sankhu and Khokana. The number for damage extent of each building type for every house is shown in Tables 2 and 3. The difference in damage by building type was remarkable. Brick and cement mortar houses without RC columns experienced substantial damage. In contrast, damage to RC structures, particularly those erected in recent years, was generally minor.

**Fig. 22** Survey of building type for every house in Sankhu (a), and Khokana (b)

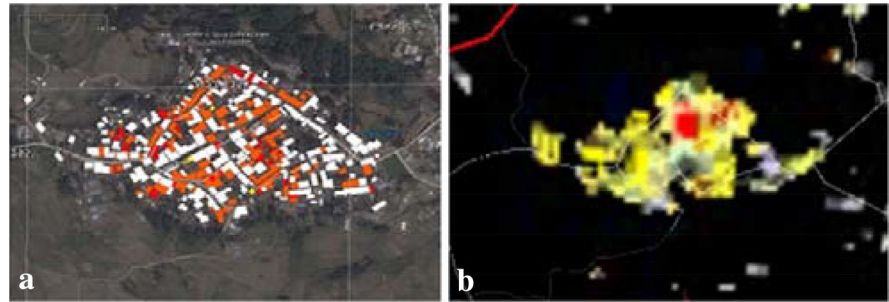
and a survey of damage extent for every house in Khokana. Reflections in the slightly damaged Kirtipur core area are not as clear and bright as those in the severely damaged core areas of Khokana and Bungamati.

**Fig. 28** Bright reflection areas for Khokana and Bungamati core areas. Kirtipur was not clear bright reflection

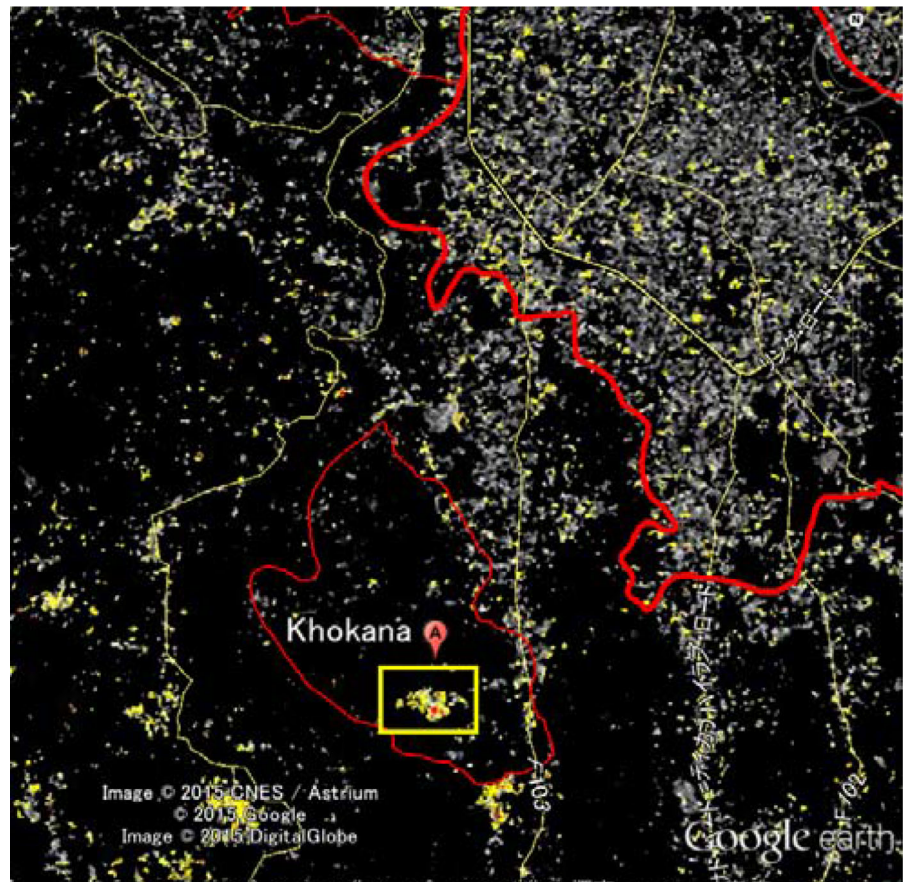
The epicentral distance of the Kirtipur core area was 79.74 km, compared with 80.69 km for the epicentral distance of the Khokana core area. Both core areas are

old traditional towns on small hills in the southwestern Kathmandu Valley. According to Takai et al. (2015), acceleration was amplified in Patan (Khokana) located in the Kathmandu Valley. In contrast, acceleration was less amplified in Kirtipur, which is located on outcropping basement rock units outside the valley.

**Fig. 29** Coherence magnitude (a) and survey of damage extent (b) for every house in Khokana

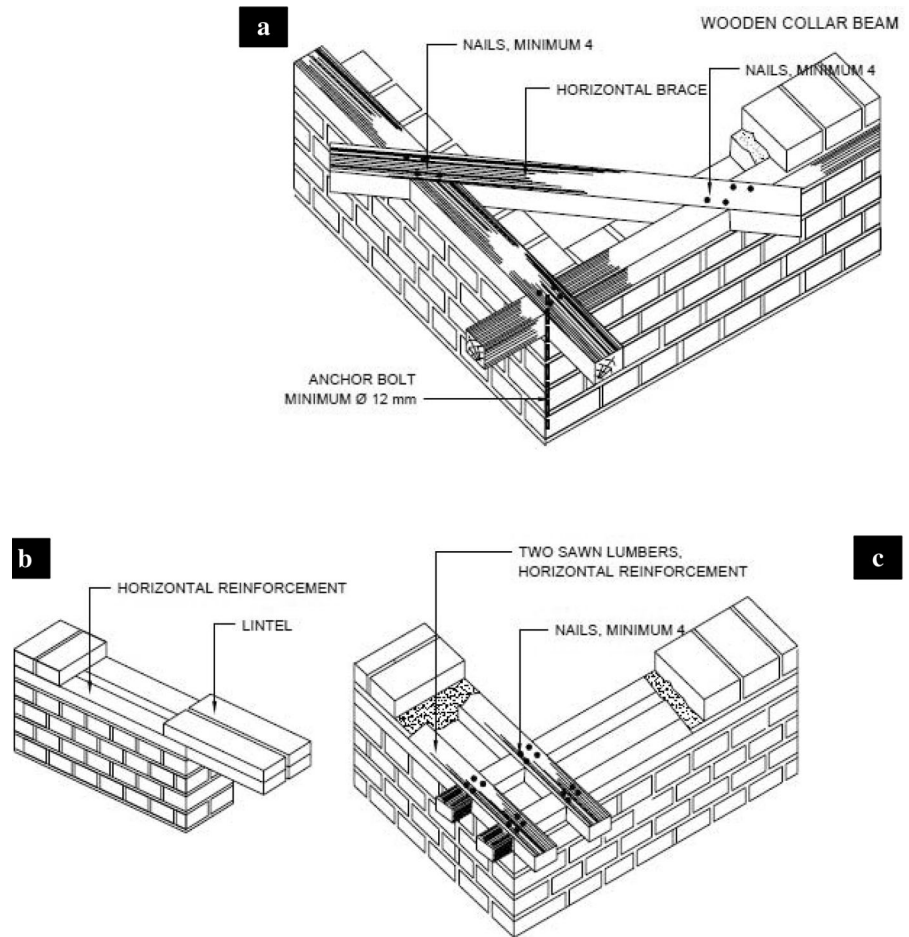
**Fig. 31** Placement of timber for horizontal reinforcement bands (after National Building Code NBC203). Wooden Collar Beam with anchor bolt (a), Horizontal reinforcement with liner (b), Two sawn lumbers (c)

NBC 203 and 204 describe the effect of wooden strips as horizontal reinforcing members. An assemblage of two parallel lengths of timber connected by struts is placed horizontally in the wall covering the entire thickness of the wall, as illustrated in Fig. 31.

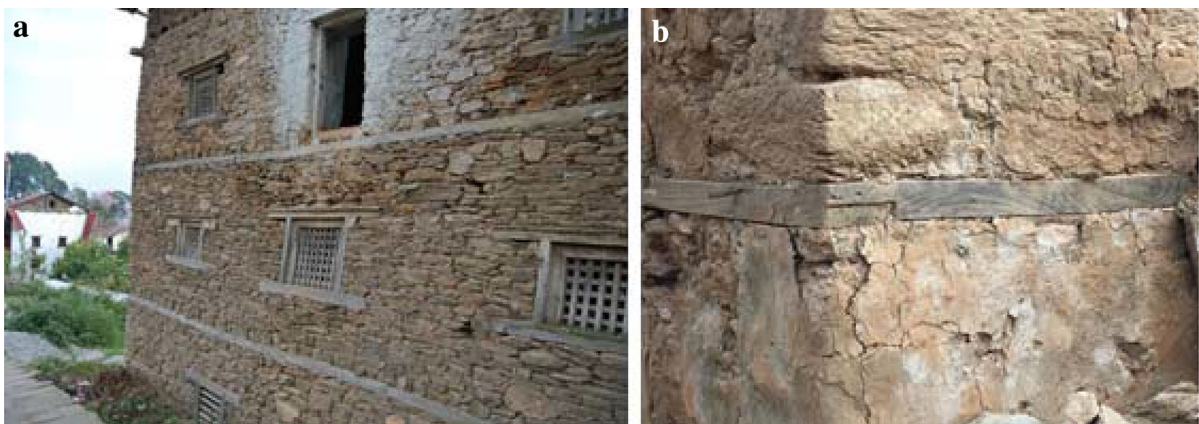
**Fig. 32** Timber band installed between the first and second floors in a house in Charikot (a) and Corner joint of horizontal timber planks (b). (Photos by Dr. Hiroshi Imai of the JICA study team)

In Dolakha Bazaar, an old town located 4 km from Charikot in north-eastern Nepal, the buildings installed horizontal timber support planks. The timber planks were installed between the first and second floors of the building, along the outside wall of the building. In buildings with narrow sides and a gable wall, the timber is usually fitted along the outer periphery of the building separate from the floor beam. In the long side of the building, the timber is installed so as to form a common joint in the outer periphery of the building. The corner joint varies according to the building style, but notched joints are commonly used (Fig. 32).
