Mosul Dam: Is it the Most Dangerous Dam in the World?

Nadhir Al-Ansari · Nasrat Adamo · Sven Knutsson · Jan Laue ·
Varoujan Sissakian

Abstract Mosul Dam is an earth fill dam, with a storage capacity of 11.11 km^3 constructed on highly karstified gypsum beds alternating with marl and limestone. After impounding in 1986, seepage locations were recognized. The dam situation now indicates that it is in a state of extreme relative risk. If it fails, then 6 million people will be affected and 7202 km^2 area will be flooded. Grouting operations will elongate the life of the dam but will not solve the problem. Building a protection dam downstream will be the best measures to secure the safety of the downstream area and its' population.

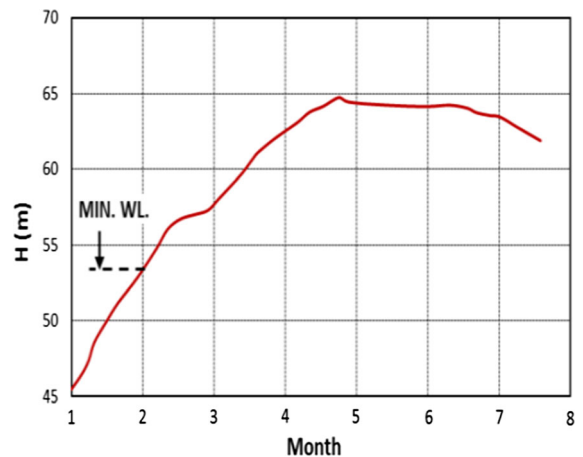
gypsum and anhydrite beds raised a big concern for the safety of the dam and its possible failure. In that winter as the reservoir level increased for the first time seepage began to appear from six major springs at the left bank downstream of the dam at different elevations. Seepage also occurred from under the dam in the deep river section which was discovered from observing the increase of sulphate concentration indicating gypsum leaching from the foundation rocks. The temporary downstream coffer dam used during diversion was raised and fitted with a measuring weir so to measure and sample the seepage from the deep river section. Results of seepage surveillance complete with salts concentration measurements were done from February 10, 1986 to August 16, Figs. 3 and 4 show the rise in reservoir water level and variation of measured seepage discharges at the different locations, Fig. 5 gives the change in transmissibility of the springs under the river section of the dam, and lastly Fig. 6 which shows the variation in dissolution rate of mineral salts. Analysis of these results yielded that

Fig. 3 Reservoir water level increase for the period February–August (after Guzina et al. 1991)

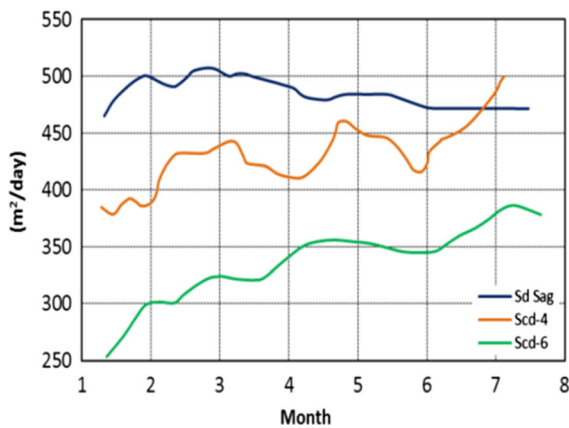
Fig. 5 Spring transmissibility change for the period February–August, 1986 (after Guzina et al. 1991)

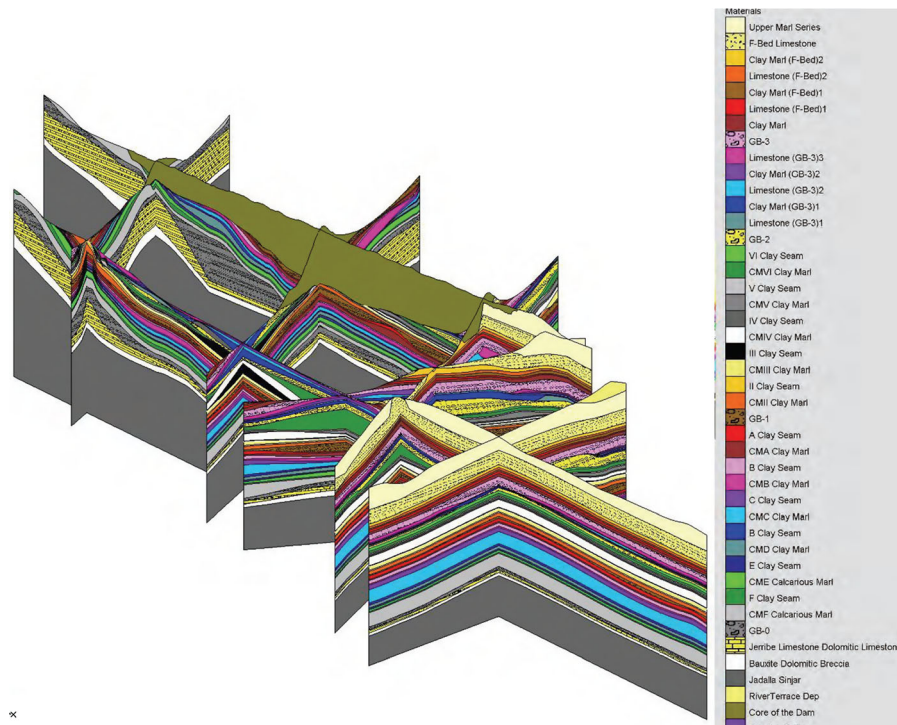
Fig. 7 Intersecting cross sections from intermediate version of ERDC geologic conceptual model, showing complex stratigraphy and partial resolution of discrepancies in stratigraphy at intersections of the geologic panels from generated boreholes. (Kelly et al. 2007)

Mosul. Wakeley et al. (2007) collected all the borehole data and constructed a model to show the complex geology at the dam site (Fig. 7).

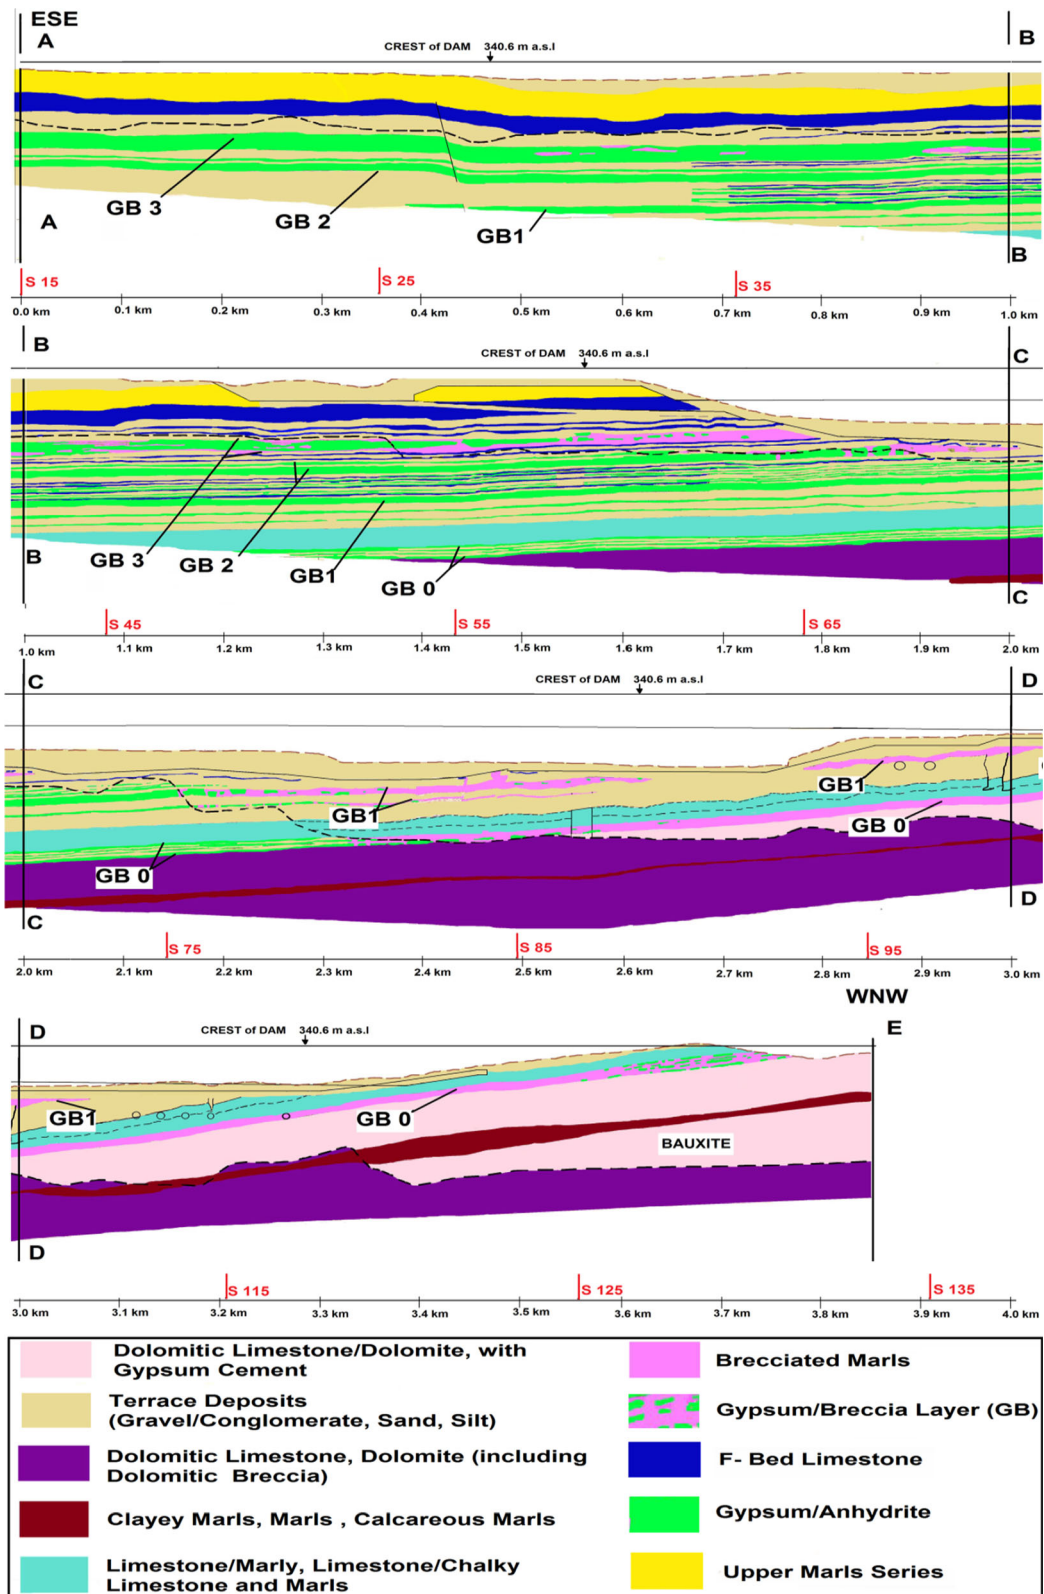
◀ **Fig. 8** Geological Cross Section along the axis of the dam

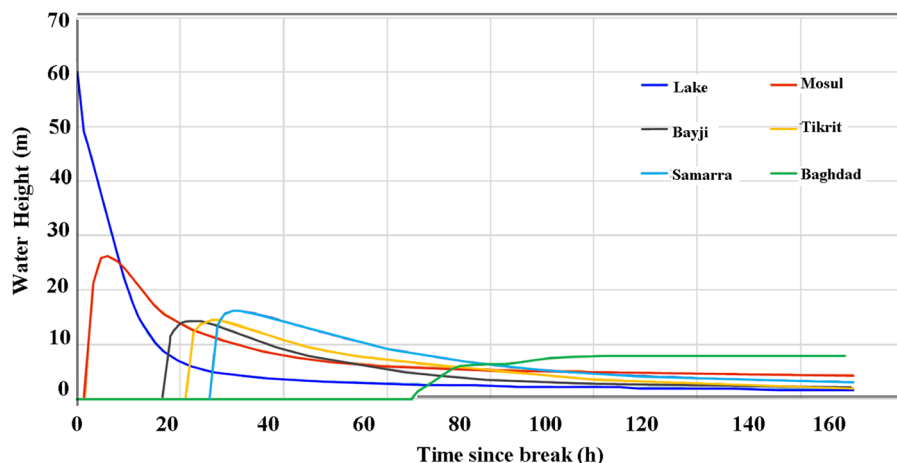
different reservoir levels and assuming bottom of the breach at level (252), breach area equals (26%) of the dam surface area, i.e. 40,560 m² out of 155,000 m². This table gives the peak height of the wave, time of arrival of the wave and time of arrival of its peak to five cities along the river. Accordingly, the wave will reach Mosul city after 1 h. 40 min. and Baghdad in 3.5 days. The maximum height will be about (26) meters and (8) meters in Mosul and Baghdad respectively. Figure 18 gives the wave peak height at five cities and its arrival time.

Fig. 18 Mosul Dam Break: Height-Time graph (Annunziato et al. 2016)

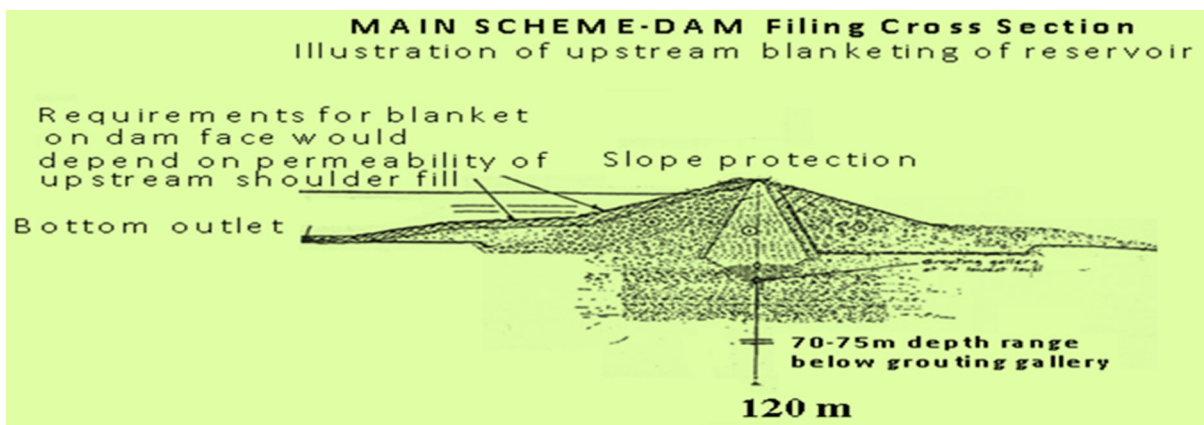
Fig. 19 Illustration of upstream blanketing arrangement

- c. Use of barriers: This can be achieved by:
 - i. Blanketing: Blanketing the upstream side of the dam and reservoir (Fig. 19). This is normal done by drawing down the reservoir and to avoid this, dropping the lining materials (bentonite pellets) through pipes lowered into the bottom of the pond then sand is placed on top to hold the clay in place against any disturbances. This method has not been used in reservoirs before.
 - ii. Positive cutoff: A cutoff wall is to be constructed as shown in Fig. 20. This procedure is very risky to be executed now on Mosul Dam. The risk involves the great height of the cutoff wall, hardness of pervious strata, presence of cavities and voids in the foundation, in addition to maintaining the verticality of the diaphragm panels at these unprecedented depths.

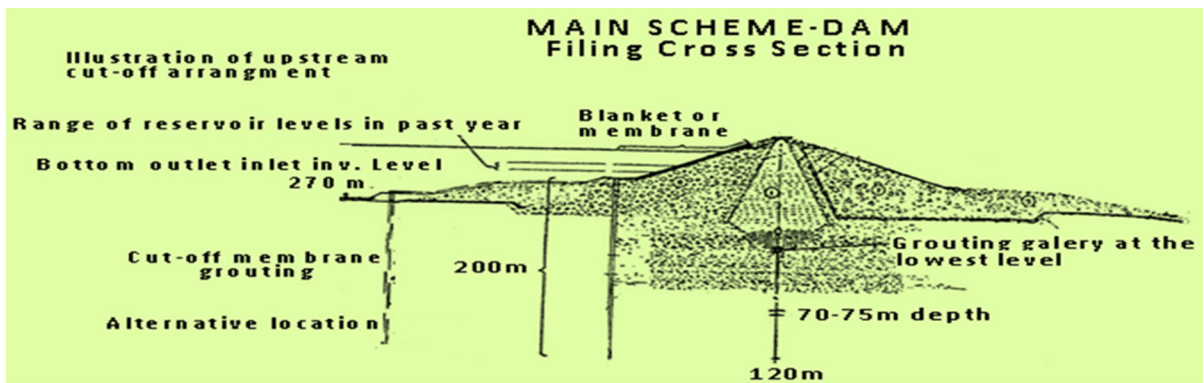
Fig. 20 Illustration of upstream cut-off arrangement

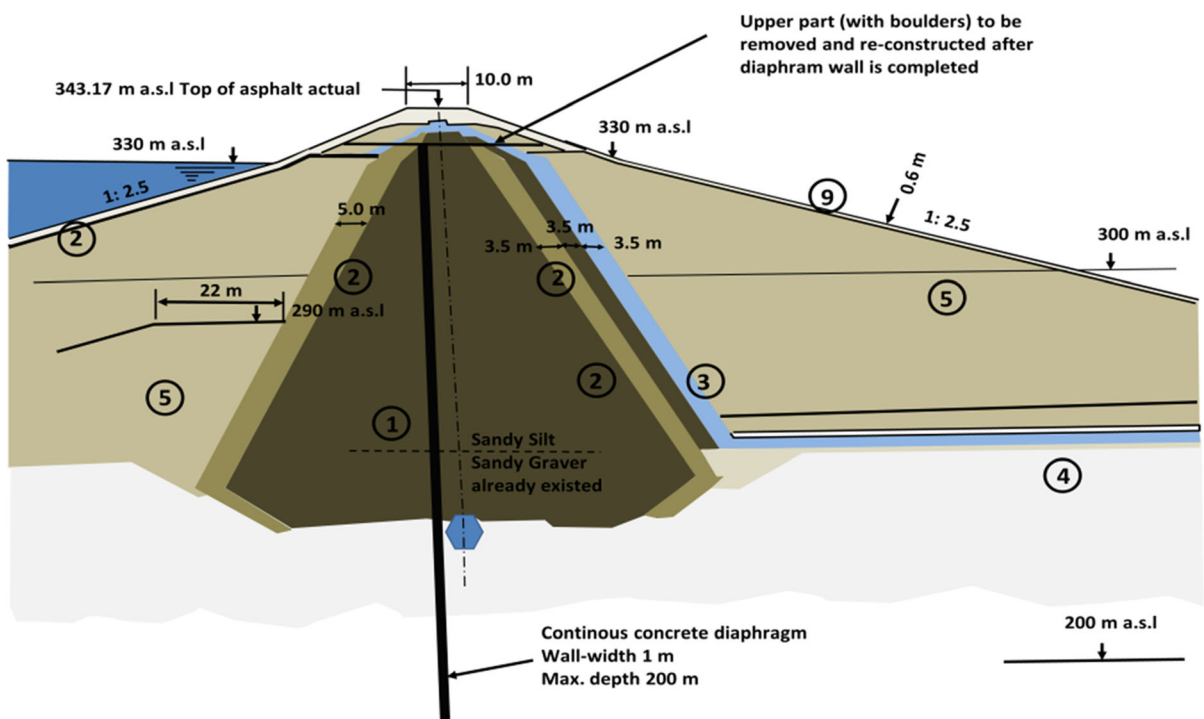
Fig. 21 Proposed Diaphragm driven from the dam crest

The fourth alternative was to construct a diaphragm wall from the upstream berm, with a sloping concrete facing from the top of the diaphragm to the top of the dam (Fig. 21). Or even to remove part of the top of the dam and install the diaphragm through the core in a location upstream of the gallery. This arrangement was attributed to the unavailability of machines that could cut to the desired level. In a later update, the removal of the dam top was thought unnecessary due to new development in diaphragm machines. The Board; however, judged this solution undesirable due to the required lowering of the reservoir level, which could extend 2–3 years in addition to the very high cost.
