Field reconnaissance and structural assessment of the October 30, 2020, Samos, Aegean Sea earthquake: an example of severe damage due to the basin effect

Onur Onat¹ · Burak Yön² · Mehmet Emin Öncü³ · Sadık Varolgüneş⁴ · Abdulhalim Karaşin³ · Selim Cemalgil²

Received: 14 July 2021 / Accepted: 9 December 2021 / Published online: 22 January 2022
© The Author(s), under exclusive licence to Springer Nature B.V. 2021

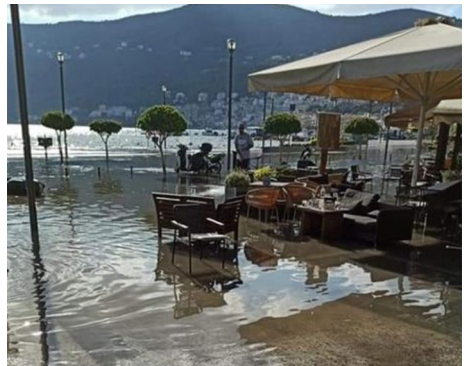
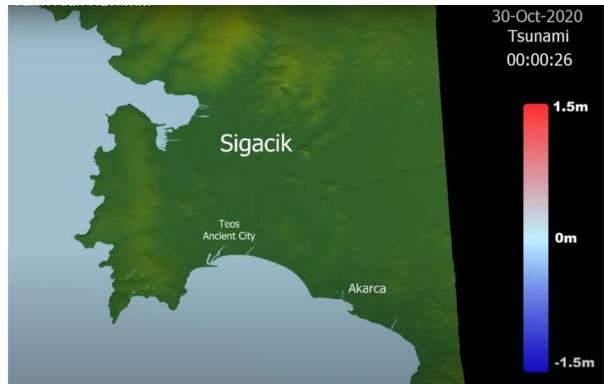
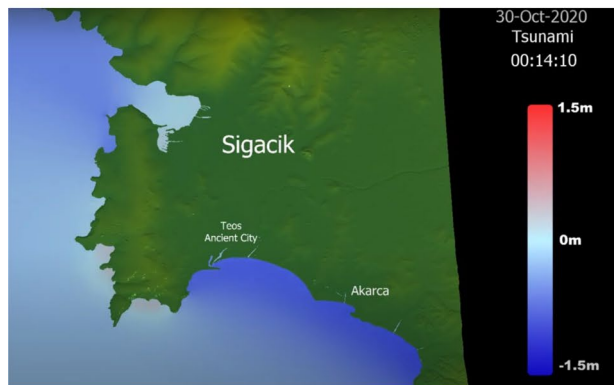
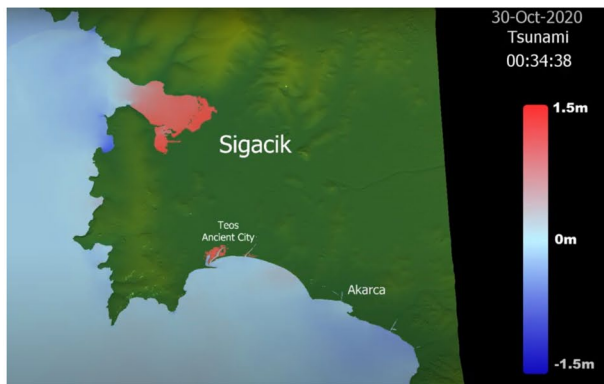
Fig. 44 Tsunami maximum inundation and flow depth simulation on coast of Izmir (METU 2020)

palm trees 50 m from the coast. At Kusadasi Davutlar Sevgi Beach, traces of the tsunami were found at the shelter for fisherman and at the canal entrance here. It was observed that the water level rose ~ 1 m in this region (METU 2020). Figure 44 depicts the tsunami and maximum wave height simulation.

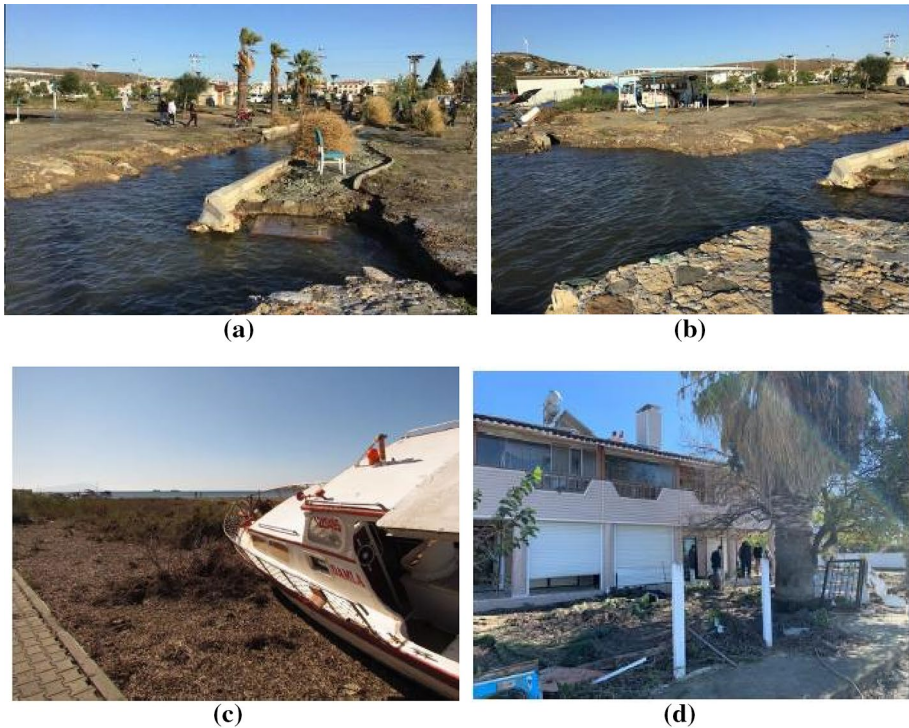
Fig. 45 a, b and c maximum inundation distance d maximum flow depth (METU 2020)

After the tsunami, the effect of it on the coast of Izmir and the structural system is presented in Fig. 45.
