Comparison of the Failures during Cyclic Oxidation of Yttria-Stabilized (7 to 8 Weight Percent) Zirconia Thermal Barrier Coatings Fabricated *via* Electron Beam Physical Vapor Deposition and Air Plasma Spray

N.M. YANAR, M. HELMINIAK, G.H. MEIER, and F.S. PETTIT

The failures during oxidation of electron beam physical vapor deposition (EBPVD) and air plasma spray (APS) yttria-stabilized zirconia (YSZ) thermal barrier coatings (TBCs) on different bond coats, namely, platinum-modified aluminide and NiCoCrAlY, are described. It is shown that oxidation of the bond coats, along with defects existing near the TBC/bond coat interface, plays a very important role in TBC failures. Procedures to improve TBC performance *via* modifying the oxidation characteristics of the bond coats and removing the as-processed defects are discussed. The influence of exposure conditions on TBC lives is described and factors such as cycle frequency and thermal gradients are discussed.

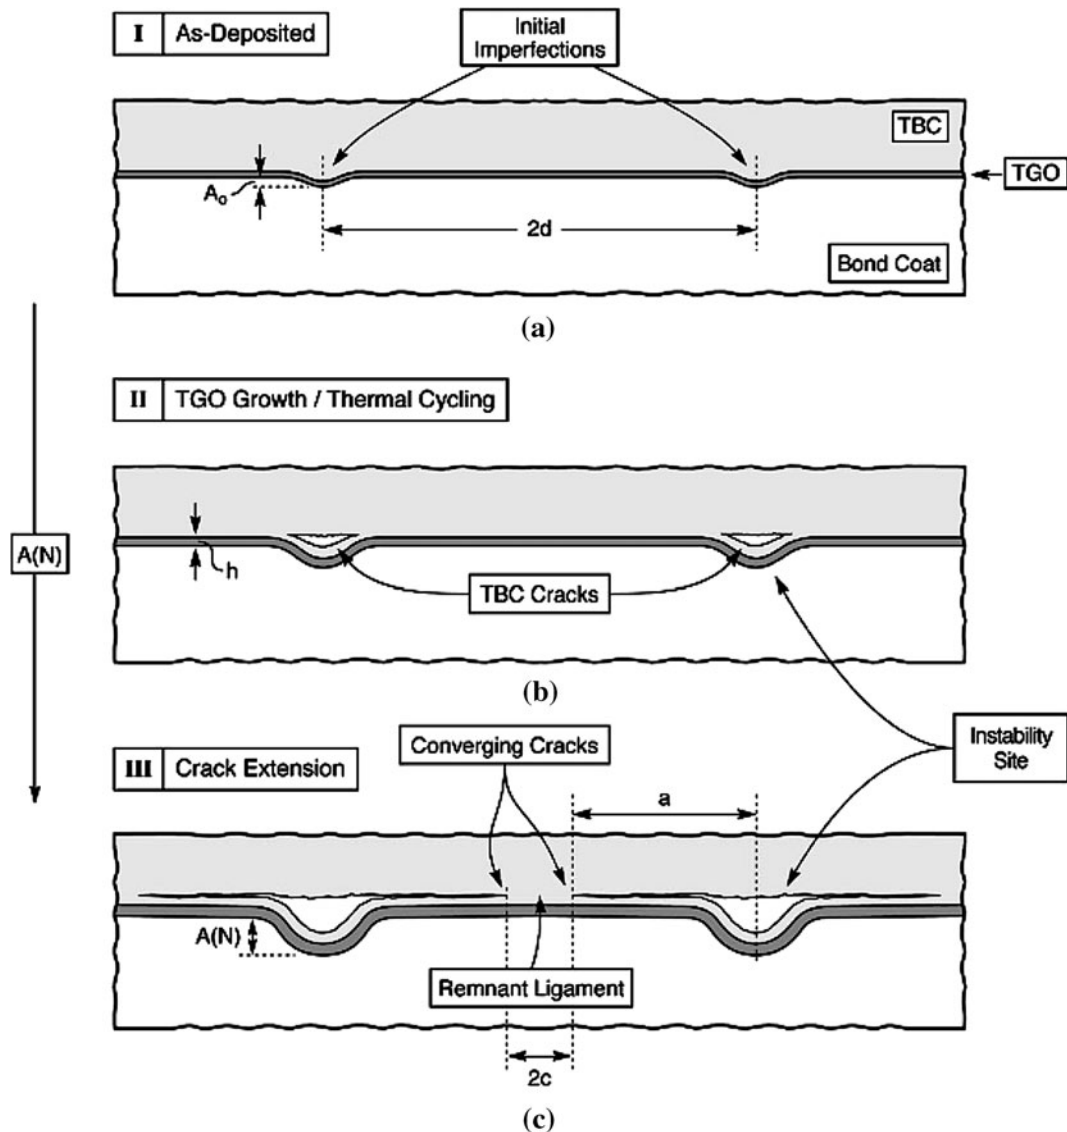
The rumpling/ratcheting type of failures originates in the vicinity of the TBC/TGO interface. As discussed by Hutchinson and Evans,^[10] there are also TBC failures within the thermal barrier layer. These failures consist of vertical separations in the TBC from which cracks develop and propagate laterally through the TBC. These vertical separations in the TBC are connected to the constraint on the thickening of the TGO forming near ridges on the bond coat surface (Figure 7).^[11] Since this growth cannot be accommodated, stresses are induced that form and widen the gap.

Fig. 6—(a) Failure of an EB-PVD TBC system driven by a cyclic instability in the thermally grown oxide layer. (b) Schematic illustrating the thermomechanical response of (Ni,Pt)Al-based bond coat, indicating the development of a displacement instability. (c) The associated crack nucleation and growth in the TBC and crack coalescence leading to coating spallation.^[4]

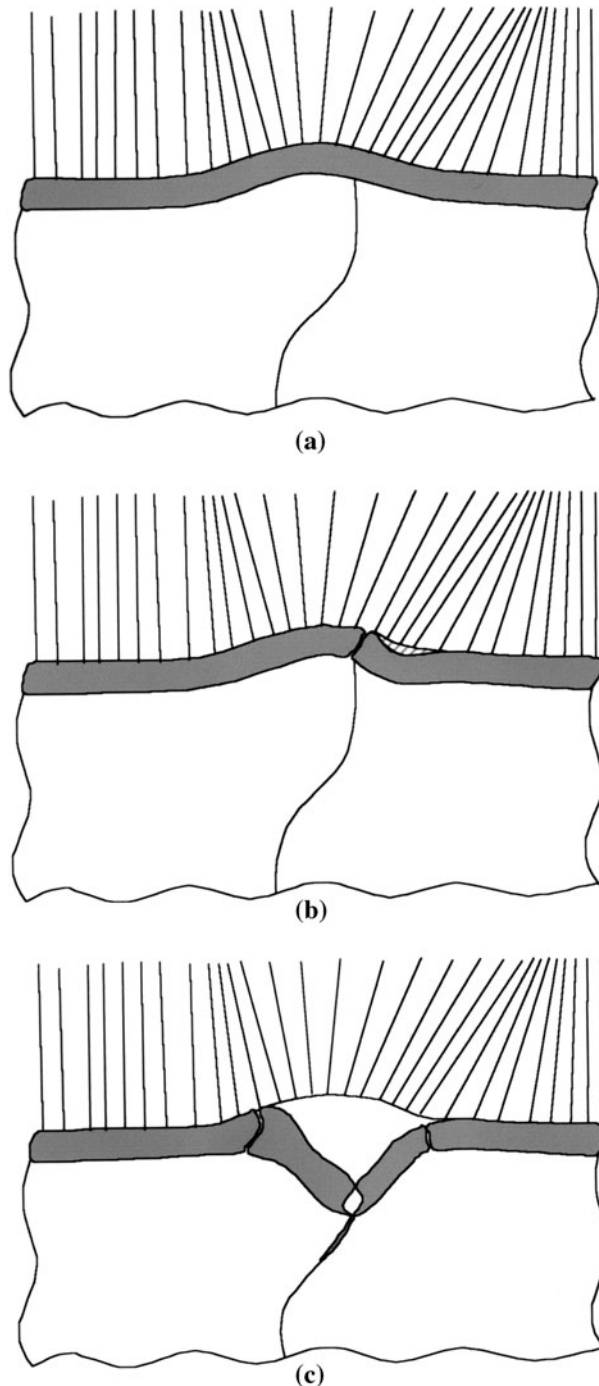
that cracks initiated at bond coat ridges due to out-of-plane tensile stresses formed at the peak of the ridges (Figure 8). These stresses are large enough to cause

cracking in the TGO above the ridges. The rapid transport of oxygen through these cracks results in preferential oxidation at grain boundaries in the bond coat. Plastic deformation of the bond coat and tensile stresses generated during cooling caused widening of these cracks into cavities and further grain boundary oxidation. This crack and cavity formation around the grain boundary ridges combined with the increase in strain energy as well as the reduction in bond strength along the TGO/bond coat interface resulted in failure of the TBC.

Fig. 8—(a) Schematic of thermal cycling mechanism in Pt-Al/EBPVD thermal barrier coatings. Microstructure of an as-received coating showing ridges. (b) Cracking of TGO provides a pathway to molecular oxygen and intergranular oxidation. (c) Grain boundary cracks widen into cavity and further intergranular oxidation occurs at the base of the cavity (reproduced by permission of 2404300334754).^[12]

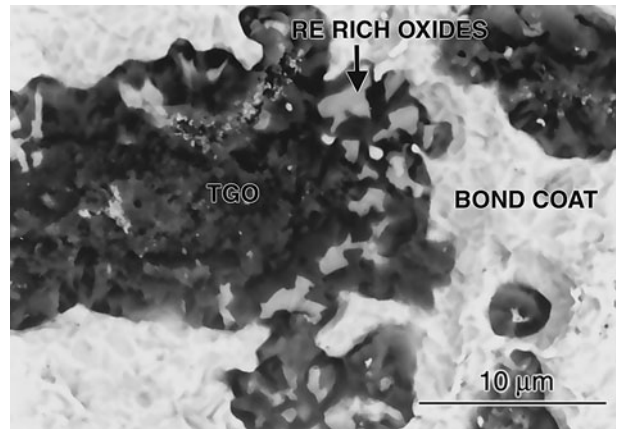
In the case of systems with NiCoCrAlY bond coats, the TGO develops thickness heterogeneities, which contain oxides other than alumina, namely, yttrium-rich oxides such as yttrium aluminum garnet. The magnitude of these heterogeneities, or pegs, is sensitive to the bond coat composition, especially the yttrium content of the coating. Xu *et al.*^[13] examined the failure of TBCs on such a system and concluded that these pegs do not seem to be an effective source of the multiple interface cracks needed to create a delamination of the TBC. These authors conclude that delaminations nucleate at large edge imperfections, which, once formed, extend quasi-stably along the interface but cut through the pegs leaving TGO islands embedded in the bond coat (Figure 9). The pegs and edge imperfections

Fig. 9—Scanning electron micrograph from the fracture surface of a NiCoCrAlY bond coat showing delaminations cutting through the pegs leaving TGO islands embedded in the bond coat.

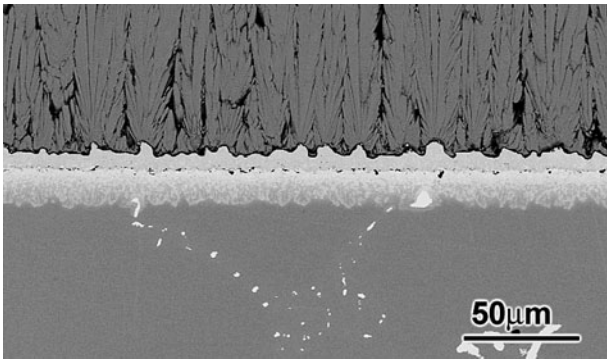
Fig. 17—Scanning electron micrograph of an as-processed EBPVD YSZ TBC on René N5 with a Pt overlayer.

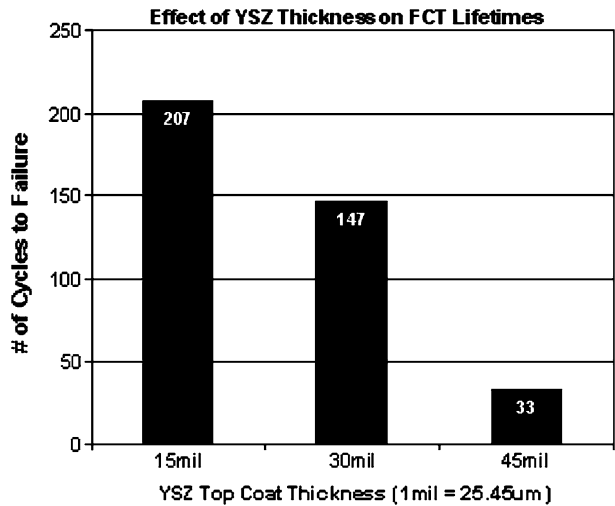
Fig. 19—Number of cycles to failure for APS YSZ TBCs with NiCoCrAlY bond coats and varying TBC thicknesses, cyclically exposed at 1373 K (1100 °C).

It has been found that the lives of APS TBC coated NiCoCrAlY coatings are strongly influenced by TBC thicknesses (Figure 19). Moreover, the failure modes can differ between thick and thin TBCs. For thick TBC (*e.g.*, 1125 µm), the failure is well into the TBC at splat boundaries (Figure 20(a)). As the TBC thickness is decreased, the failure moves toward the TBC/TGO interface and the failure mechanism is similar to that described previously for such TBC systems (Figure 20(b)). It has been found that APS TBC failures on NiCoCrAlY bond coats are also influenced by the alloy substrate (Figure 21).^[20]

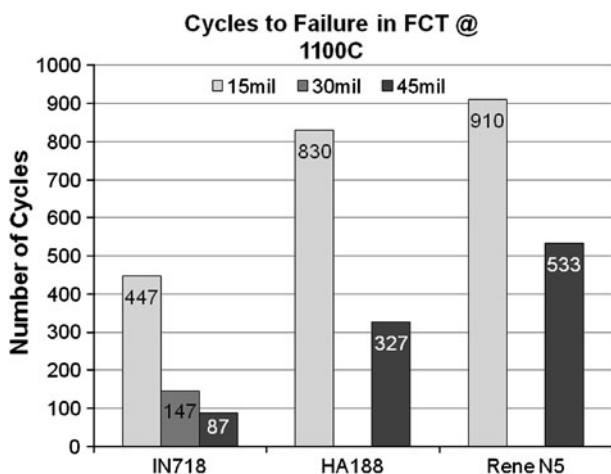
Fig. 21—Cycles to failure in a cyclic oxidation test at 1373 K (1100 °C) for APS YSZ TBCs on NiCoCrAlY bond coats with different TBC thicknesses on three different alloy substrates.

It has been found that the superalloy substrate also affects the lives of TBCs.^[20] A good correlation was shown between the cyclic life of the APS TBC and TBC/substrate CTE mismatch (Figure 38). The magnitude of the CTE mismatch between the superalloy substrate and top coat will affect the elastic strain energy stored in the topcoat during cooling from the exposure temperature. Larger strain energies will lead to shortened spallation lives. The superalloy substrate also affects the lives of TBCs *via* diffusion of elements from the superalloy into the bond coats. The effects of this interdiffusion may cause TBC lives to be increased or decreased depending upon the particular element. For example, when Hf diffuses into the bond coat the adherence of the TGO can be improved, which can result in longer TBC lives. On the other hand, the diffusion of tantalum into the bond coat can affect the composition of the TGO such that oxides other than alumina form in the TGO. Such a condition can adversely affect the lives of the TBC.

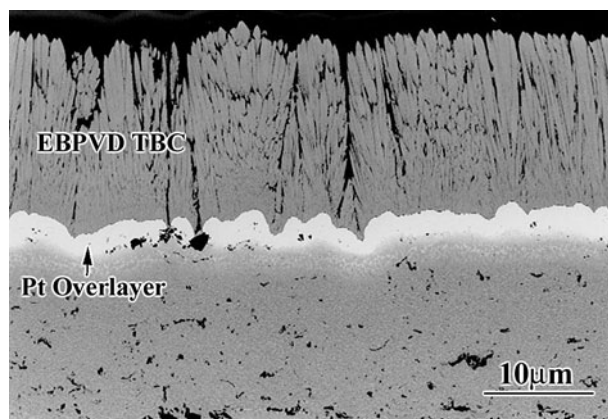
Fig. 23—Scanning micrograph of an as-processed NiCoCrAlY bond coat with a platinum overlayer.

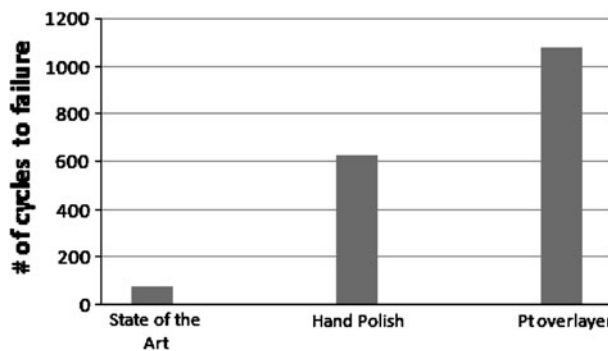
Fig. 24—Average failure times for TBC systems with modified NiCoCrAlY bond coats that were exposed to cyclic oxidation at 1373 K (1100 °C).

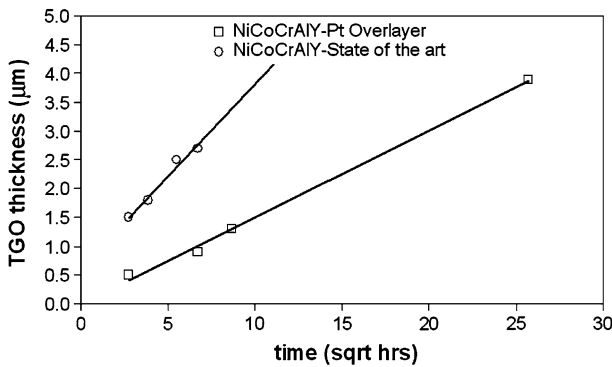
Figure 25. The TGO is thick due to reactive element oxides in the TGO, but the TBC/TGO interface is very smooth and free from most of the defects. The TBC system with the NiCoCrAlY bond coat with the Pt overlayer is presented in Figure 26. Cracks are evident in the TBC. The growth rate of the TGO is slower compared to the growth rate of the TGO on the state-of-the-art NiCoCrAlY systems (Figure 27).

Fig. 27—TGO thickness vs. square root of time for an EBPVD YSZ TBC with a Pt overlayer on a NiCoCrAlY bond coat and for a state-of-the-art NiCoCrAlY bond coat at 1373 K (1100 °C).

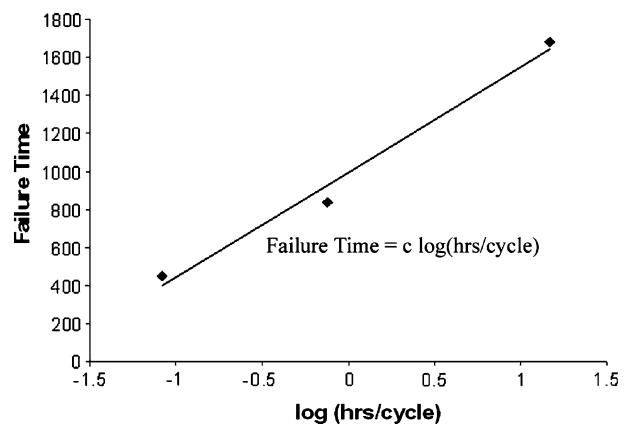
The effect of cycle frequency on the failure of EBPVD TBCs was found to differ for systems with NiCoCrAlY and Pt-aluminide bond coats.^[21] Table III presents data for the effect of cycle frequency on both the number of cycles to failure and the hot time to failure of state-of-the-art EBPVD TBCs with NiCoCrAlY and Pt-aluminide bond coats. Approximate results for the hot time of exposure under the isothermal condition, which will result in spallation during cooling, are included. Table III indicates the hot time to failure of TBCs with Pt-aluminide bond coats decreases markedly as the cycle frequency is increased. Figure 31 indicates that the hot time to failure

Fig. 31—Failure times for EBPVD YSZ TBCs on platinum aluminide bond coats for cyclic oxidation at 1373 K (1100 °C) as a function of cycle length.

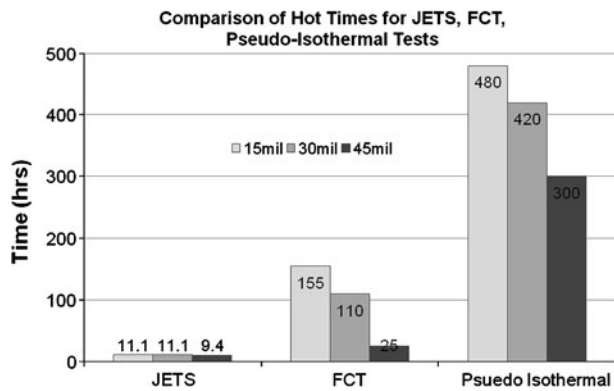
The effect of cycle frequency was apparent on the hot time to failure for APS TBCs subjected to different thermal tests. The hot time to failure for identical 350 to 1100 μm APS TBCs on argon-shrouded NiCoCrAlY bond coats with IN718 substrates that were thermally cycled in two different tests, the FCT and the pseudo-isothermal tests, is shown in Figure 35. In each of these

Fig. 35—Comparison of hot times for JETS, FCT, and pseudo-isothermal tests of IN718-NiCoCrAlY-APS TBC systems (1 mil = 25.45 μm) with different YSZ TBC thicknesses.

tests, the heating and cooling periods were identical so the only difference in the temperature-time profiles was the length of the isothermal hold at 1373 K (1100 °C). As shown by the graph, the hot time to failure was increased by reducing the number of heating and cooling periods (*i.e.*, switching from FCT testing to pseudo-isothermal testing). Furthermore, the JETS test, which has the most rapid cycling (20 seconds heating, 20 seconds cooling, and 40 seconds ambient cooling), had the shortest hot time to failure, followed by the FCT test, and then the pseudo-isothermal test. However, it should be noted that the JETS test induces a thermal gradient over the TBC, which is different from the other two tests, so another factor besides thermal cycle frequency may be involved here. Nonetheless, comparison of only the FCT and pseudo-isothermal testing results indicates the presence of a thermal cycle frequency effect.

Figure 35 compares the hot time and cycles to failure of the porous APS TBCs on IN 718 substrates (*i.e.*, those in Figure 20) in three different tests: JETS, FCT, and a “pseudo-isothermal test.” The hot time to failure in all three tests is reduced as the topcoat thickness is

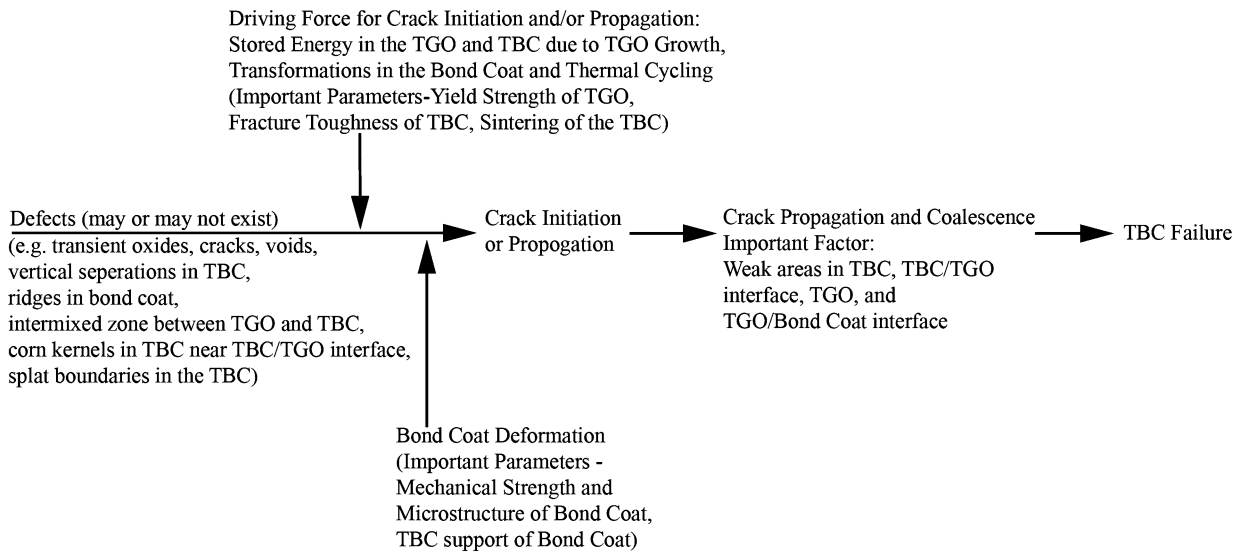
shown in Figure 37 is presented in order to attempt to provide a qualitative description applicable to all of these failures. Defects may be present in the TBC system, and if not, cracks will eventually develop upon exposure at elevated temperatures coupled with thermal cycling. The important factors are the stored energy in the TGO and TBC due to growth of the TGO, phase transformations in the bond coat, and thermal cycling of the TBC system coupled with bond coat deformation, sintering of the TBC, TGO relaxation, and TBC fracture toughness. Cracks, once formed, propagate and coalesce until failure occurs.

Fig. 37—Sequential diagram showing qualitatively the factors that can affect TBC failure.

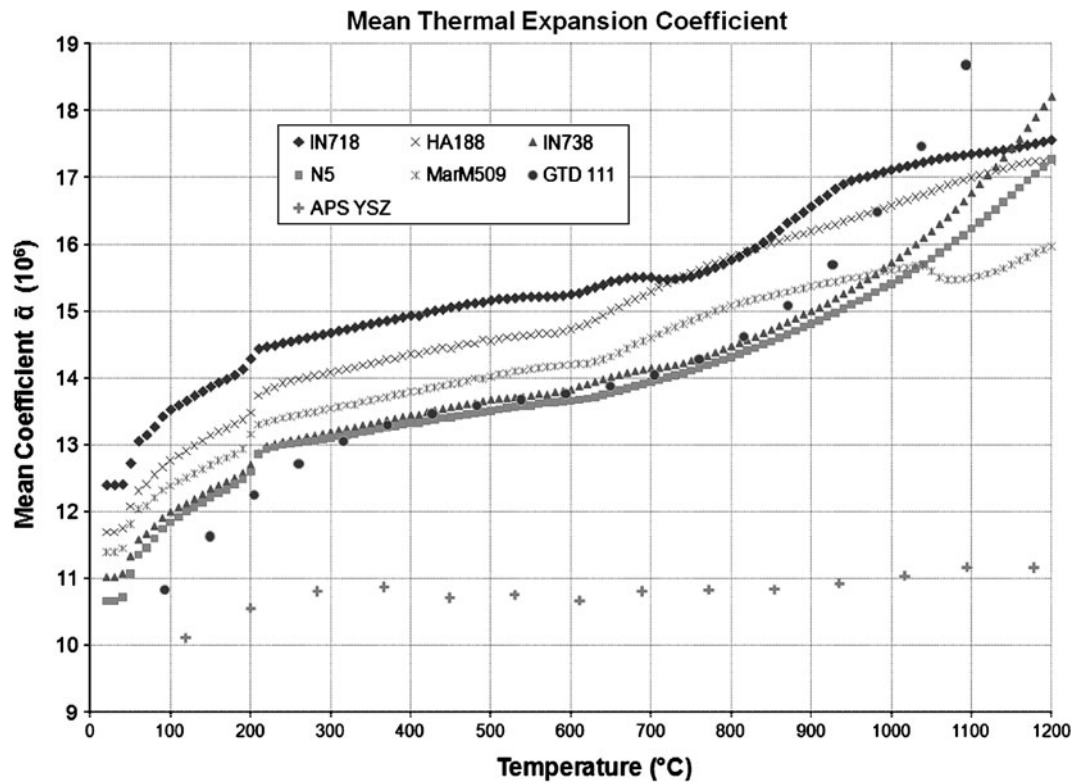
Fig. 38—Coefficients of thermal expansion for some relevant alloys as a function of temperature.
