Corrosion of 1.4016 Ferritic Steel by Urea at High Temperature

Anastasiia Galakhova, Fabian Kadisch, Gregor Mori, Susanne Heyder, Helmut Wieser, Bernhard Sartory, Jaroslav Wosik, Sabine Schwarz, and Simon Burger

Submitted: 7 June 2022 / Revised: 22 August 2022 / Accepted: 19 January 2023 / Published online: 9 March 2023

The corrosion behavior of a ferritic unstabilized stainless steel 1.4016 during decomposition of aqueous urea solution at high temperature has been investigated. Corrosion was obtained from 100 h of cyclic heating (from room temperature up to 600 °C) and injection of aqueous urea solution on the steel plate in a laboratory-scale test bench. The evaluation procedure covered the metallographic analysis of corroded steel samples by high-resolution scanning electron microscopy (HR-SEM) and transmission electron microscopy (TEM). Uniform corrosion underneath deposits was found as one of the drivers for degradation of the steel. Damage happened by high-temperature depassivation of stainless steel due to the excess of the aggressive medium. Besides uniform corrosion, a nitridation layer underneath surface oxides together with chromium carbonitride particles precipitated

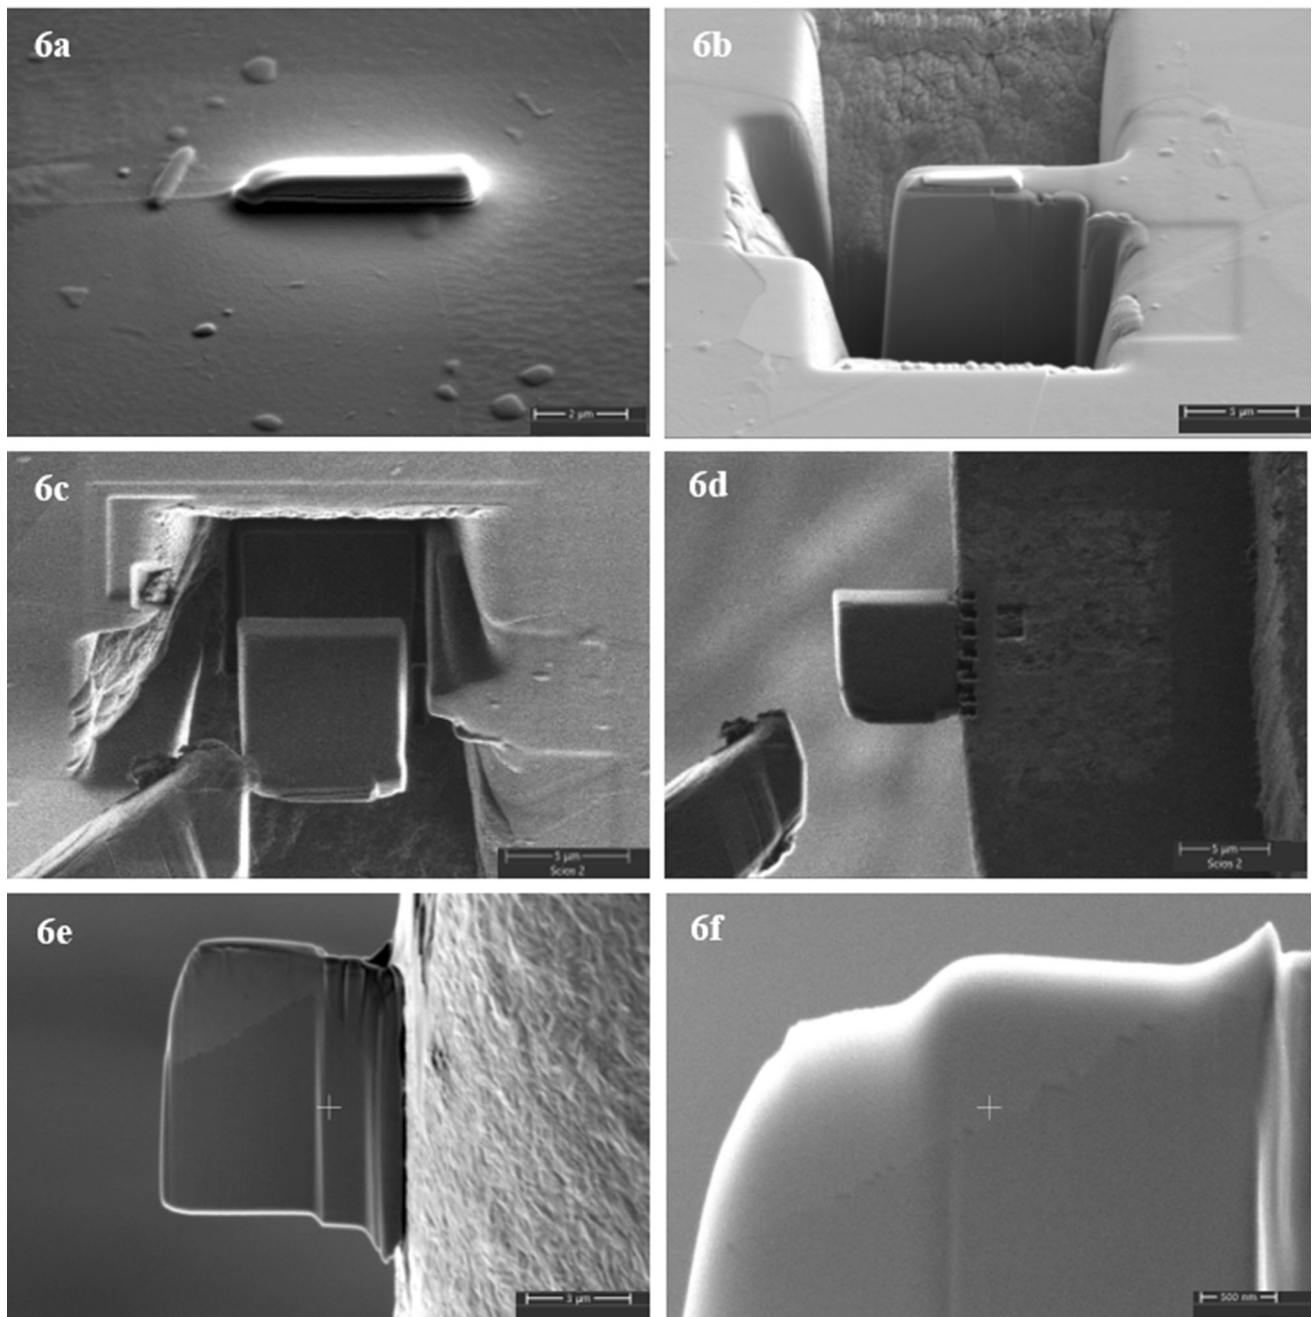
this purpose, focused ion beam (FIB) instrument has been used to prepare a thin specimen from the same corroded area A (Fig. 6).

FIB lift-out specimen was prepared in a cross section geometry to produce a lamella perpendicular to the polished surface of the bulk sample. After selecting the region of interest for specimen extraction, Pt layers were deposited in order to protect and frame the region of interest (Fig. 6a). Afterward, “C”-shaped channels were milled around the Pt protected area (Fig. 6b). A “bridge” was left at one of the short edges of the specimen to support the specimen until it is cut free from the bulk sample. Finally, the specimen was lifted out of bulk sample by a micromanipulator needle and transferred to the FIB TEM grid holder at 90° angle between the surfaces of the specimen and the grid (Fig. 6c and d). The final FIB thinning of lamella was performed in two thicknesses: Thinner part is generally preferable for TEM analysis, and thicker part is preferable for EDS analysis (Fig. 6e and f).

Fig. 6 FIB preparation of the lamella from the corroded sample in area A for TEM analysis. (a) Pt layer deposition, (b) “C” channel milling, (c, d) transfer of specimen to grid holder, (e, f) final thinning of lamella
