Failure of Multilayer Suspension Plasma Sprayed Thermal Barrier Coatings in the Presence of Na₂SO₄ and NaCl at 900 °C

Abstract The current investigation focuses on understanding the influence of a columnar microstructure and a sealing layer on the corrosion behavior of suspension plasma sprayed thermal barrier coatings (TBCs). Two different TBC systems were studied in this work. First is a double layer made of a composite of gadolinium zirconate + yttria stabilized zirconia (YSZ) deposited on top of YSZ. Second is a triple layer made of dense gadolinium zirconate deposited on top of gadolinium zirconate + YSZ over YSZ. Cyclic corrosion tests were conducted between 25 and 900 °C with an exposure time of 8 h at 900 °C. 75 wt.% Na₂SO₄ + 25 wt.% NaCl were used as the corrosive salts at a concentration of 6 mg/cm². Scanning electron microscopy analysis of the samples' cross sections showed that severe bond coat degradation had taken place for both the TBC systems, and the extent of bond coat degradation was relatively higher in the triple-layer system. It is believed that the sealing layer in the triple-layer system reduced the number of infiltration channels for the molten salts which

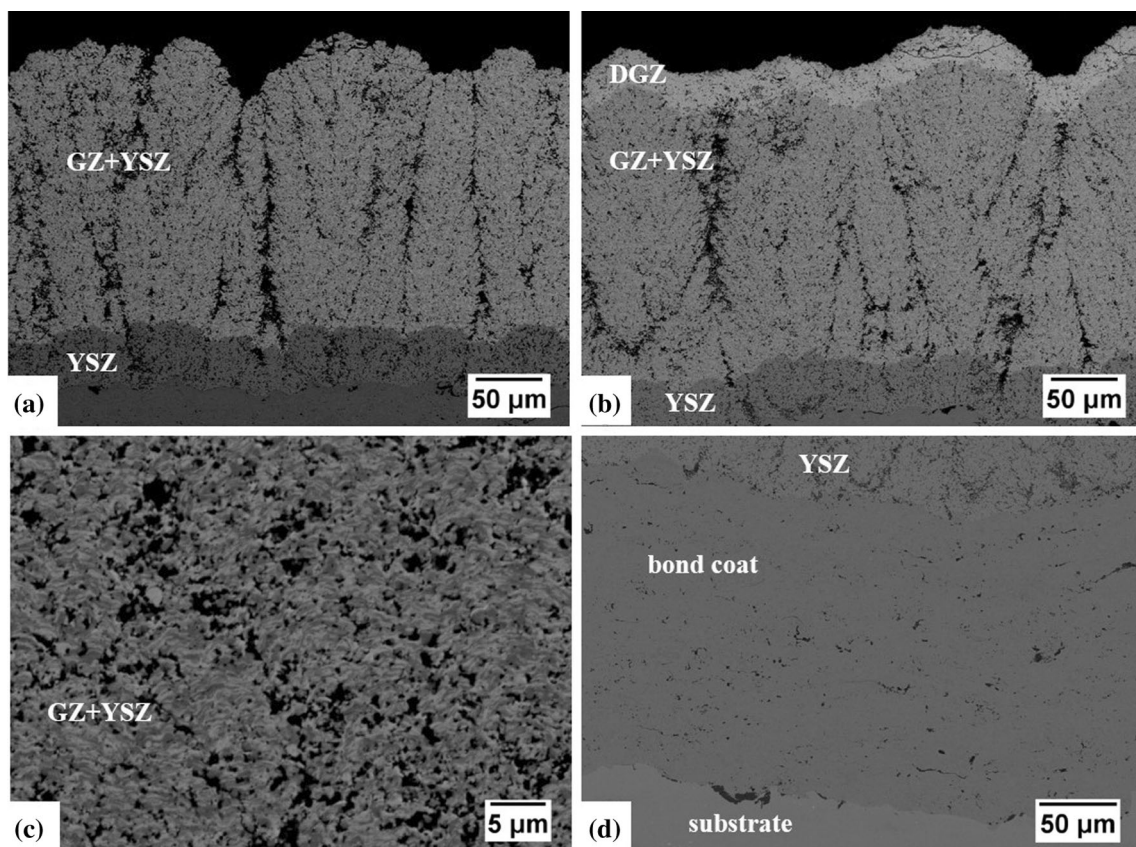
Figure 2(a)–(c) shows the SEM images of the as-received double-layer (see Fig. 2a) and triple-layer (see Fig. 2b) coating systems, respectively. The nominal thickness of YSZ layer is 40 μm , GZ + YSZ layer is 210 μm , and the DGZ layer is 30 μm . Columnar structure for YSZ and GZ + YSZ layer can be observed. The third layer (DGZ) is compact and does not have a columnar structure. Fig-

Fig. 2 Cross-sectional SEM images of as-received (a) double-layer GZ + YSZ/YSZ, (b) triple-layer DGZ/GZ + YSZ/YSZ, (c) high magnification image of GZ + YSZ in (a), and (d) bond coat

ure 2(c) shows the high magnification image of the GZ + YSZ layer where both the gadolinium zirconate and yttria-stabilized zirconia are present. Figure 2(d) shows the HVAF sprayed bond coat layer with a dense microstructure. Good bond coat/YSZ, YSZ/GZ + YSZ and GZ + YSZ/DGZ interface, free from cracks, were observed.
