Liquid Metal-Assisted Cracking During Hot-Dip Galvanizing of Complex Structures: A Case Study

Abstract A pipe rack assembly uses hot-dip galvanized trusses joined together by screw connections. The welded trusses were manufactured with ASTM A572 gr.50 W steel profiles. Two of them fractured during the galvanizing bath. The fractures presented typical characteristics of the LMAC — liquid metal-assisted cracking mechanism. In both cases, the fracture was located in the structural element base metal and followed the fillet weld to the neighboring elements at a distance beyond the heat-affected zone. The trusses height was greater than the depth of the molten zinc vat, and double immersion is required for complete galvanization. The failed trusses had a particular geometry, distinct from the others. The design of the trusses was verified taking into account the thermal stresses generated by the partial immersion in the zinc bath. Among all, only the two broken trusses were exposed to stresses of thermal origin substantially higher than the material yield strength. Metallographic analysis revealed secondary intergranular cracks near the fracture surface. The crack roots contained zinc.

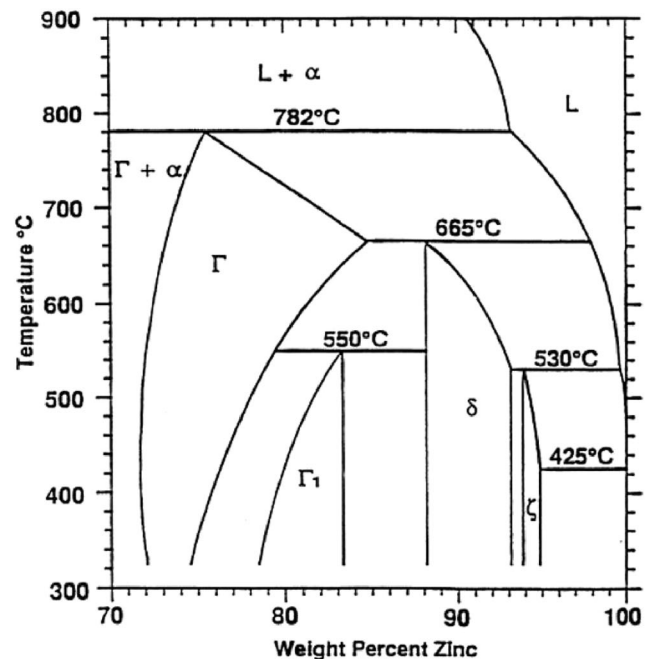
Fig. 3 Zn-Fe system intermetallic layers resulting from the hot galvanizing of a carbon steel: A) typical galvanizing microstructure (1) gamma prime phase (Γ_1); (2) delta phase (δ); (3) zeta phase (ζ) B) zinc-rich corner of the Fe-Zn binary phase diagram [6]

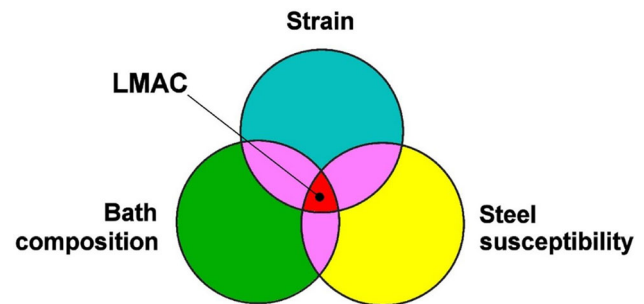
Fig. 9 LMAC mechanism factors diagram: the superposition of the effects controls the activity of this mechanism. This new conceptual version of the classic diagram replaces mechanical loading by the strain imposed on the material during the zinc bath

The crack propagation by LMAC during the galvanizing process depends directly on the localized strain presented by the truss. It justifies the reformulation of the classic diagram that explains the contributing factors for this kind of damage. It is proposed to replace “mechanical loading” usually considered a factor on the literature by “strain”, Fig. 9.
