Microstructural Aspects of Premature Pitting Corrosion of Steel Pipe–Case Study

Dorota Tyrała · Bogdan Pawłowski

Abstract A premature pitting corrosion in seam-welded 3-inch L235 steel pipe was reported to occur after 8 years in service. This pipe was part of a closed ice water cooling system, where the inlet water temperature was 6 °C and the outlet water temperature was 11 °C. The present work aimed to investigate the causes of this premature pitting corrosion of the pipe through metallographic investigations. This work comprised a visual examination of the internal surfaces of the pipe and microstructural examinations of the corrosion perforation regions (pitting corrosion areas) using optical and scanning electron microscopy (SEM) with energy dispersive X-ray (EDX) analysis. The investigations showed that the corrosion pits occurred only in areas with a huge number of specific micro-voids that can be associated with the excessive presence of trapped hydrogen dissolved in the steel, probably during steelmaking operations.

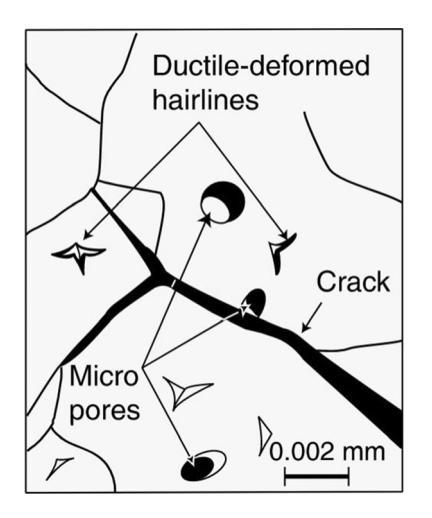
According to the diagram (Fig. 8) presented in an extensive study by the Graz University of Technology [16], the microstructure defects observed in this study are probably caused by the presence of dissolved hydrogen in the steel.

Fig. 8 The microstructure defects caused by hydrogen (scheme by Axel Rossmann)

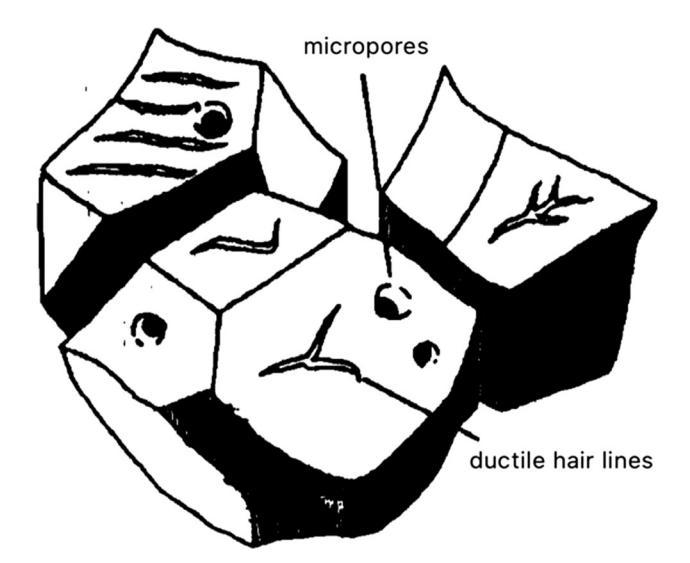
accumulates at voids or defects within the steel, forming molecular hydrogen (Fig. 9). The molecular hydrogen leads to an inner pressure increment and microcrack initiation which consequently accelerates the pitting corrosion processes [20].

Fig. 9 The microstructure defects caused by hydrogen (scheme by Engel and Klingele)
