Fan Blade Fatigue Fractures in CFM56-7B Engines

M. R. Fox · W. R. Rossey Jr. · M. Raguet

Abstract The National Transportation Safety Board investigated two accidents involving fan blade fatigue fractures in CFM International CFM56-7B engines. Fatigue cracks developed in the Ti-6Al-4V blades in an area of high contact stresses in the dovetail. Additional cracked blades were found using nondestructive inspections developed after the first accident. Although the blades had been shot peened, many of the blades had relaxed compressive residual stress profiles at the surface, making them more susceptible to fatigue crack initiation under the combined effects of loading/friction changes over time, coating condition, surface condition, and engine operational differences. Flight cycle estimates based on striation counting on the fracture surfaces revealed that blades with normal residual stress profiles had been overhauled after cracks had initiated, masking the original surface condition. As a result of investigation findings, new procedures were developed, including more frequent dovetail lubrications, improved visual inspection procedures, and new ultrasonic testing and eddy current pr

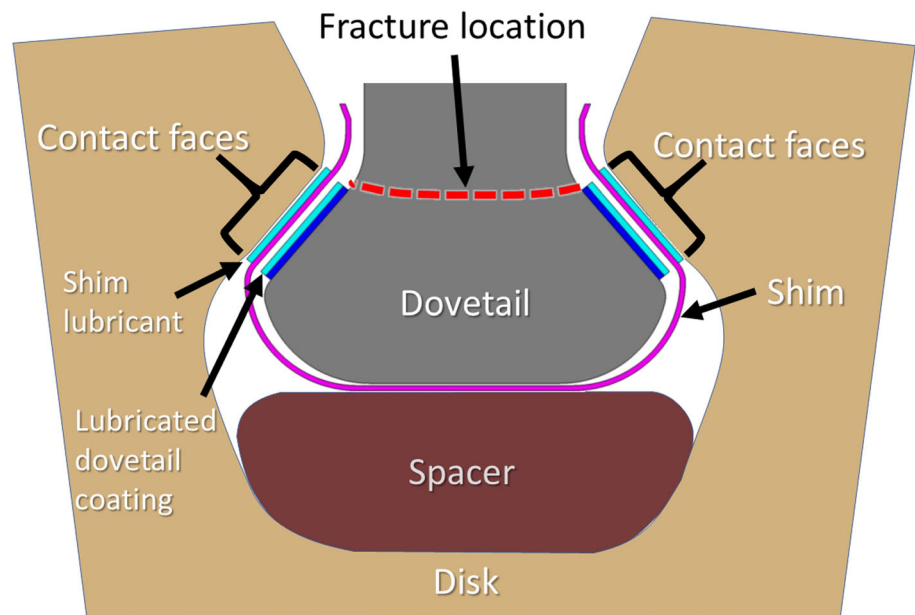
Fig. 2 Fan blade dovetail cross section diagram as presented at the NTSB public meeting convened to discuss and adopt NTSB Accident Report NTSB/AAR-19/03

In the 2016 accident, blade 23 had fractured in the dovetail at the location indicated in Fig. 2, and most of the remainder of the blade was not recovered. The remaining blades were intact but had impact damage at the leading and trailing edges such as the blades adjacent to blade 23. Many of the shims and dovetails were damaged consistent with blade movement after blade 23 fractured.
