# The Synergy Between Corrosion and Fatigue: Failure Analysis of an Aerator and a Cooling Tower

Luciano da Rocha Magalhães · Rodrigo Freitas da Silva Alvarenga · Flávio Augusto Coelho Resende · Leonardo Rosa Ribeiro da Silva

**Abstract** Corroded points can act as stress concentrators, usually resulting in the component failure at fewer cycles than was initially projected. Aerators are widely used in waste treatment units for chemical and biological control. Due to the chemically aggressive environment to which these components are subjected, they usually fail due to corrosion in one or more components. Cooling towers are one of the most applied equipment for temperature control in industrial processes. Due to generally hostile environments and operating conditions, this equipment is subject to failures which almost always lead to system imbalance followed by the catastrophic failure of the component. This work investigates the synergic effect of corrosion and fatigue in two separate case studies. In the first, the wear of the mixing shaft of an aerator was investigated. It was observed that the root cause of wear was the corrosion of the dissimilar welded joints in the mixing bl

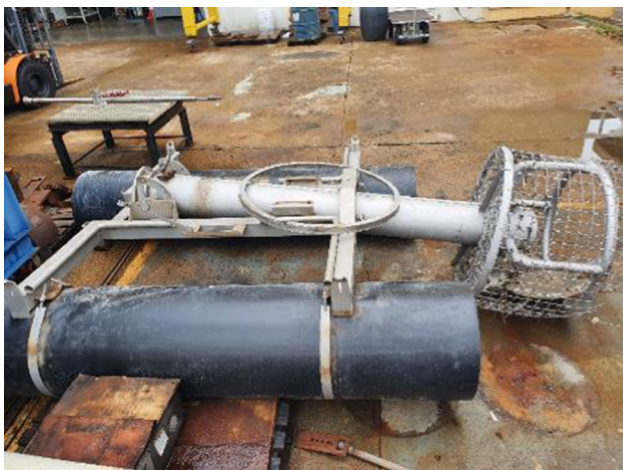
**Fig. 3** Overview of the aerator submitted for analysis

**Fig. 4** Mixer plate highlighting the blades that were already broken and the advanced corrosion in the welded joint

broken blades

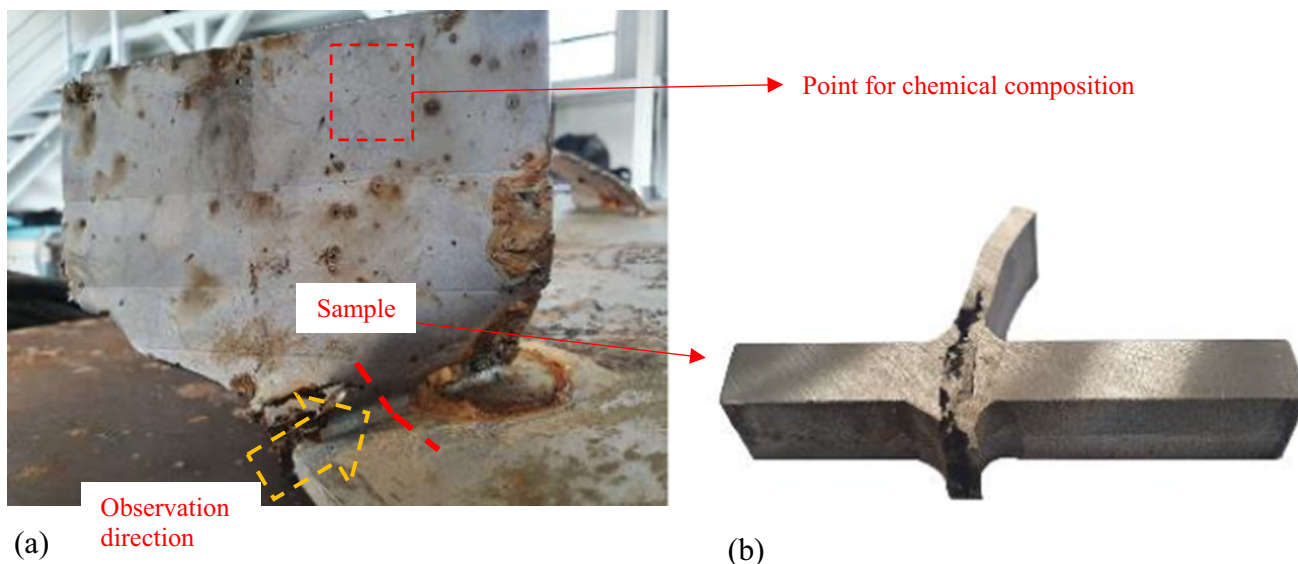
**Fig. 7** Sampling points from the plate/blade assembly, where (a) shows the blade still attached to the plate and (b) is the cross section of the weld bead for corrosion analysis

**Fig. 9** Photographs of assembled propellers (left) and fractured components (right)

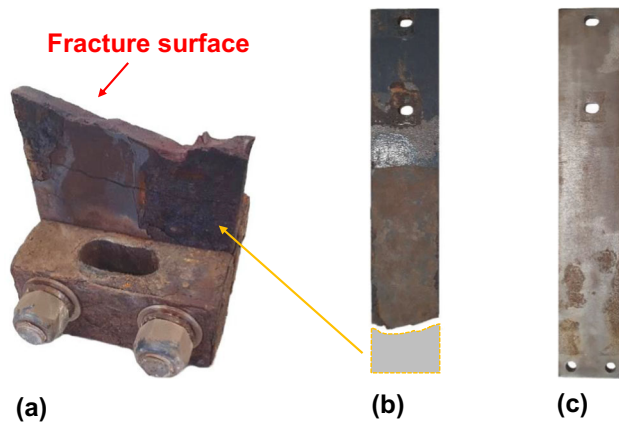
The components sent by the company for analysis are shown in Fig. 10. The fractured rod (center) was sent along with its support (left). The intact shaft (that is, one that did not fracture or present any crack) was sent without support.

**Fig. 10** Fractured shaft (a) and (b) and intact (c) shaft, as received for analysis

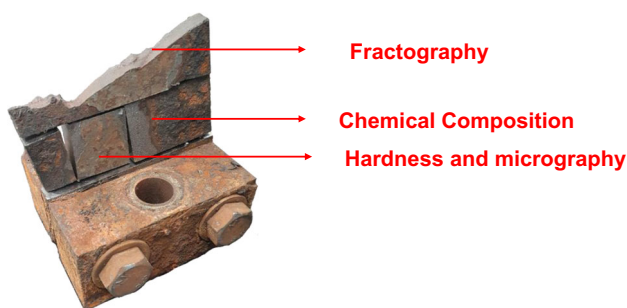
Samples were taken from the locations as shown in Fig. 12, with an indication of the analyzes that were carried out on each sample. These cuts were performed using a refrigerated abrasive disk, in such a way as to preserve the original microstructure.

**Fig. 12** The fracture surface analyzed with an emphasis on the sample withdrawal region

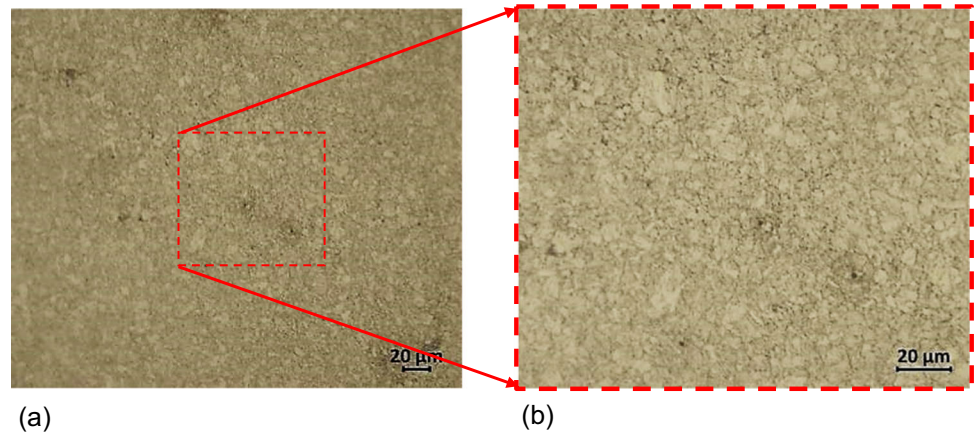
The microstructures found can be seen in Fig. 21 for the fractured sample and Fig. 22 for the intact sample. It is possible to observe a quenched and tempered martensitic microstructure in both samples, with no variation in the components’ thickness. No evidence of nonconformity in relation to the microstructure that could cause component fracture was found.

**Fig. 21** Micrographs of the microstructure of the fractured sample revealed with 2% Nital

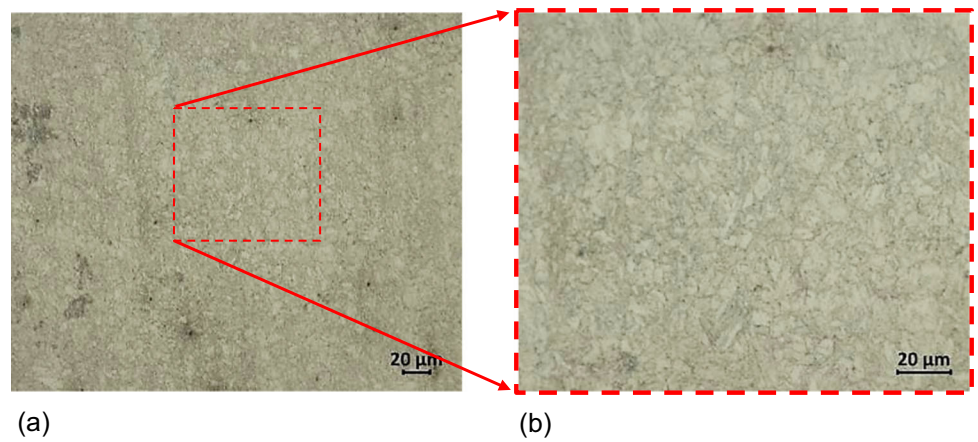
**Fig. 22** Micrographs of the intact sample microstructure were developed with 2% Nital

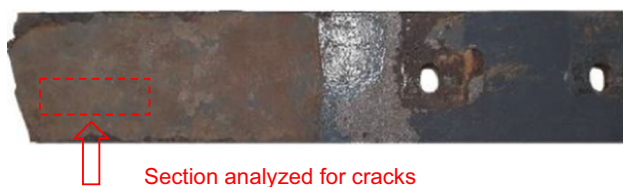
In order to confirm the hypothesis of cracks being formed from points of localized corrosion (which functioned as points of stress concentration), samples were taken from both rods, as shown in Fig. 25. Each sample was approximately 40 mm in thickness and length, having been analyzed in the longitudinal section of the stem.

**Fig. 25** Place of removal of samples to search for cracks
